**Northwest Hydraulic Consultants Ltd.**

NHC Reference 3008460  
May 10, 2024

**Re:** **Barnston Island Dike Assessment Update 2023**  
**Preliminary Report, Final**

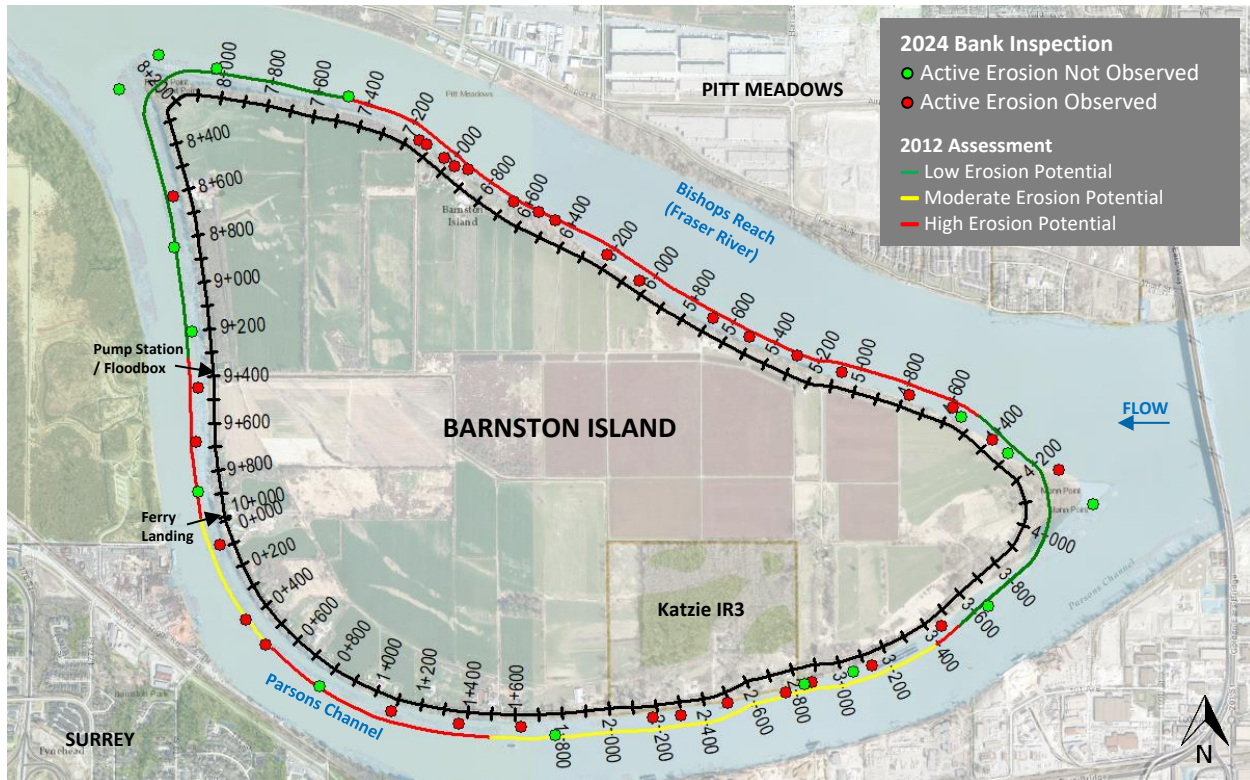
**Figure 2 Summary of March 14, 2024 bank inspection observation locations, and erosion areas identified in the 2012 Assessment**

Bank conditions along Parsons Channel were generally similar to that observed in 2012. Notable erosion sites are as follows:

- The riverbank is actively eroding in the vicinity of Station 3+495. This location was also noted in the 2012 Assessment. The dike centreline is 35 m from the bank, and there is minimal mature vegetation between the dike and bank.
- Near Station 2+850, a timber crib wall that supports the bank near a power pole has sustained some damage from a leaning tree.

- Along Katzie IR3 (Station 2+000 to Station 2+825), some locations are actively eroding, with failed riprap observed near Station 2+750. The dike centreline is 60 m to 70 m from bank upstream of Station 2+600, and generally within 30 m downstream of that.

The bank inspection was intended to document visible erosion along the upper bank at low tide/ flow. The inspection does not provide insight on potential larger-scale bank retreat due to channel migration and scour. A more detailed bank erosion study is recommended.

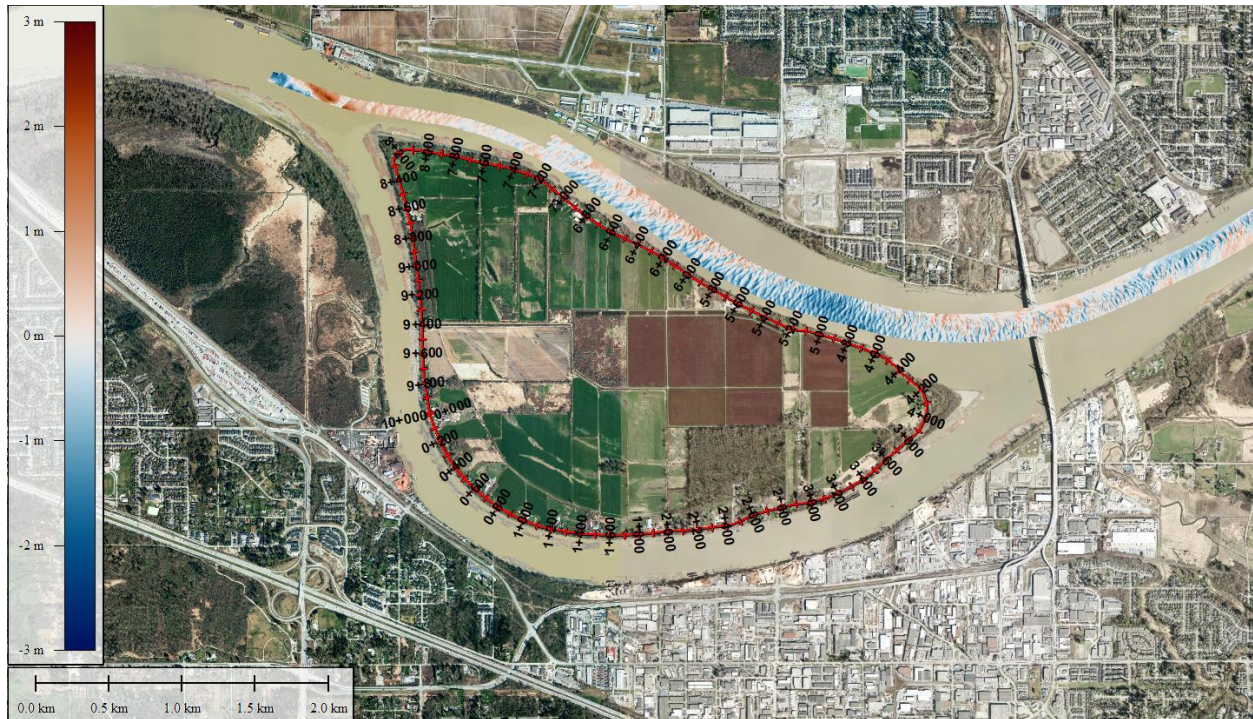
**Figure 4 Bathymetry changes in Bishops Reach from 2015 to 2021 (PSPC data)**

Based on Public Services and Procurement Canada's (PSPC's) multibeam data, Figure 4 shows bed level changes in Bishops Reach from August 2015 to October 2021. A blue colour indicates bed lowering (degradation) and red a build up of material (aggradation). The channel lowering, roughly off-set from Station 4+600 to 5+000 indicates there could be some future undermining of the bank, raising concern as the dike is set back from the bank by only a relatively short distance (less than 20 m). This type of

bank erosion has been observed elsewhere along the lower Fraser River, where the bank line was previously stable for decades but then suddenly retreated.

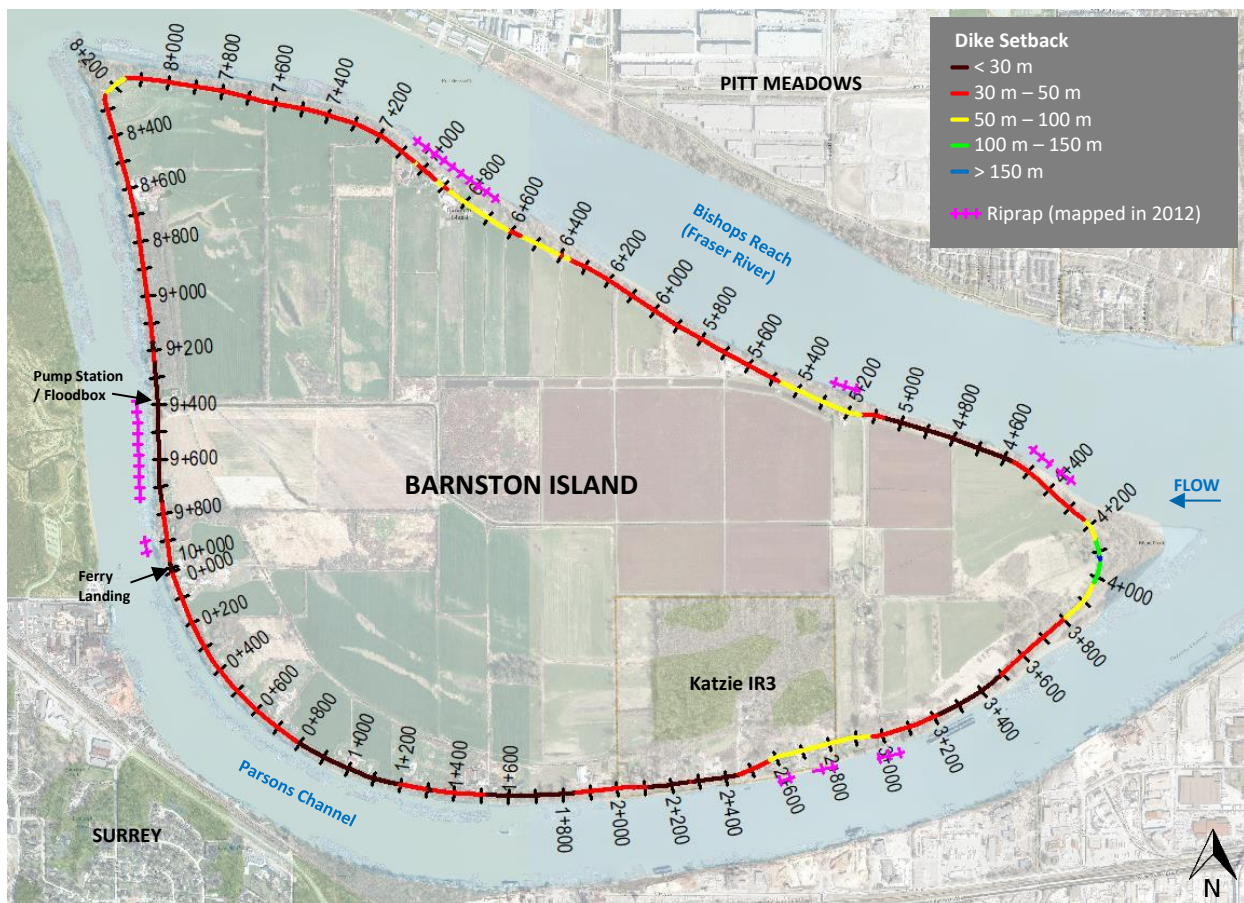
**Figure 5** Dike centreline setback from the active channel (based on 2022 Google Earth imagery), and locations of existing riprap (mapped in the 2012 Assessment)

Erosion hazard for the existing dike was assessed through a simplified analysis, which classified the distance from the dike centreline to the bank of the active channel. Results are shown in Figure 5, along with locations where riprap (of varying condition) is present, as mapped in 2012. Most of the dike has a centreline within 50 m of the channel, vulnerable to dike erosion hazard. About 2.5 km of the dike has its centreline within 30 m of the channel, and most of these locations have no existing riprap along banks. Mature vegetation is important for arresting upper bank retreat that could encroach upon the dike.

A more detailed bank erosion study involving bathymetric surveys is recommended to identify bank protection requirements in more detail. The objective of such a study would be to better understand erosion hazard at Barnston Island, to identify potential threats to the dike in its current alignment, and to develop recommendations for erosion mitigation measures. This study is particularly important if new fill is to be placed on the riverside of the dike along Bishops Reach, disturbing existing vegetation.

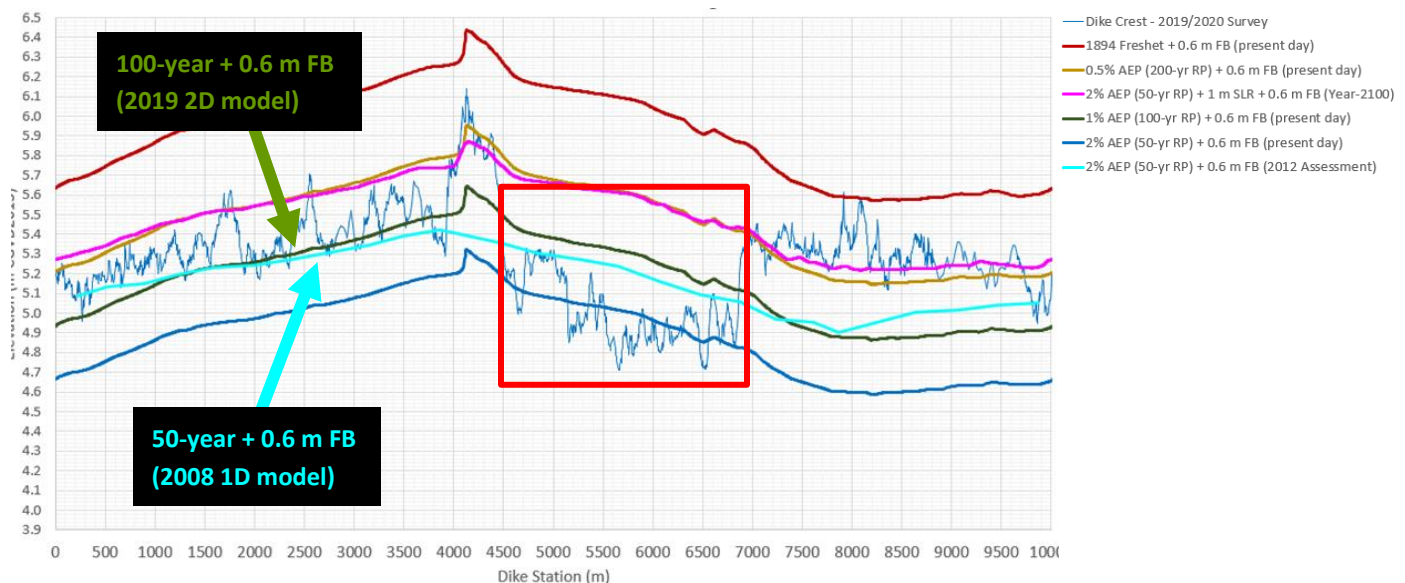
**Figure 6** Existing dike crest profile and simulated design flood elevations for various return periods, showing approximate location where dike raise is recommended

The main location requiring raising is an approximately 2.5 km-length along the north side of Barnston Island. This location is shown on the dike crest profile in Figure 6, and on the map in Figure 7. To meet the recommended height, the dike must be raised by approximately 0.2 m to 0.5 m.

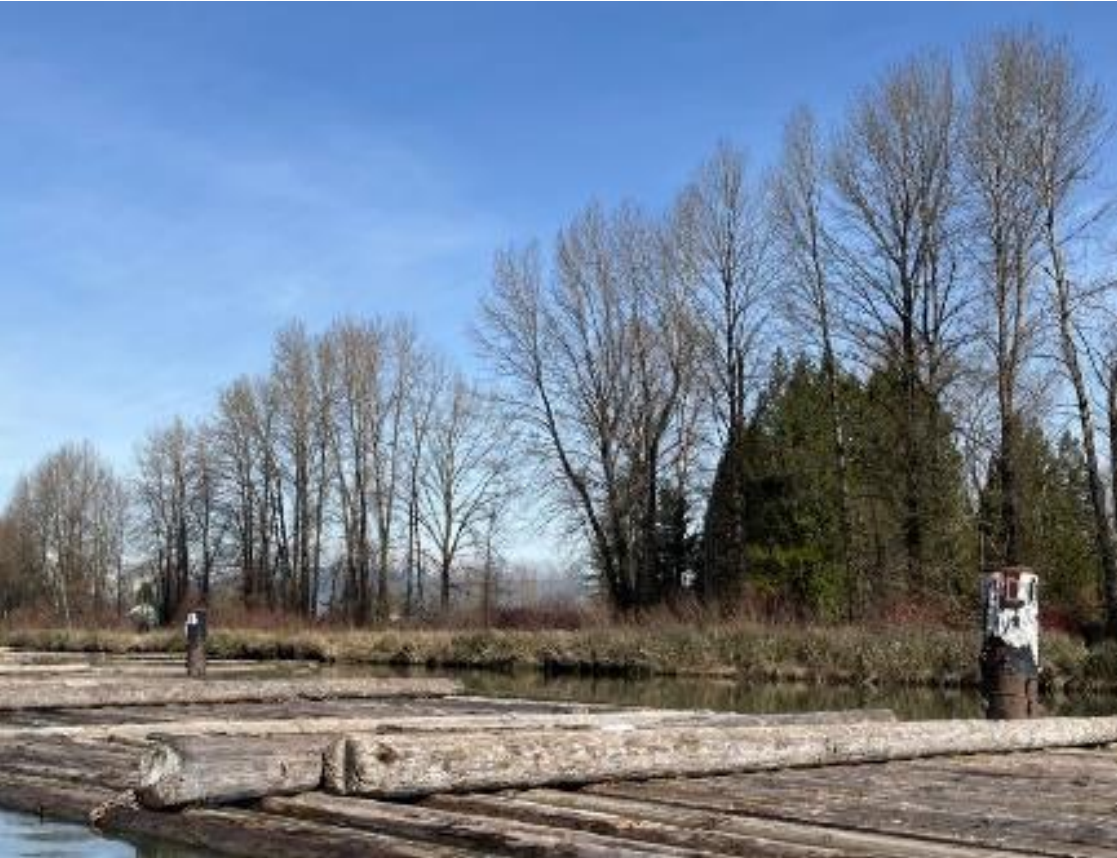
<div>Dike Station</div> <div>0+400</div>	<div>Inspection Location</div> <div>

</div>
<div>Active Erosion</div> <div>Yes</div>	<div>Bank Protection</div> <div>No</div>
<div>Notes</div> <div>Bank is generally steep and showing signs of erosion. Some mature trees are present between bank and dike.</div>

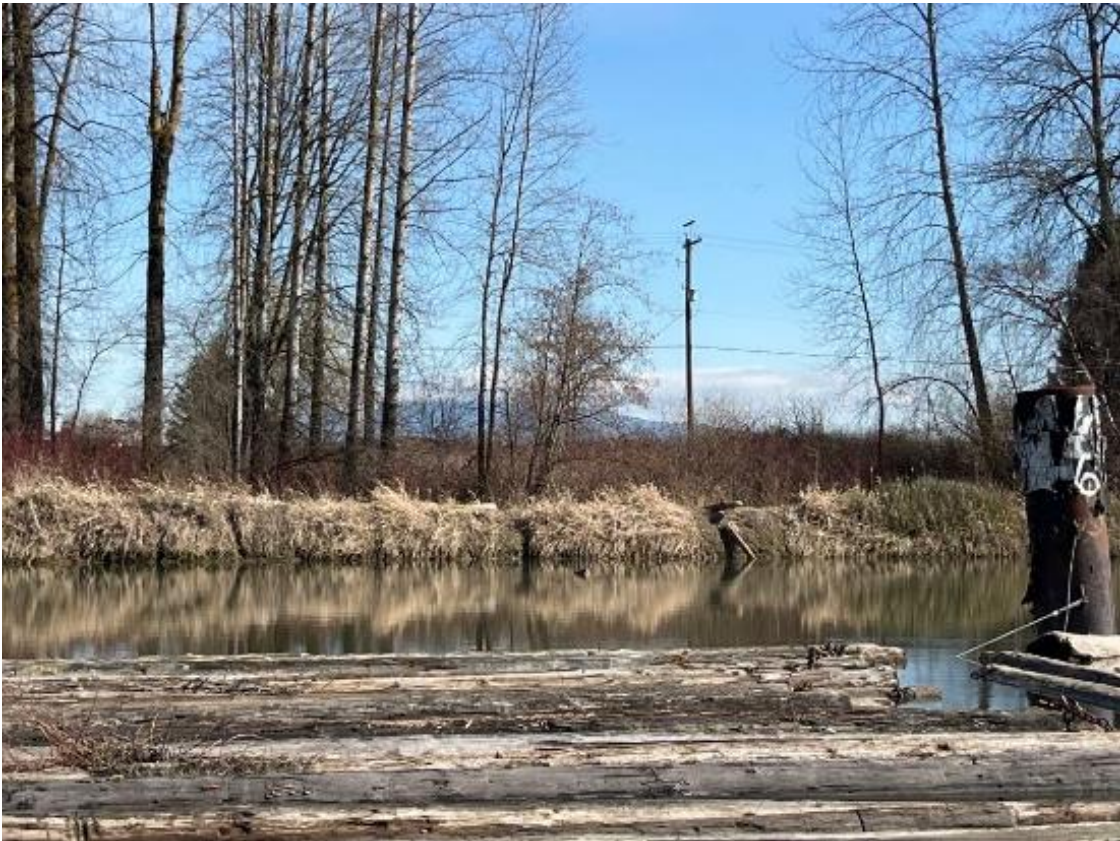
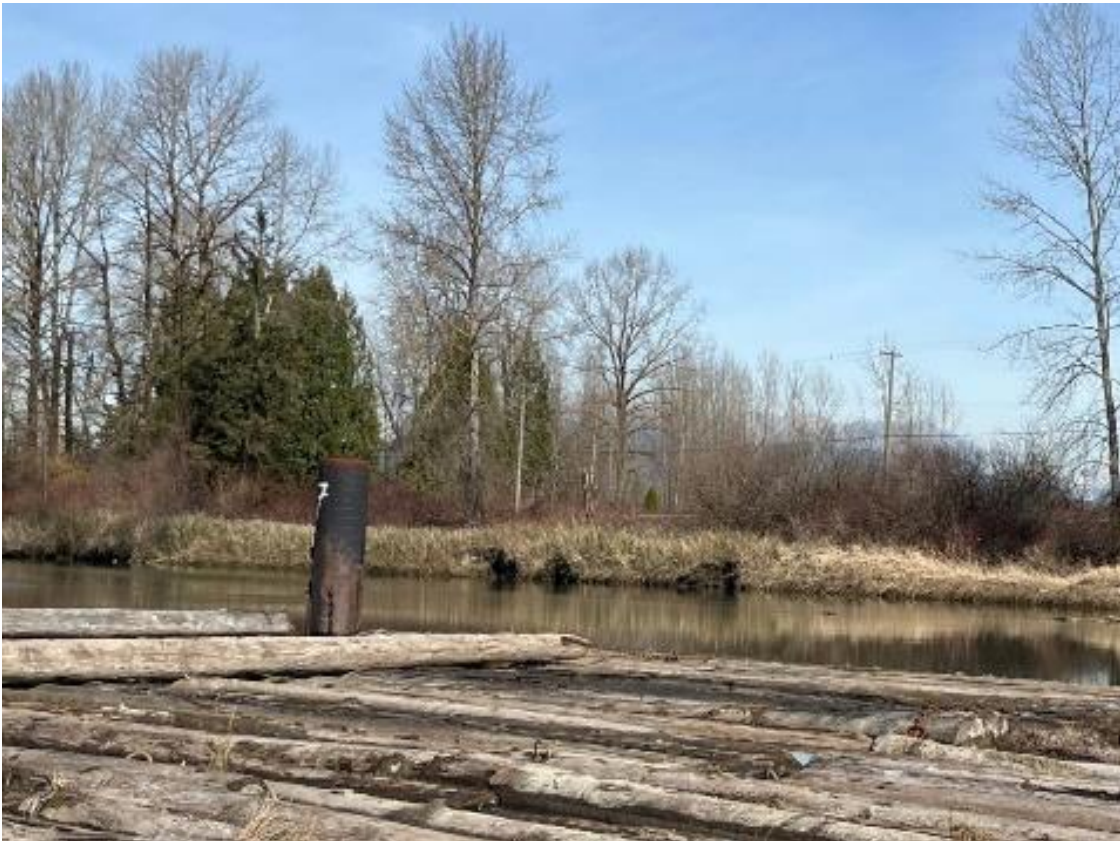
<div>Dike Station</div> <div>0+525</div>	<div>Inspection Location</div> <div>

</div>
<div>Active Erosion</div> <div>Yes</div>	<div>Bank Protection</div> <div>No</div>
<div>Notes</div> <div>Sandy bank covered with grassy vegetation, localized near-vertical banks. Mature vegetation grows between eroding bank and dike.</div>

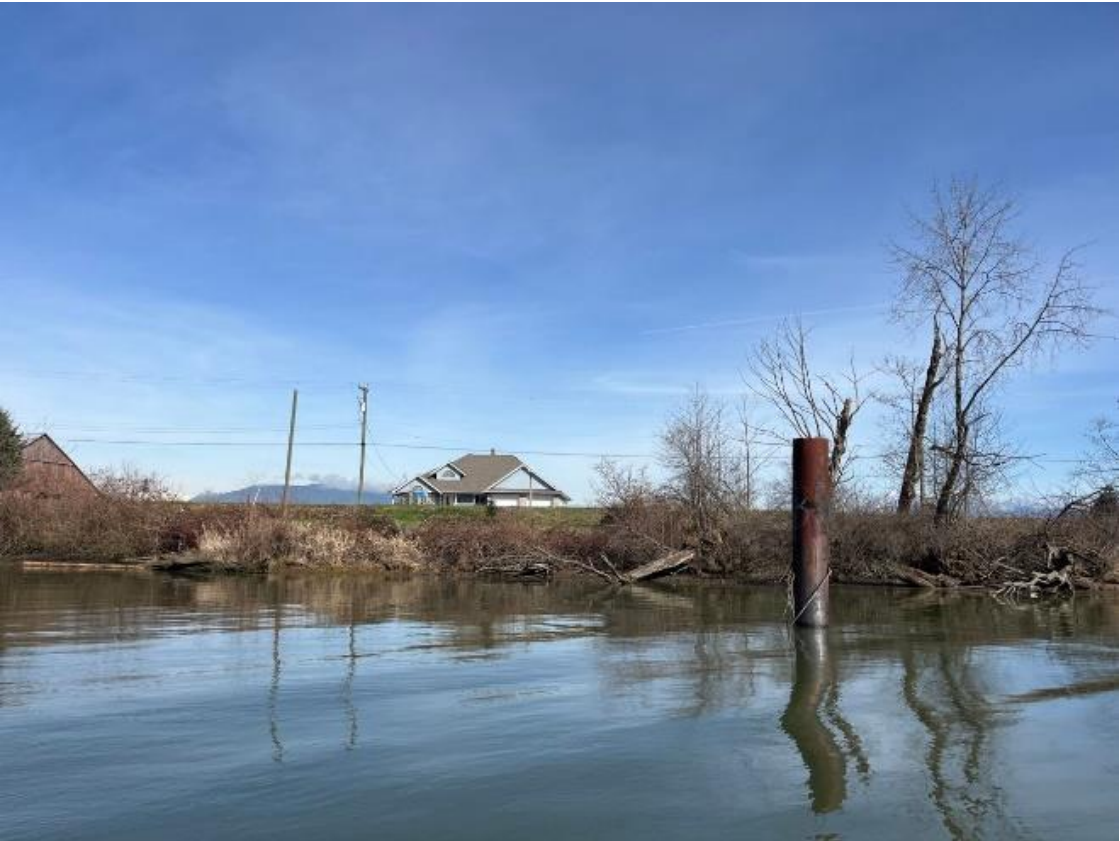
<div>Dike Station</div> <div>1+100</div>	<div>Inspection Location</div> <div>

</div>
<div>Active Erosion</div> <div>Yes</div>	<div>Bank Protection</div> <div>No</div>
<div>Notes</div> <div>Undercut banks and leaning trees. Some trees along bank in 2012 photos are no longer present.</div>

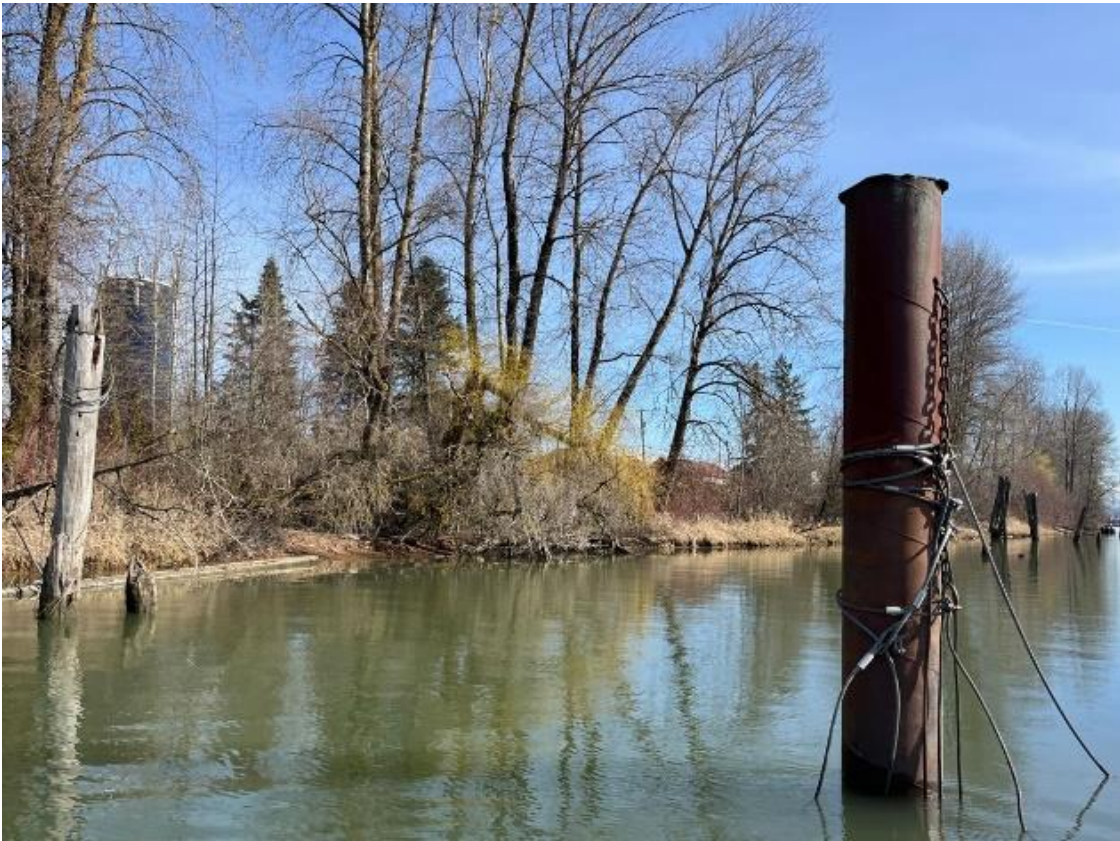
<div>Dike Station</div> <div>1+375</div>	<div>Inspection Location</div> <div>

</div>
<div>Active Erosion</div> <div>Yes</div>	<div>Bank Protection</div> <div>No</div>
<div>Notes</div> <div>Trees leaning toward channel. House outside dike is close to channel with steep bank.</div>

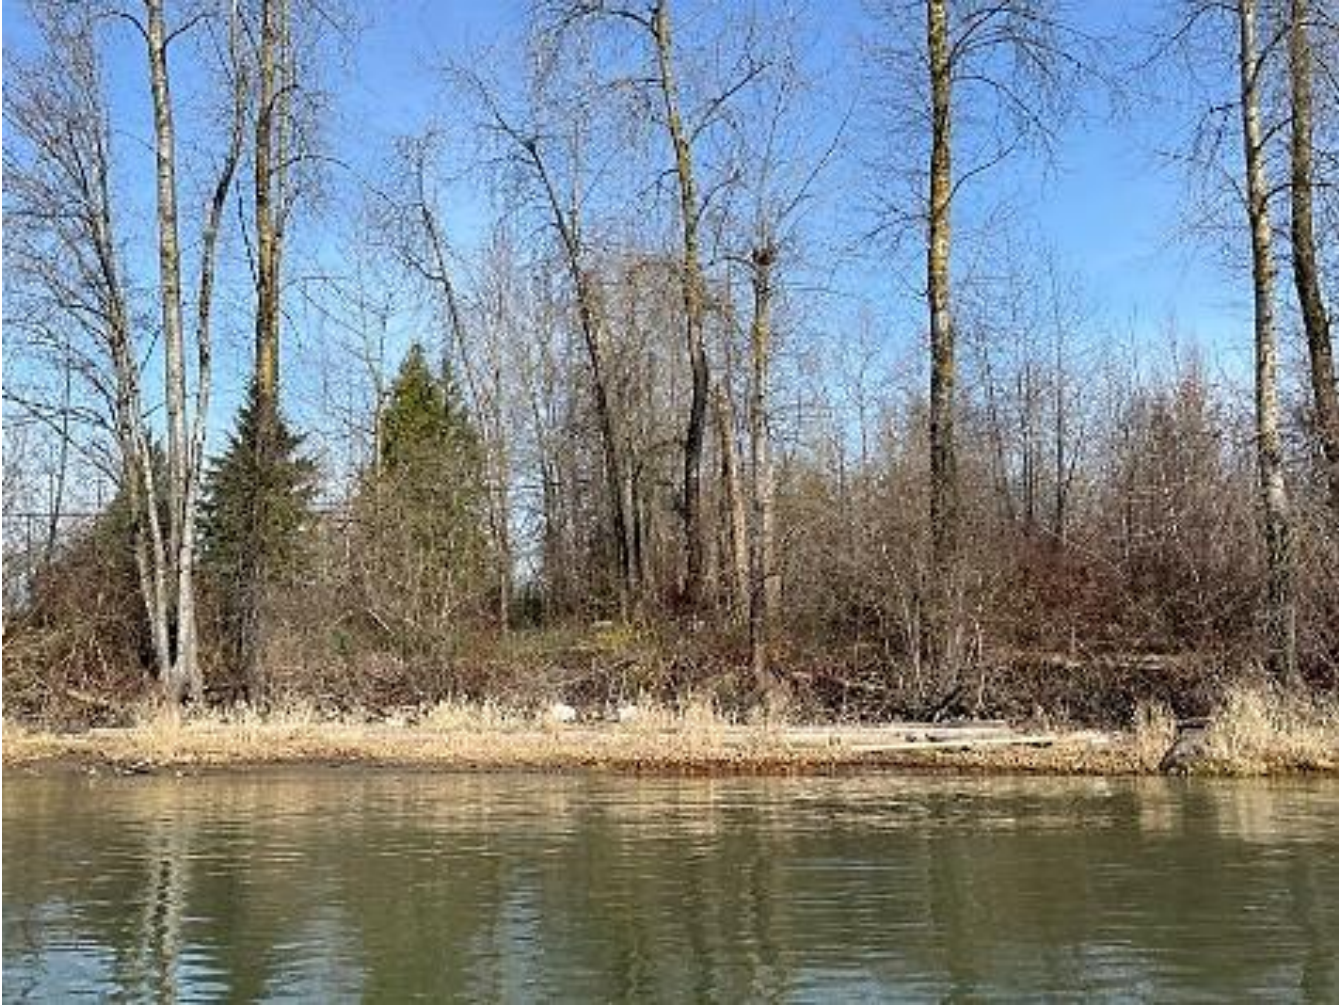
<div>Dike Station</div> <div>2+175</div>	<div>Inspection Location</div> <div>

</div>
<div>Active Erosion</div> <div>Yes</div>	<div>Bank Protection</div> <div>No</div>
<div>Notes</div> <div>Bank shows some signs of erosion, with some exposed tree roots. There is a sandy terrace at bottom of visible bank.</div>

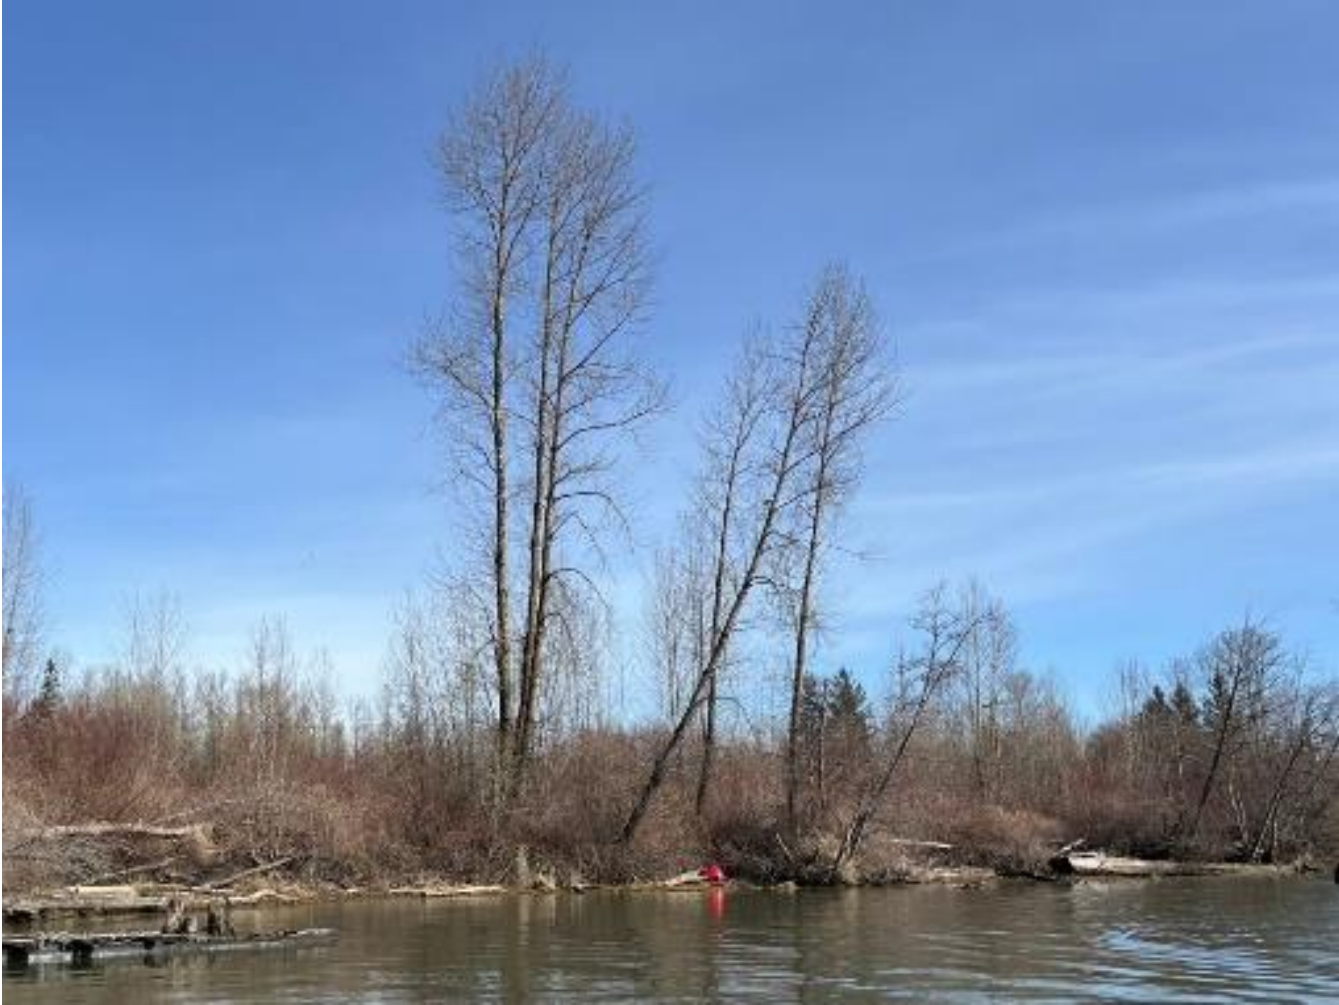
<div>Dike Station</div> <div>2+300</div>	<div>Inspection Location</div> <div>

</div>
<div>Active Erosion</div> <div>Yes</div>	<div>Bank Protection</div> <div>No</div>
<div>Notes</div> <div>Active erosion. Leaning trees.</div>

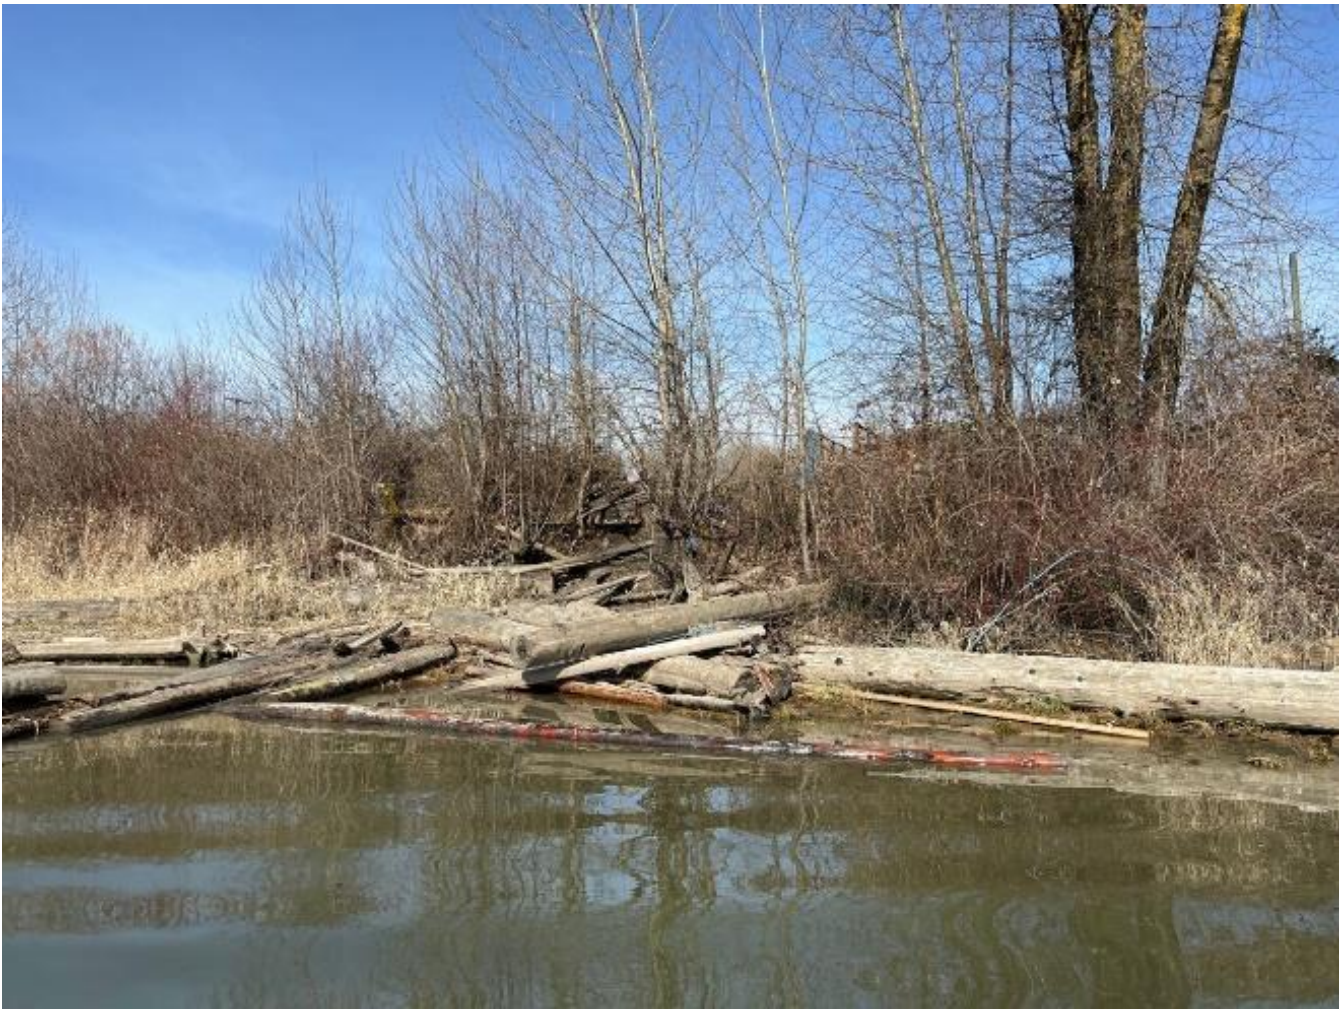
<div>Dike Station</div> <div>2+500</div>	<div>Inspection Location</div> <div>

</div>
<div>Active Erosion</div> <div>Yes</div>	<div>Bank Protection</div> <div>No</div>
<div>Notes</div> <div>Location of active erosion, potentially from foot access to the river.</div>

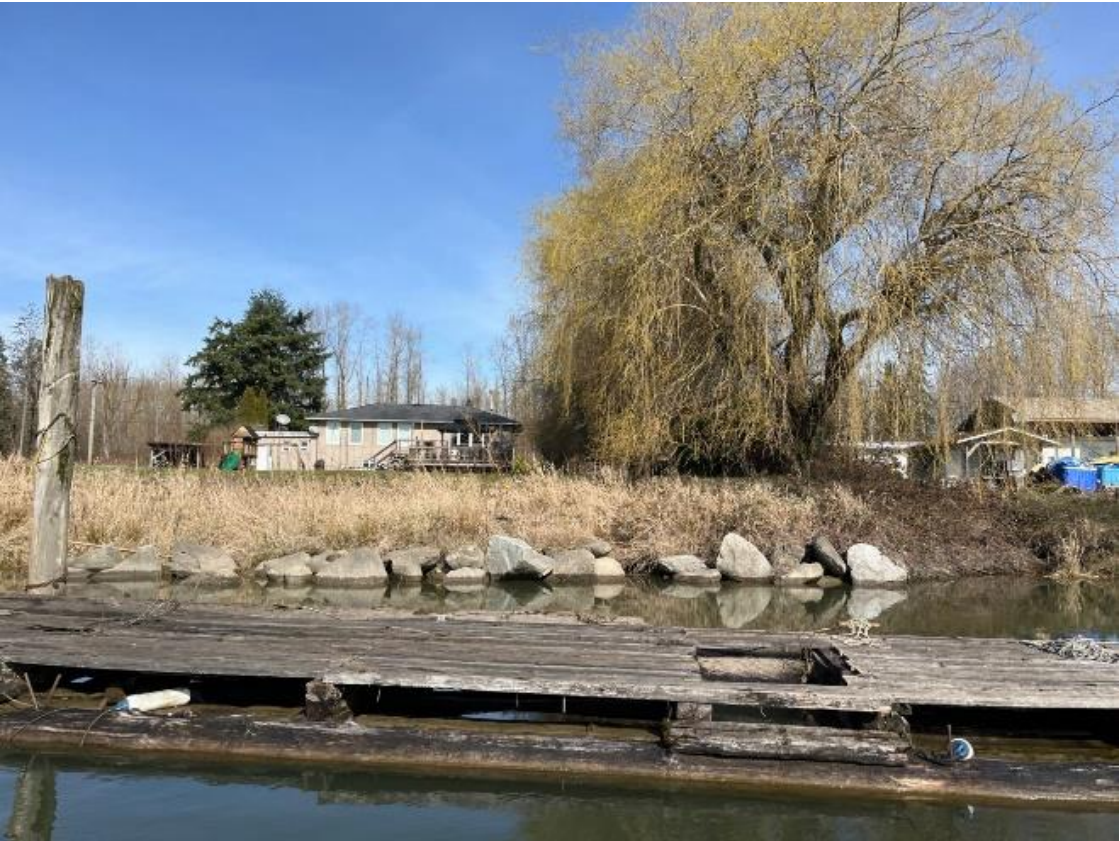
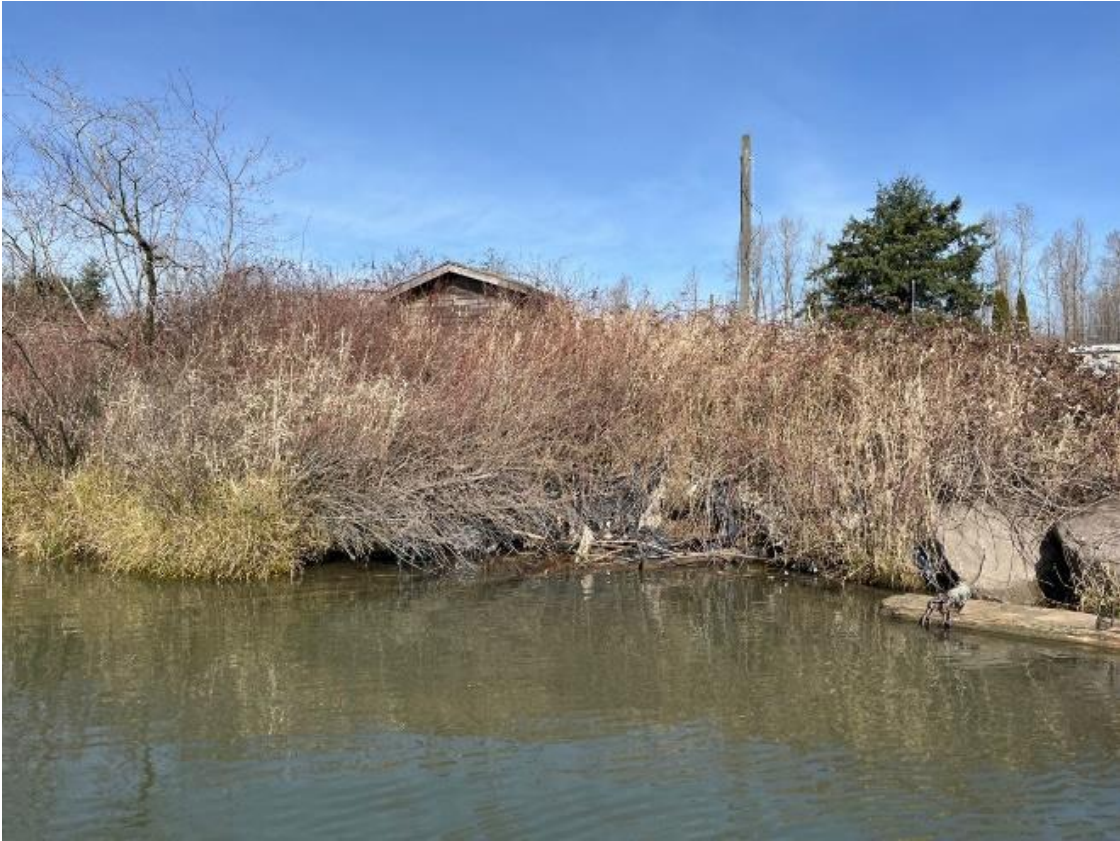
<div>Dike Station</div> <div>2+750</div>	<div>Inspection Location</div> <div>

</div>
<div>Active Erosion</div> <div>Yes</div>	<div>Bank Protection</div> <div>Yes</div>
<div>Notes</div> <div>Larger rock has been placed along bank. Some was either dumped in-channel or has launched. Local bank oversteepening.</div>

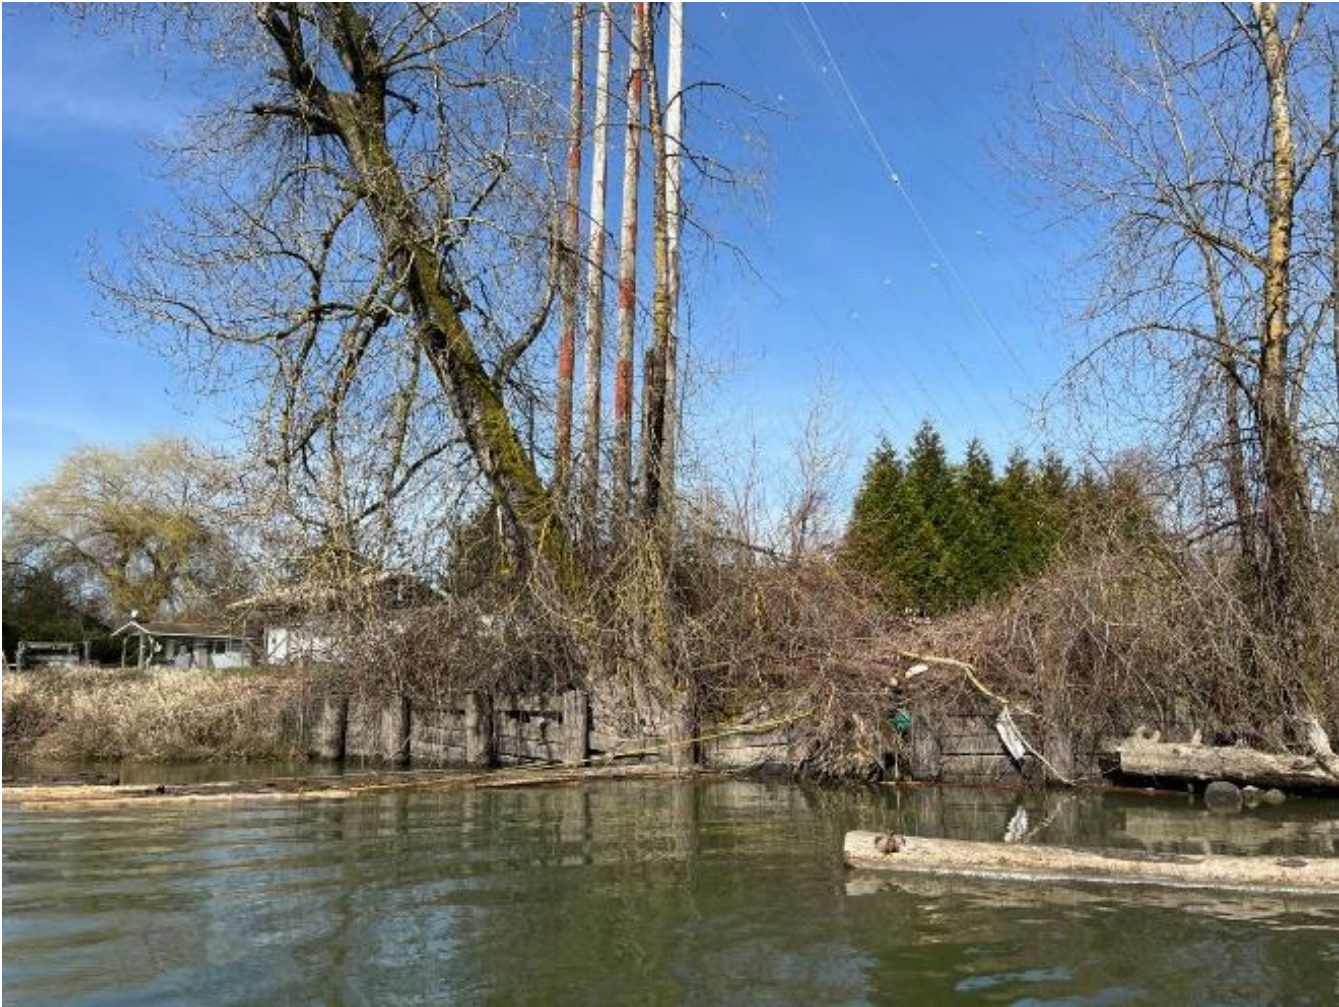
<div>Dike Station</div> <div>2+850</div>	<div>Inspection Location</div> <div>

</div>
<div>Active Erosion</div> <div>No</div>	<div>Bank Protection</div> <div>Yes</div>
<div>Notes</div> <div>Timber crib wall supports bank near power pole. Crib wall is damaged with overhanging trees.</div>

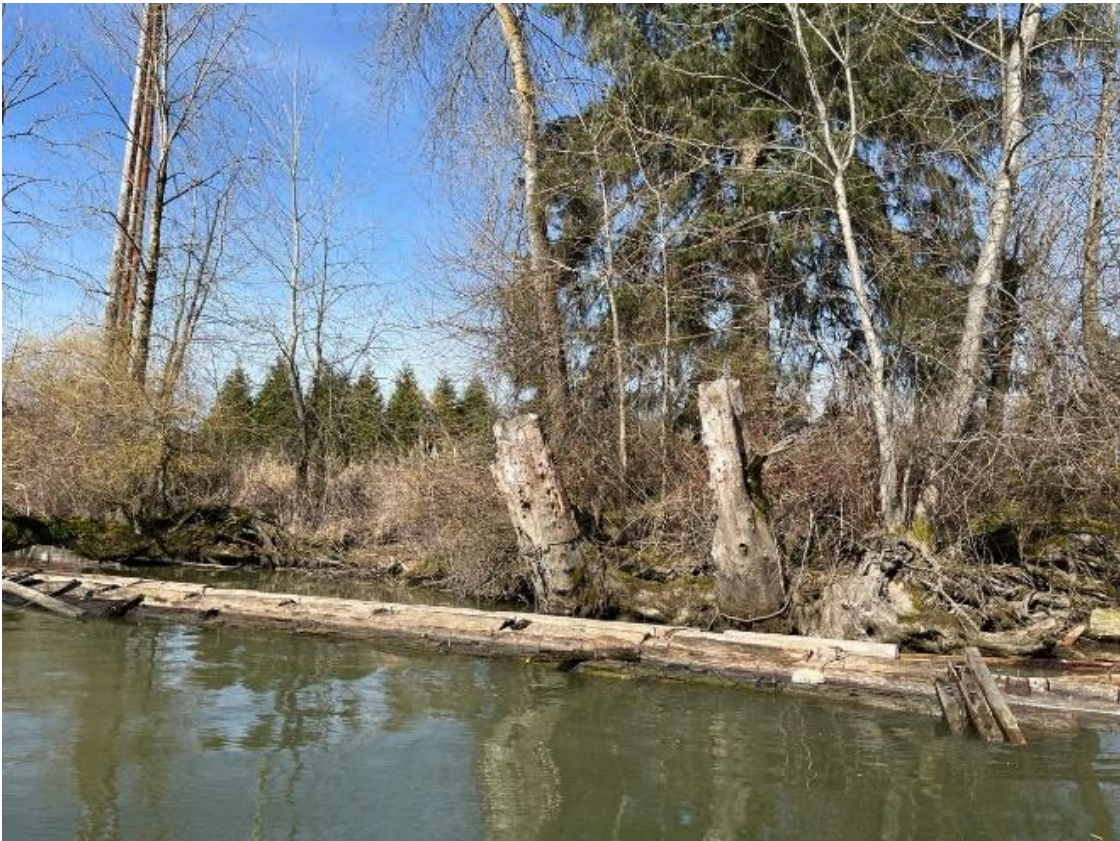
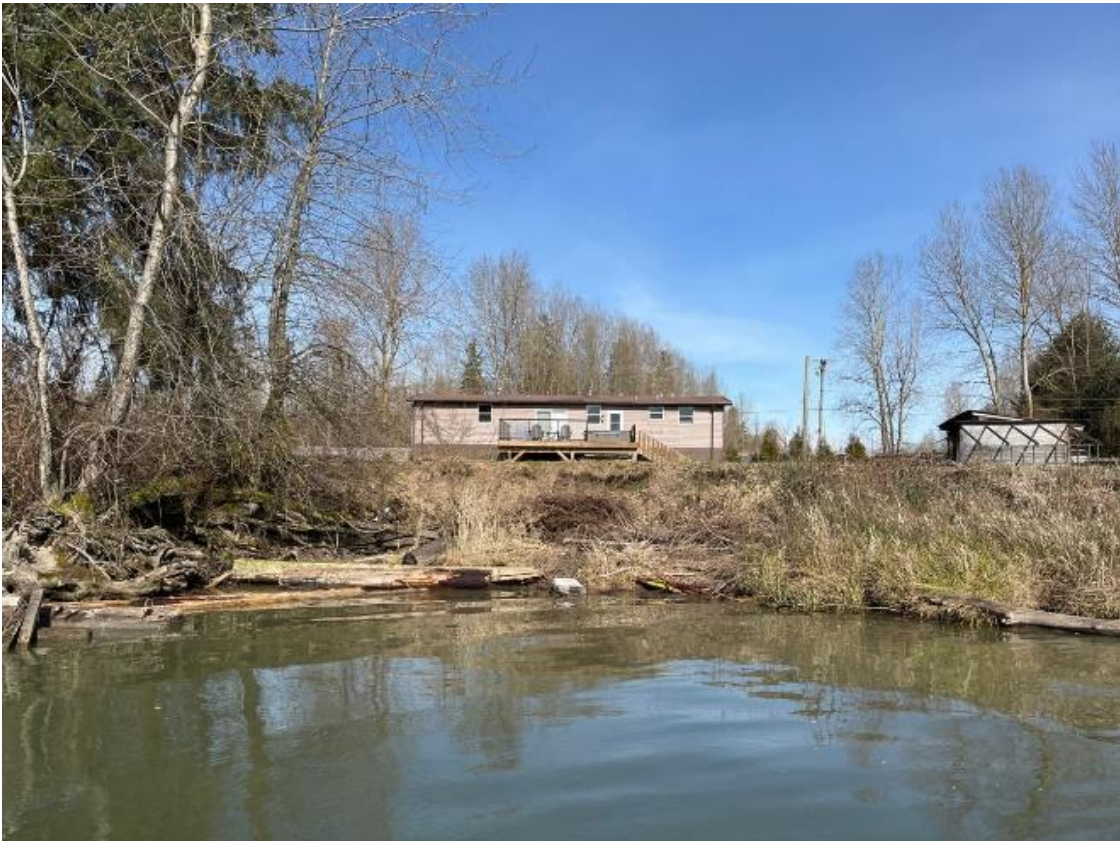
<div>Dike Station</div> <div>2+875</div>	<div>Inspection Location</div> <div>

</div>
<div>Active Erosion</div> <div>Yes</div>	<div>Bank Protection</div> <div>No</div>
<div>Notes</div> <div>Active bank erosion. Oversteepening at top of bank. Trees leaning with roots exposed.</div>

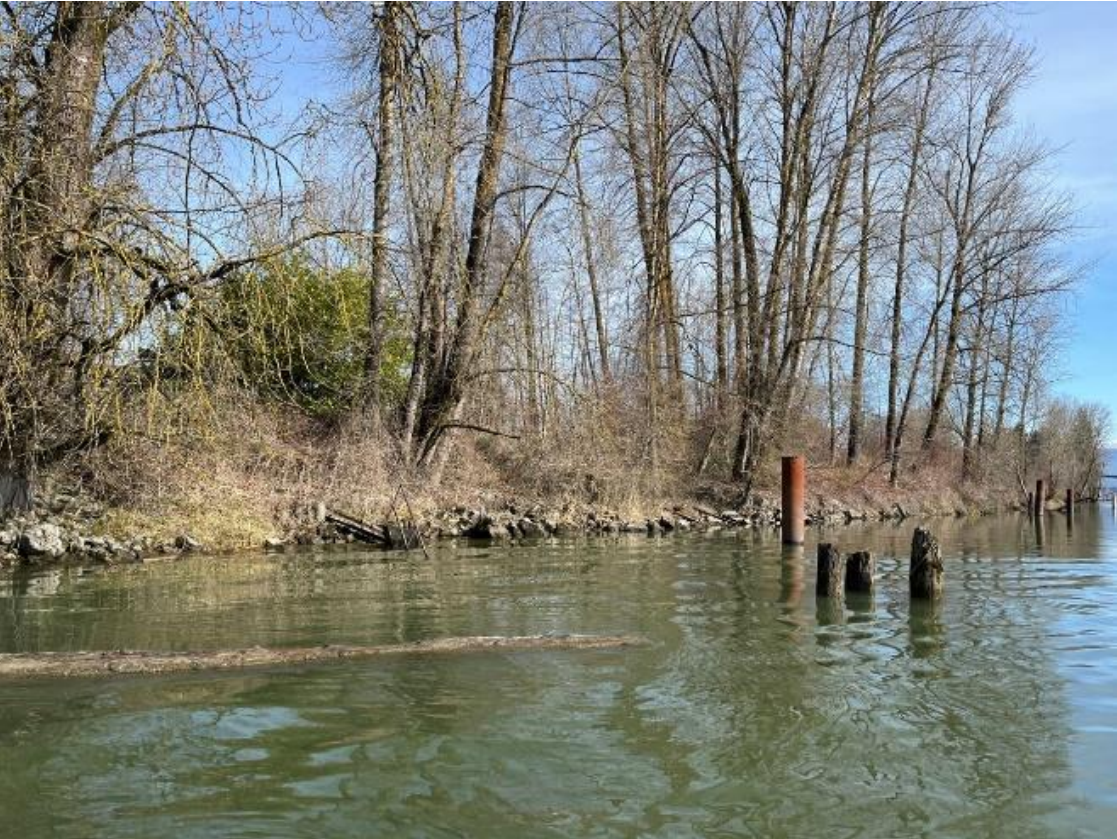
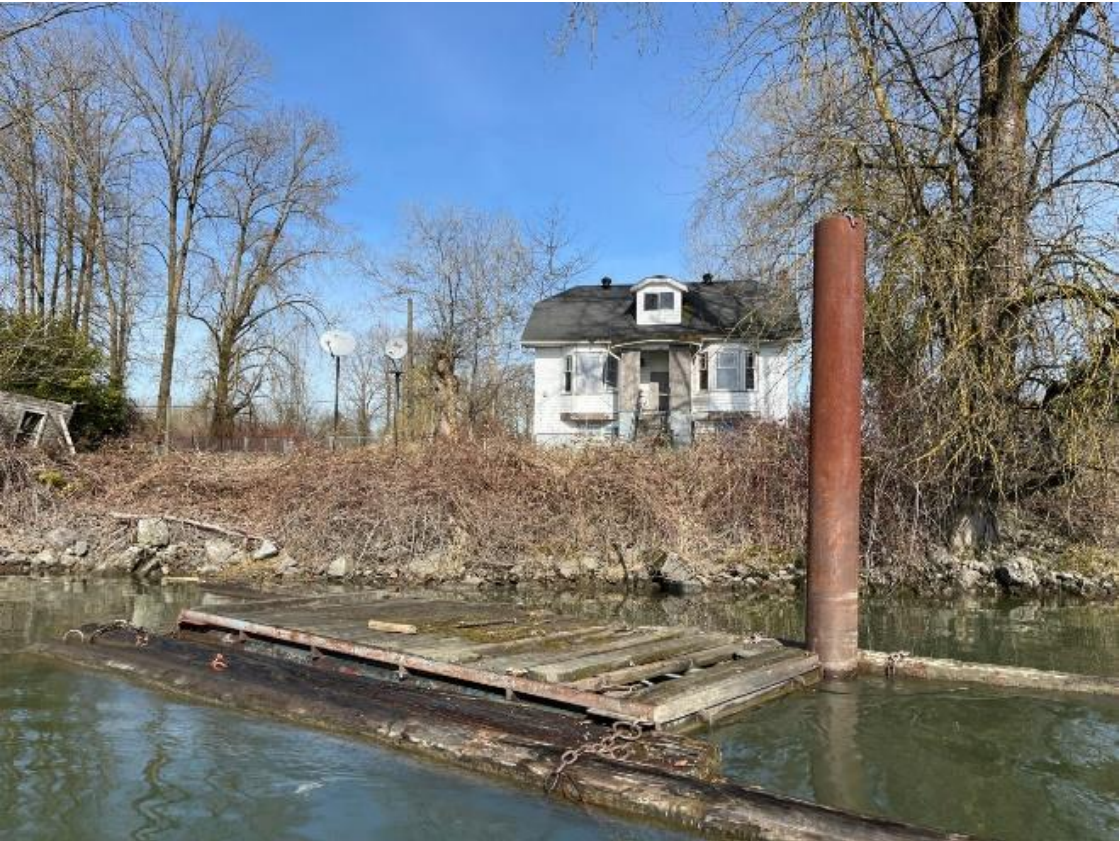
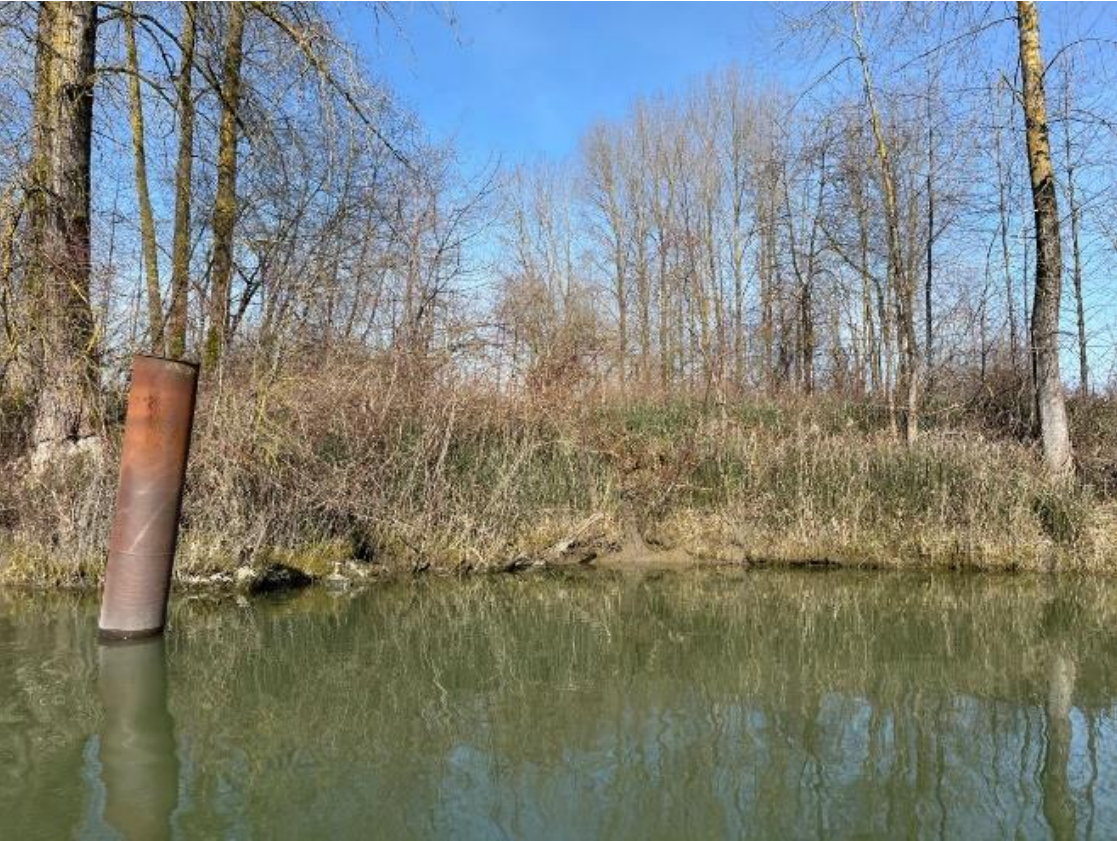
<b>Dike Station</b> 3+125	<b>Inspection Location</b>

<b>Active Erosion</b> Yes	<b>Bank Protection</b> Yes
<b>Notes</b> Old riprap in poor condition. Leaning trees suggests active erosion, and bank is oversteepened in some locations. Steep bank at upstream end of riprap
