**Northwest Hydraulic Consultants Ltd.**

NHC Reference 3008460  
May 10, 2024

**Re:** **Barnston Island Dike Assessment Update 2023**  
**Preliminary Report, Final**

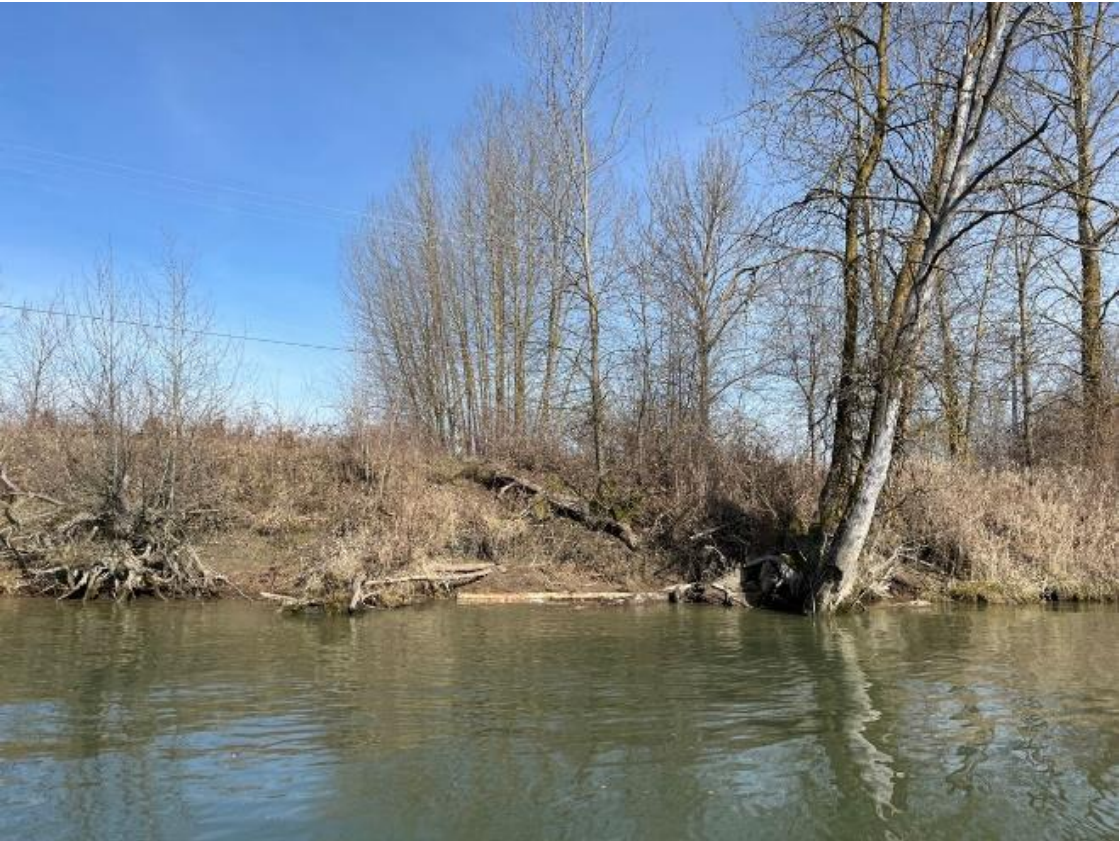
<div>Dike Station</div> <div>3+450</div>	<div>Inspection Location</div> <div>

</div>
<div>Active Erosion</div> <div>Yes</div>	<div>Bank Protection</div> <div>No</div>
<div>Notes</div> <div>Active erosion. Trees leaning toward channel, roots exposed. Sparse vegetation between bank and dike.</div>

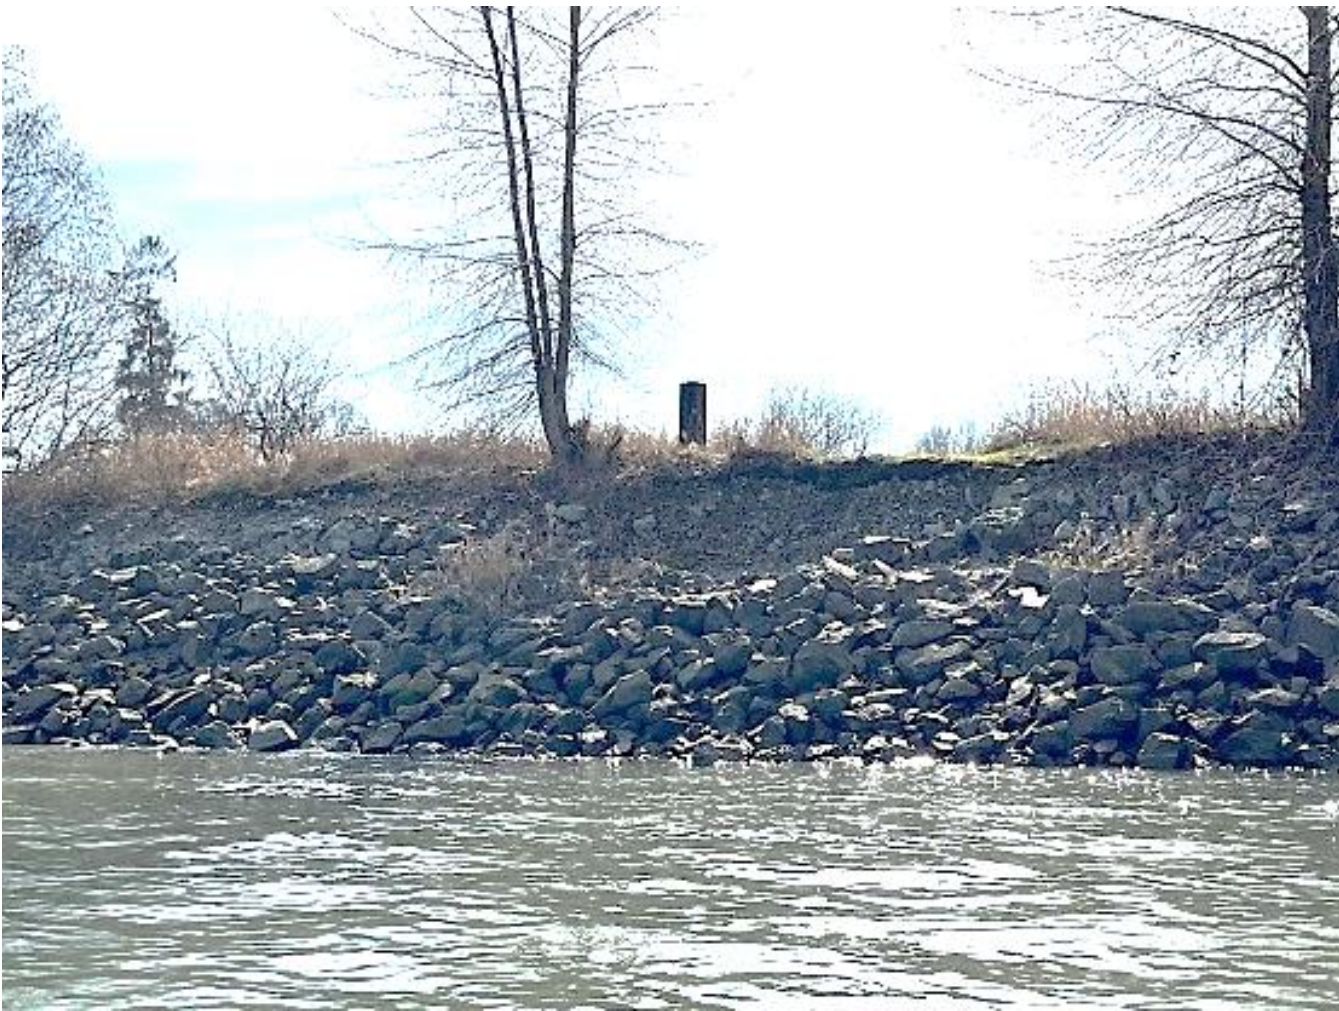
<div>Dike Station</div> <div>4+390</div>	<div>Inspection Location</div> <div>

- At Station 4+390 (also noted in the October 17, 2023 observations), the existing riprap protection has failed in some locations, which may be due to erosion from vessel generated waves and/or from foot access to the bank. This location also has limited vegetation along the bank, and the dike is within about 20 m to 30 m from the active channel.

</div>
<div>Active Erosion</div> <div>Yes</div>	<div>Bank Protection</div> <div>Yes</div>
<div>Notes</div> <div>Upstream end of riprap section. Some erosion near top of bank, potentially due to foot access down bank. This erosion was noted in the 2012 Assessment. There is minimal mature vegetation at top of bank.</div>

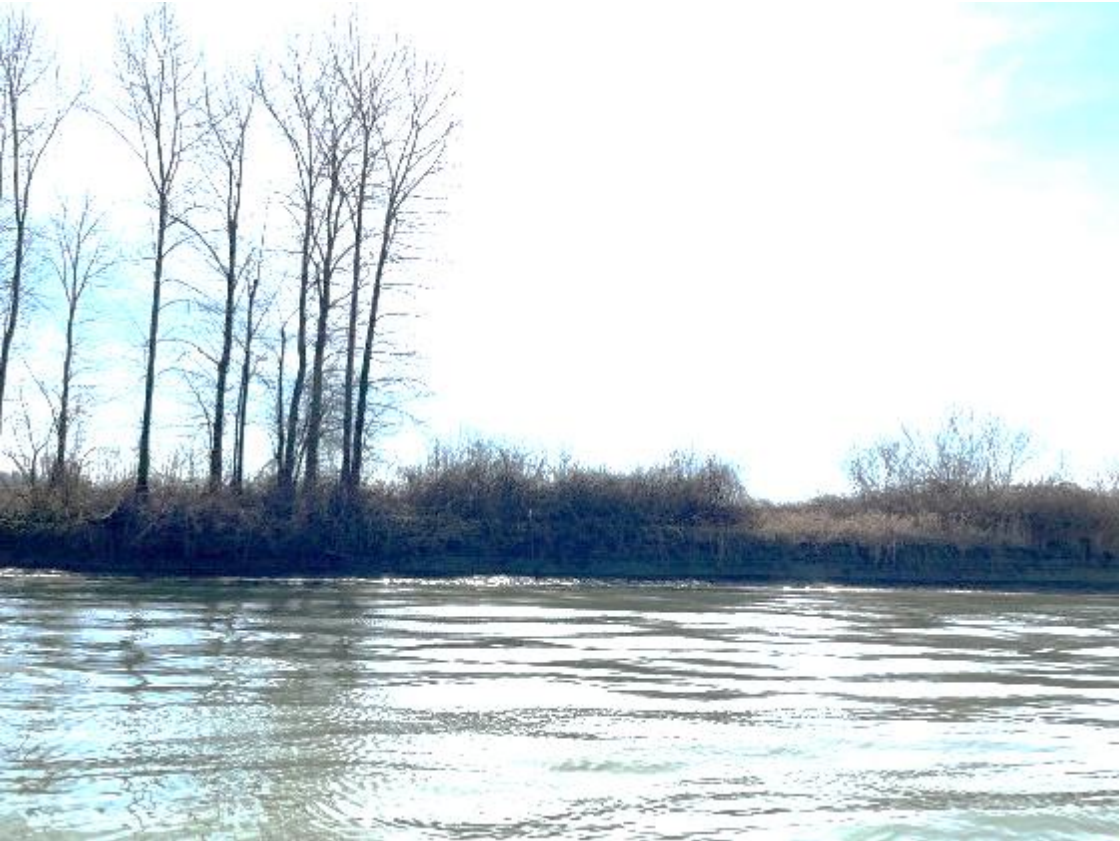
<div>Dike Station</div> <div>4+575</div>	<div>Inspection Location</div> <div>

- Riprap near Station 4+550 appeared to be in good condition. However, a 150-200 m long section of active erosion is present immediately downstream of this riprap.

</div>
<div>Active Erosion</div> <div>Yes</div>	<div>Bank Protection</div> <div>No</div>
<div>Notes</div> <div>Section of eroding bank (150-200 m long) downstream of riprap. A portion of this eroding bank lacks mature vegetation between the bank and dike.</div>

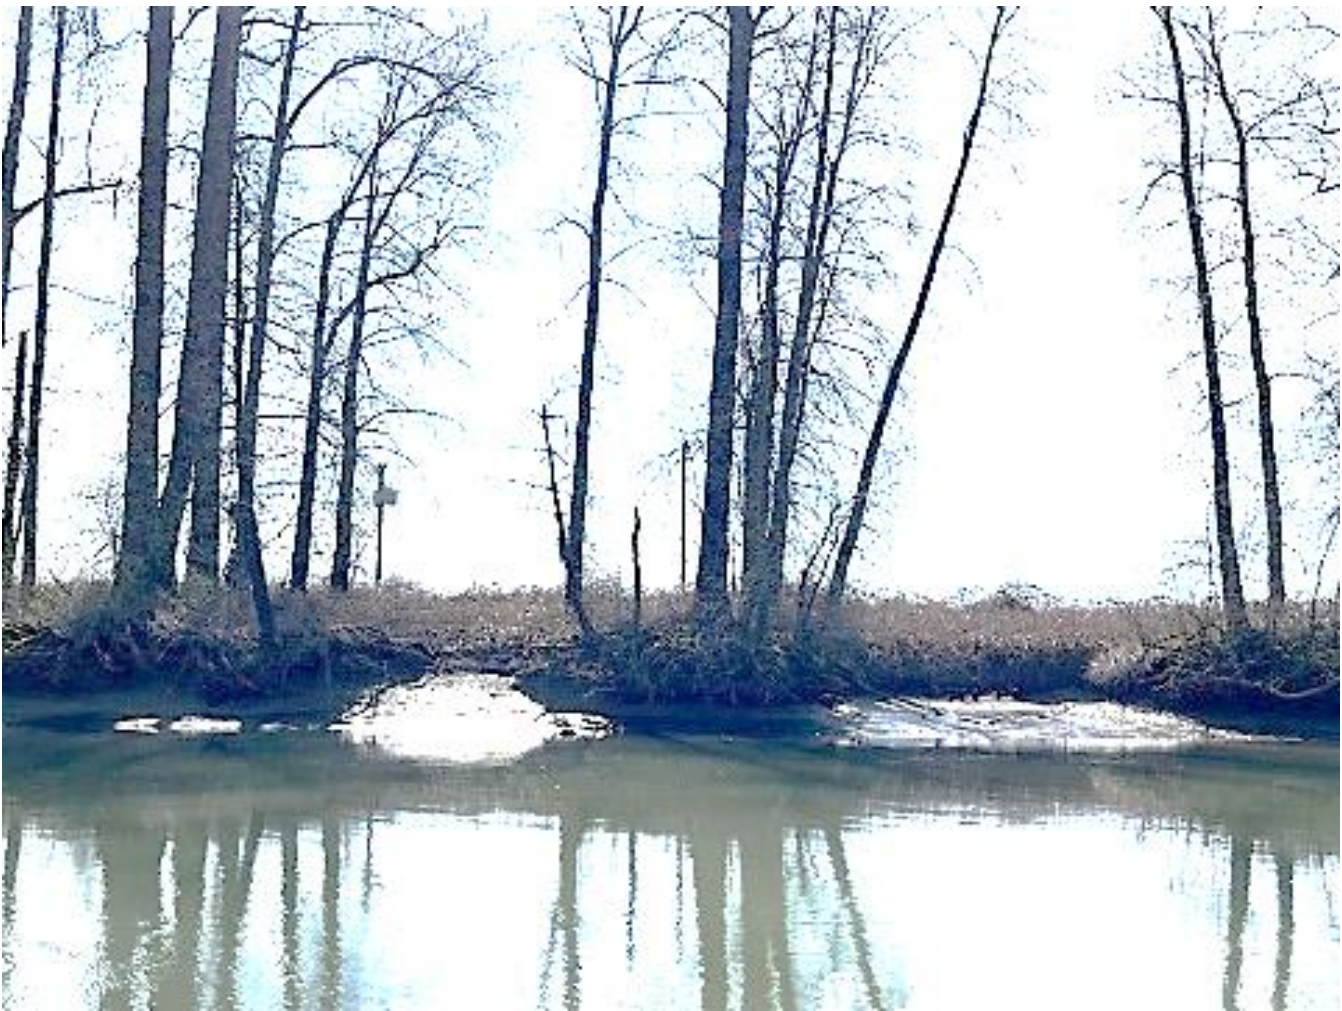
<div>Dike Station</div> <div>5+500</div>	<div>Inspection Location</div> <div>

</div>
<div>Active Erosion</div> <div>Yes</div>	<div>Bank Protection</div> <div>No</div>
<div>Notes</div> <div>Bank retreat has exposed the roots of mature trees. Root structures have created hard points that have resulted in small erosion arcs forming upstream and downstream of mature trees.</div>

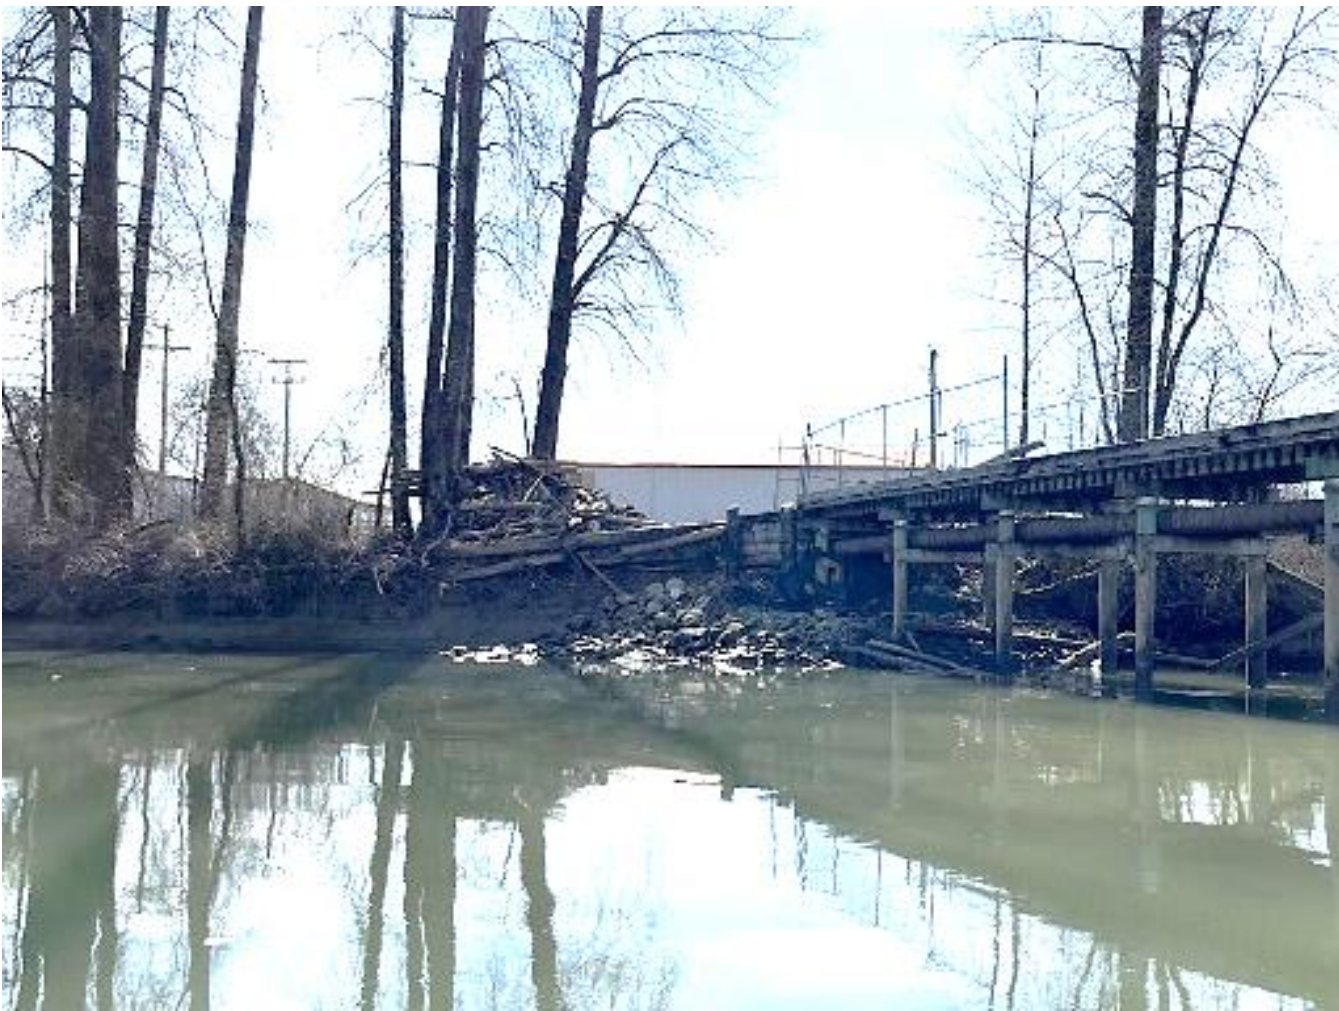
<div>Dike Station</div> <div>5+675</div>	<div>Inspection Location</div> <div>

</div>
<div>Active Erosion</div> <div>Yes</div>	<div>Bank Protection</div> <div>Yes</div>
<div>Notes</div> <div>Riprap is present near an intake structure. Bank is actively eroding upstream and downstream of the limits of the riprap.</div>

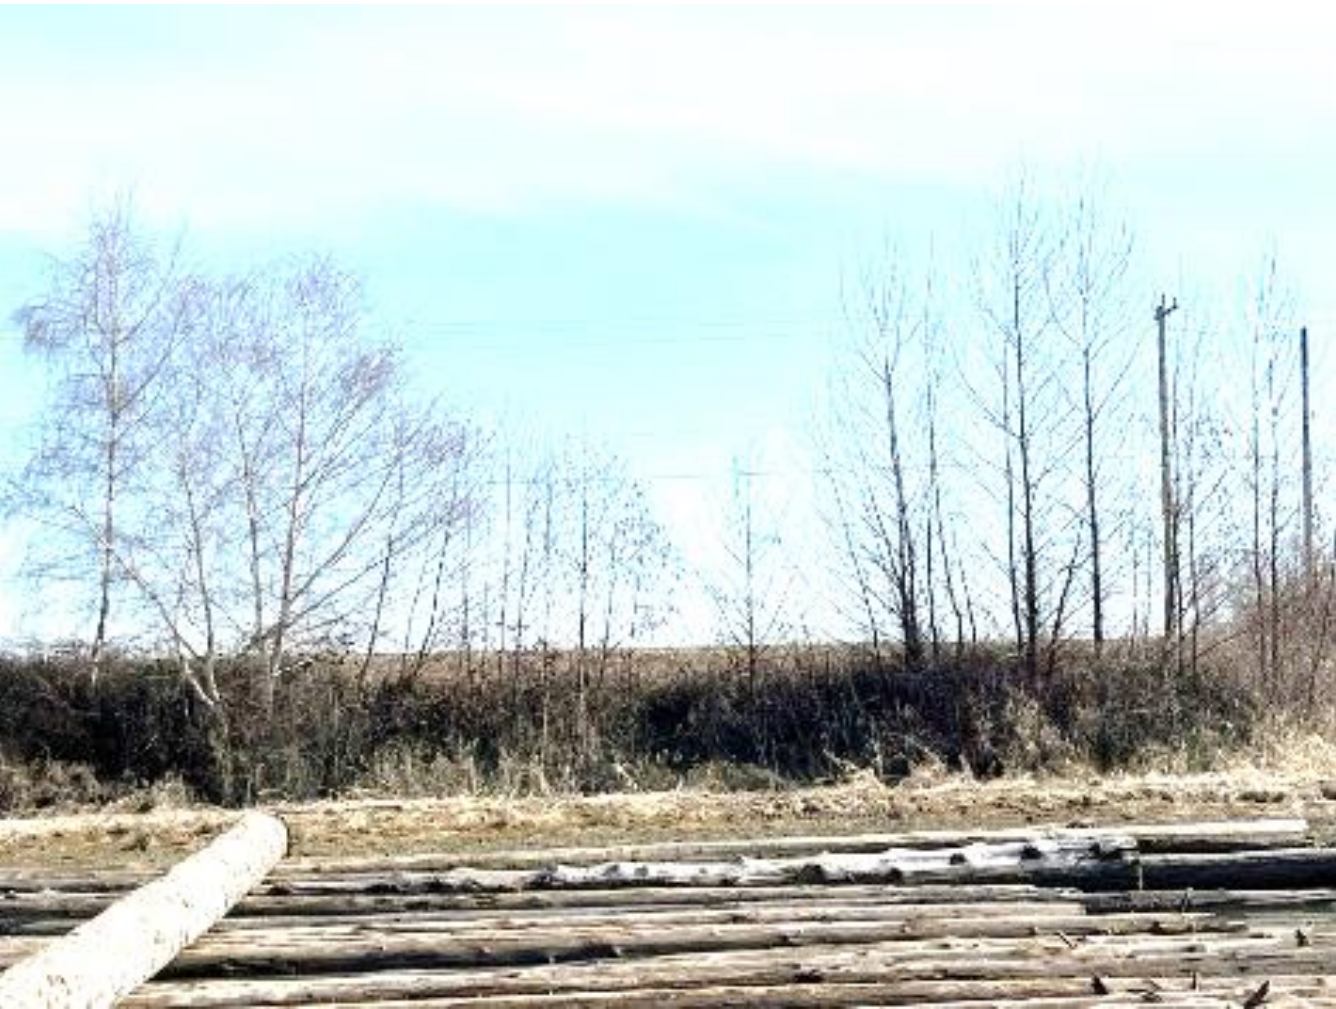
<div>Dike Station</div> <div>9+675</div>	<div>Inspection Location</div> <div>

</div>
<div>Active Erosion</div> <div>Yes</div>	<div>Bank Protection</div> <div>No</div>
<div>Notes</div> <div>Bank is quite close to dike, with minimal mature vegetation providing protection against erosion. Exposed tree roots indicate active erosion. This is the location of self-launching riprap that is buried in a trench on land. It was observed during the October 2023 inspection by car that the riprap was exposed/imminently launching in some locations, indicating bank retreat since 2012.</div>
