Landslide Risk Assessment, Moonshine Bay, Pitt Lake

Cordilleran Geoscience
PO Box 612
Squamish, BC
V8B 0A5

Draft: December 8, 2020; Final: December 16, 2020

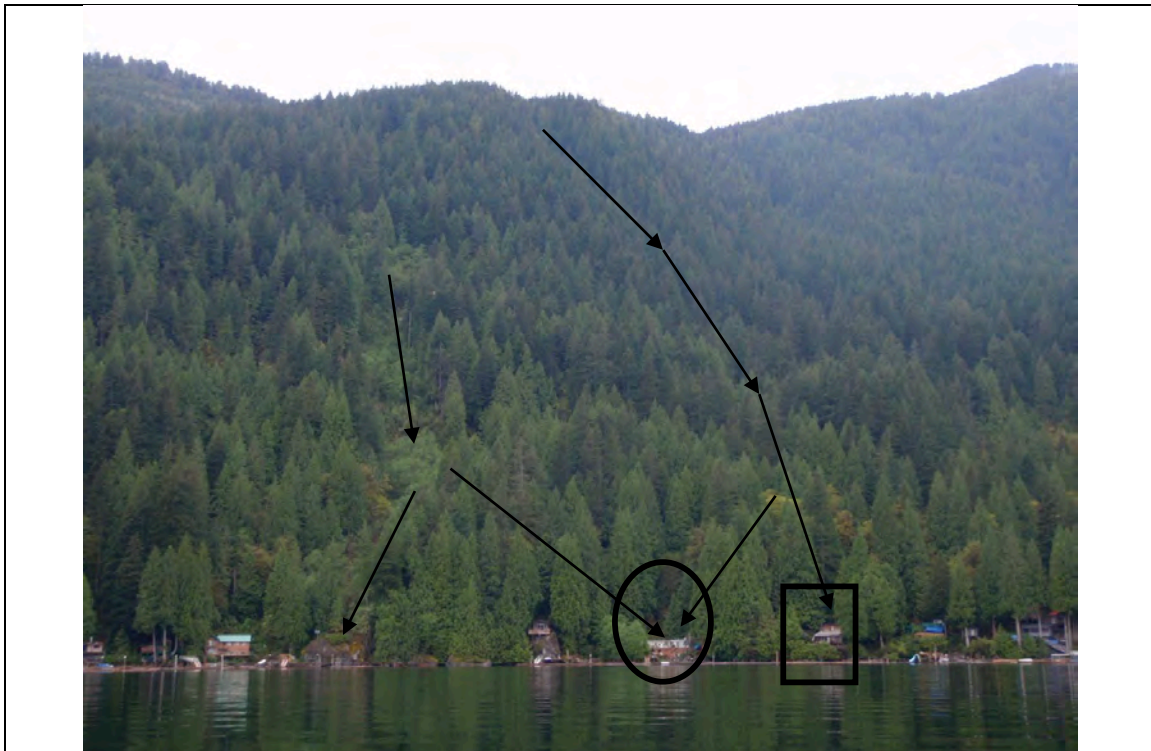
Photo 1. View west showing slopes above Lots 5-10. On left (south) the black arrows identify the 1990 debris slide track. The circled cabin is on Lot 8. On the right (north) the black arrow is the 2020 track. The destroyed cabin on Lot 7 is shown by the black rectangle.

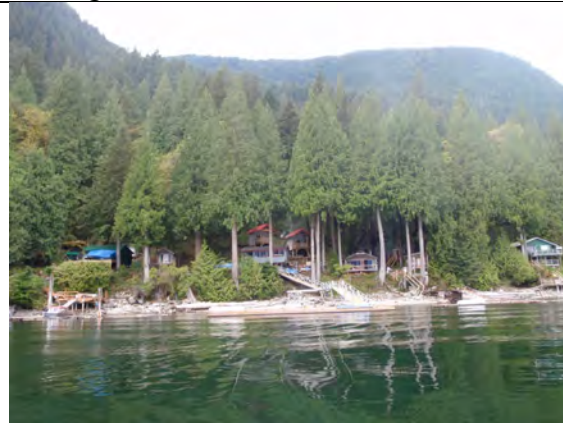
Photo 2. Lots 3-7. 2009. View west. Structures with the red roofs are Lot 5 cabins. The destroyed lot 7 cabin is far left with green roof.

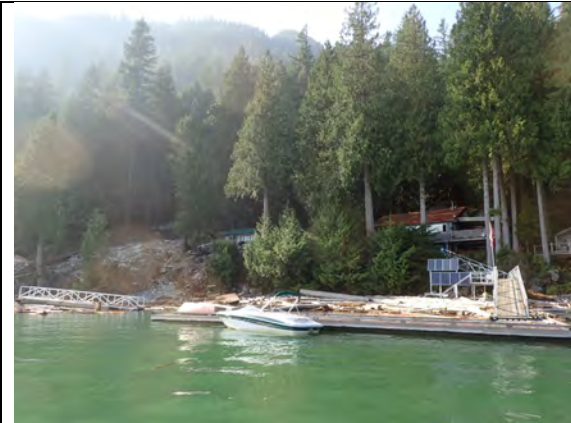
Photo 3. Lots 5-7. 2020. View southwest. Structures with the red roof is Lot 5 cabin. The destroyed lot 7 cabin was far left.

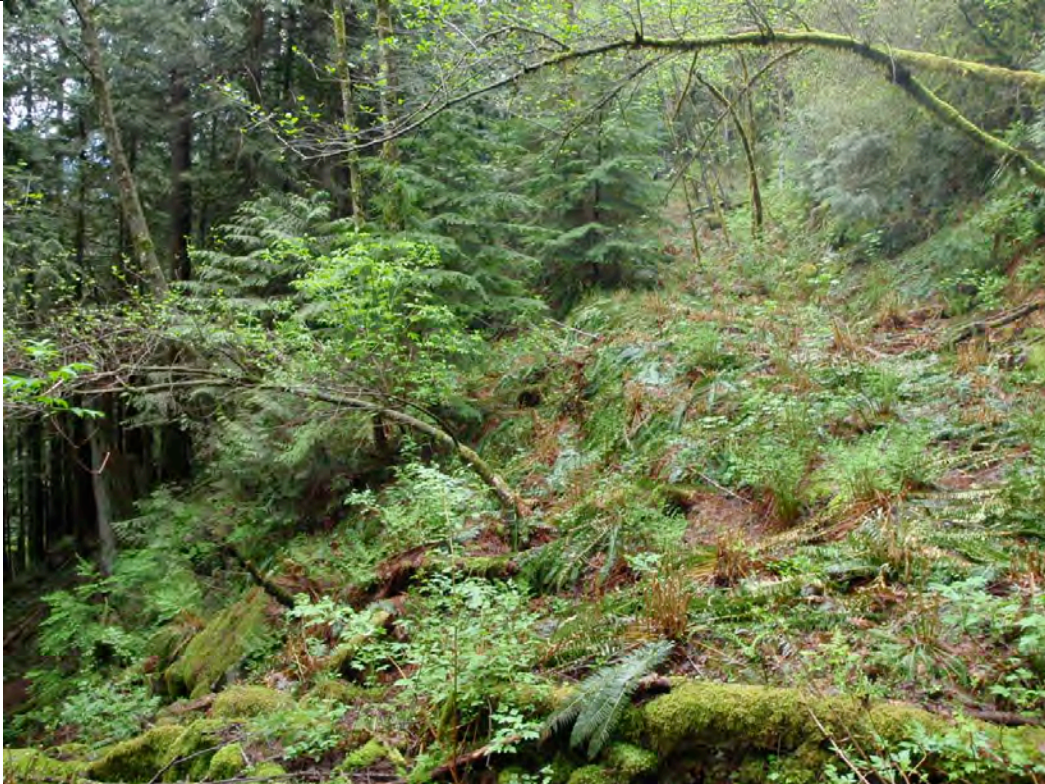
Photo 4. Zone of fillslope failures start 30m south of Waypoint 192. View south.

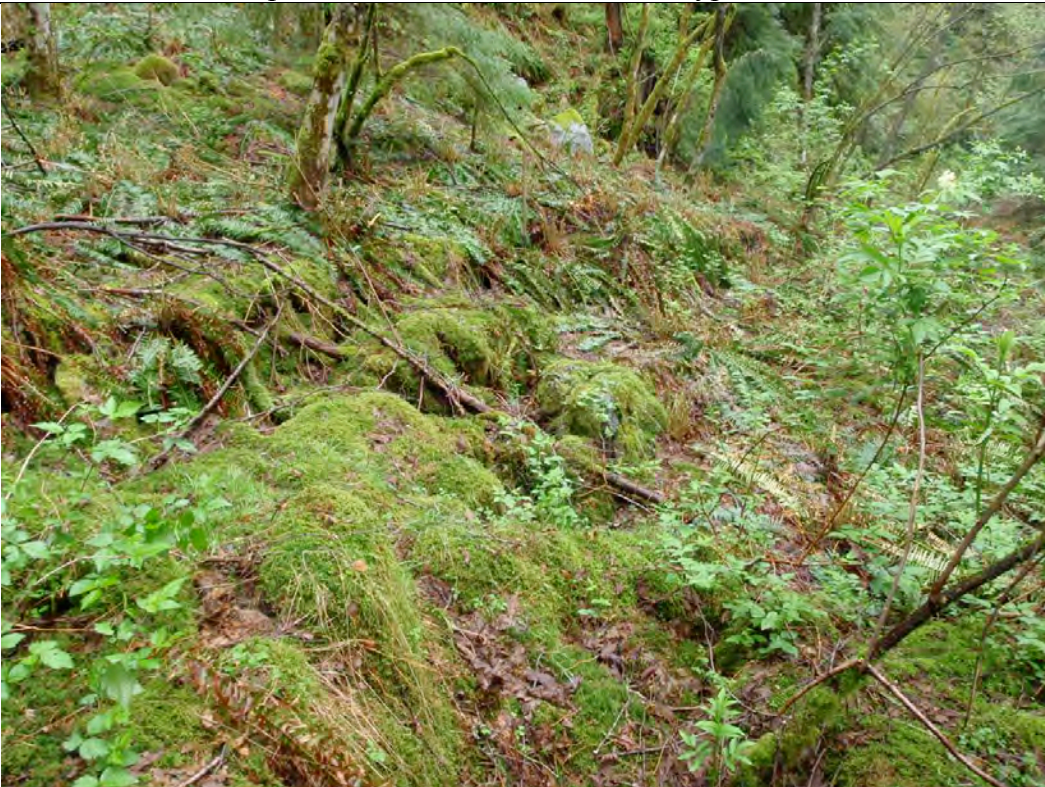
Photo 5. Fillslope failure at WP193. View north.

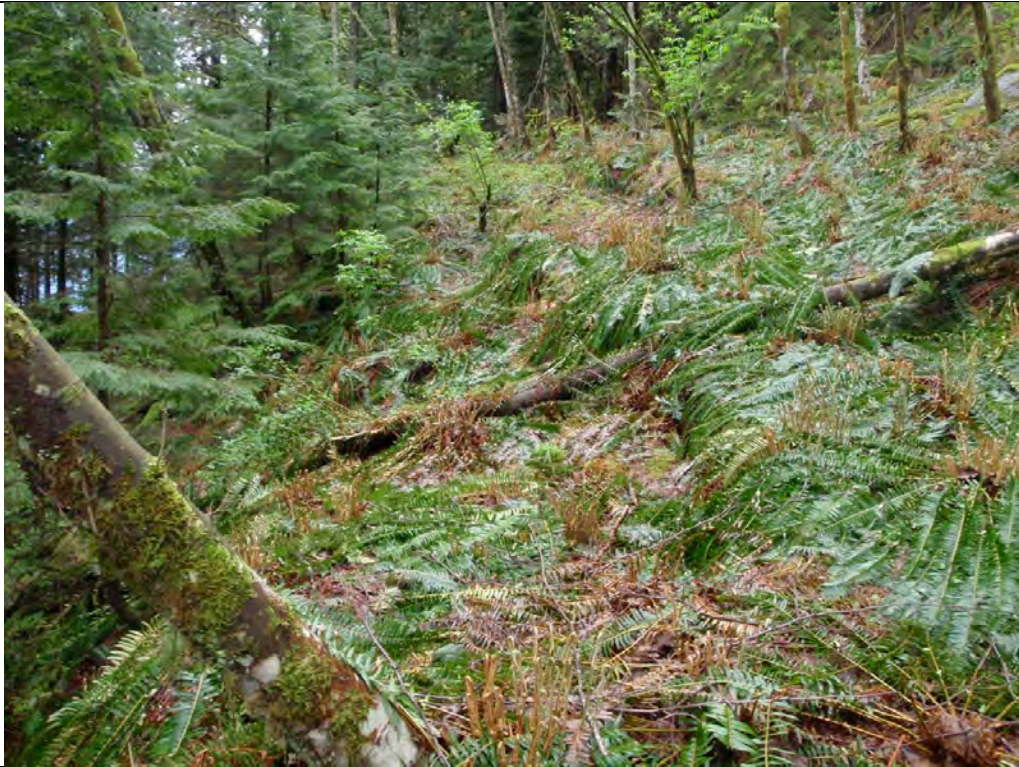
Photo 6. Fillslope failure at WP193. View south.

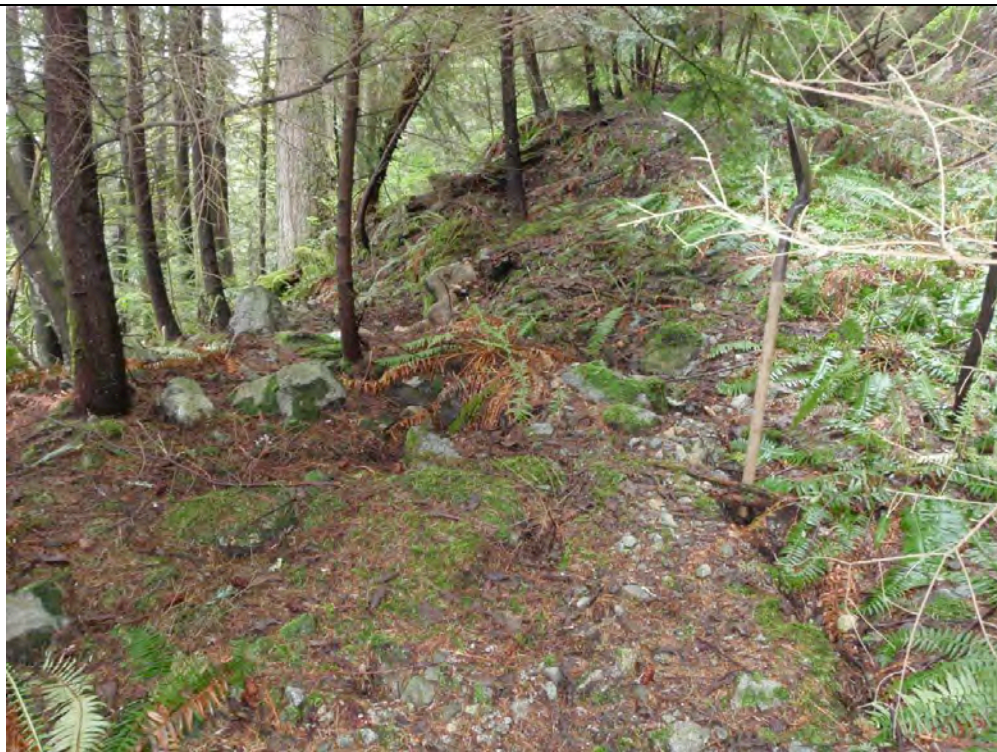
Photo 7. Unstable fillslope at WP194. View south. Note shovel stuffed into tension crack.

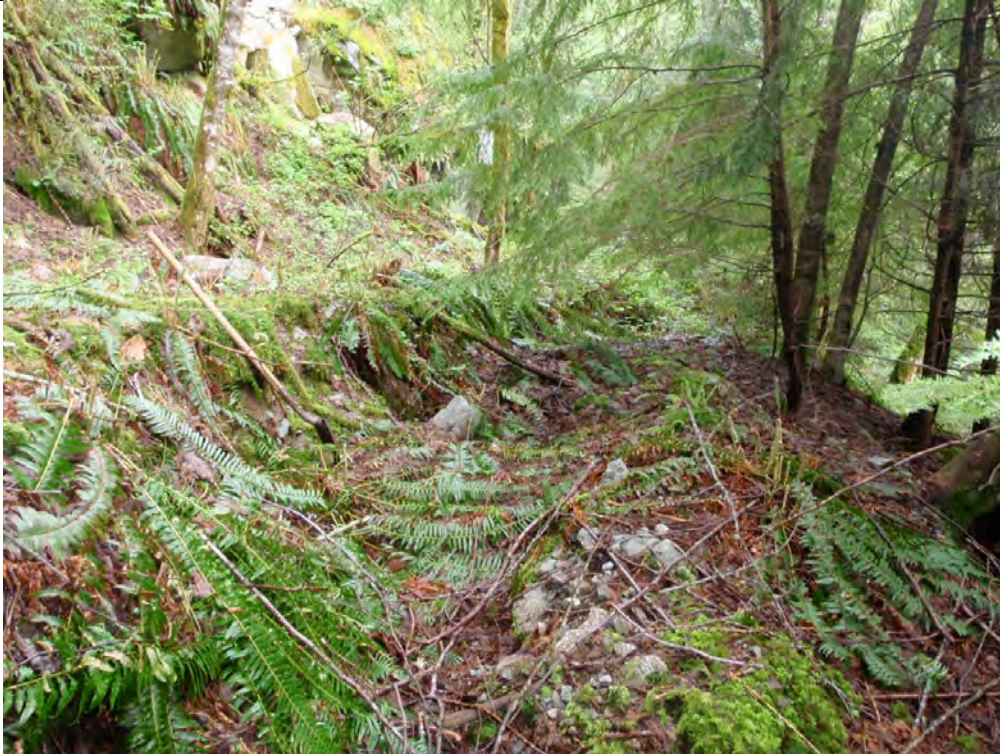
Photo 8. Unstable fillslope at WP196. View south. Note the shovel for scale.

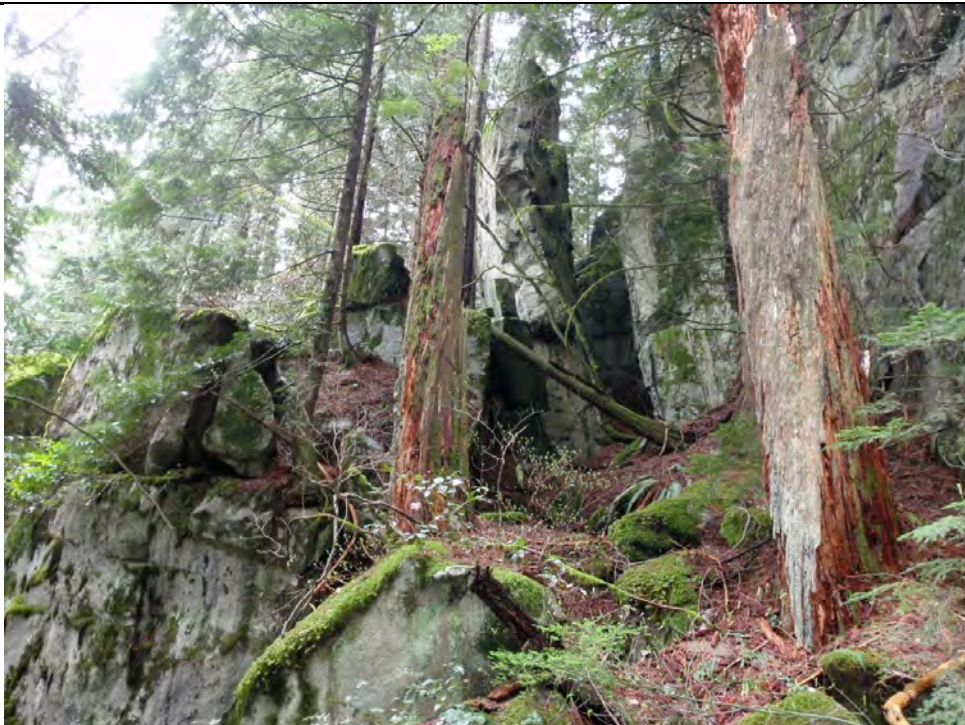
Photo 9. Rockfall source area in the vicinity of Waypoints 205-206.

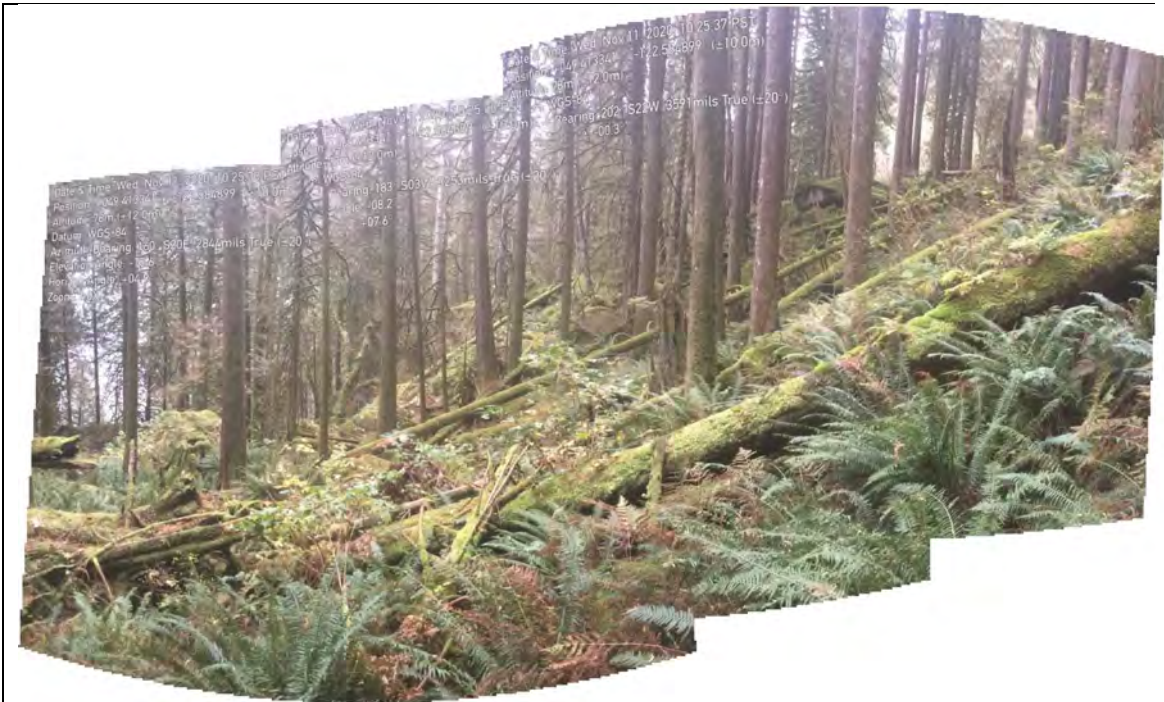
WP10. View south showing rockfall cone. Note 10 m diameter megablocks.

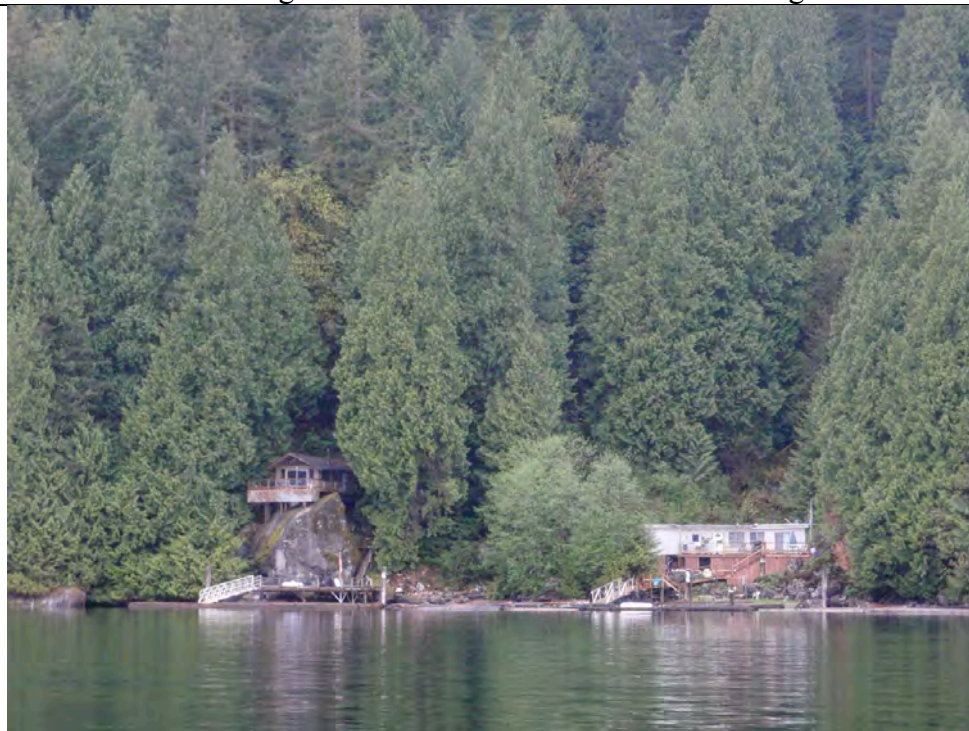
Photo 11. Lot 9 Cabin (left) built on large rockfall block below rockfall source area (Waypoints 205-206). Lot 8 cabin (right) was knocked off its foundation by 1990 debris slide. Lot 9 experienced a near miss, and was not affected because trees caused a jam and diverted the landslide toward Lot 8.

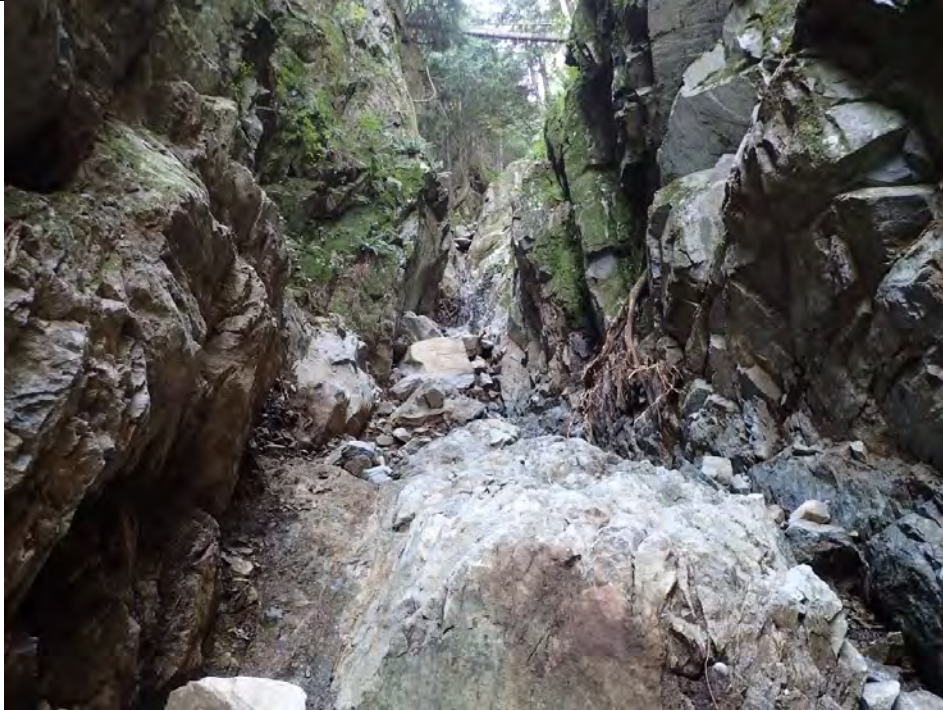
On October 3, 2020, the debris flow track was traversed from the lake edge to the headscarp at ~410 m elevation (Photos 12-18). It was found that the debris flow initiated as a channel fill failure near the downslope end of a steep sided rock canyon (Photo 12, 13). No point source sidewall failures contributed to the debris flow.

Photo 12. WP54. View up into rock slot canyon from headscarp in channel.

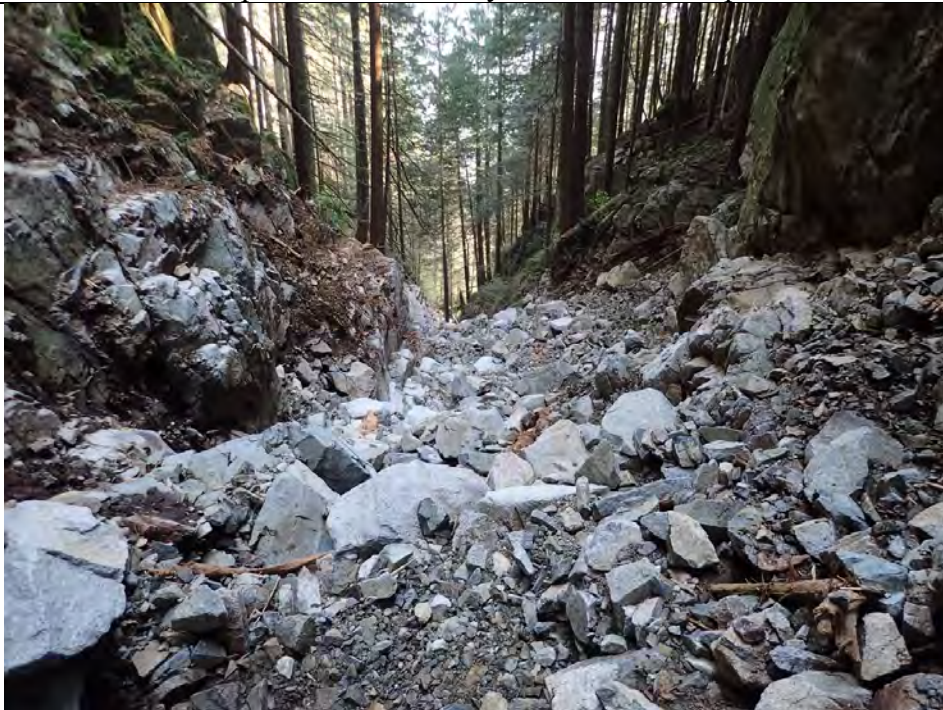
Photo 13. WP54. View down from headscarp in channel.

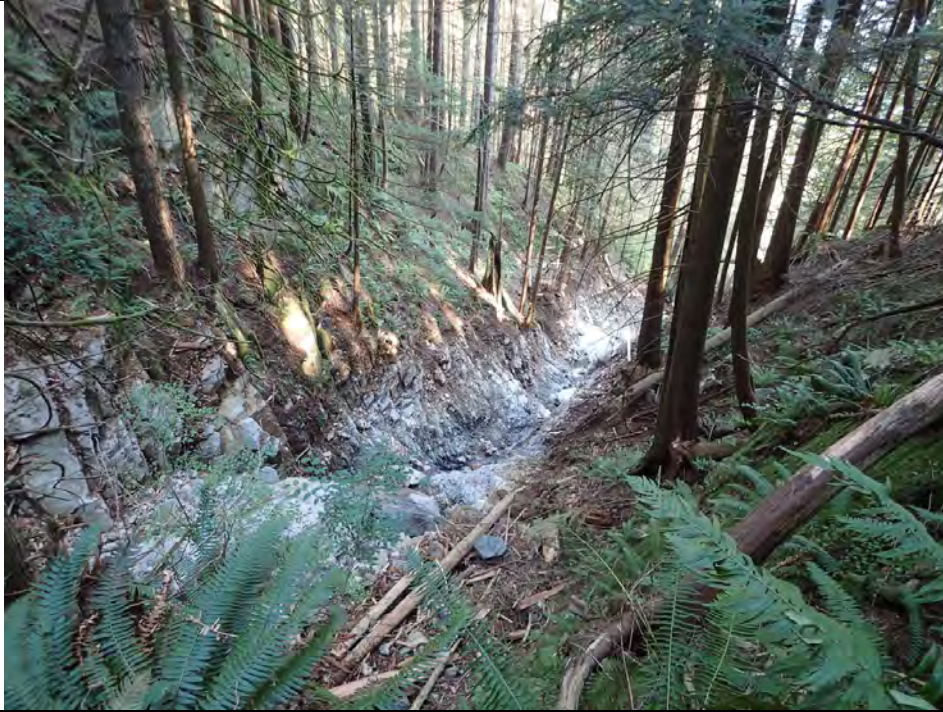
During the 2020 debris flow, the Basin 3 channel was scoured down to bedrock (Photos 14, 15), so another channel scour event is not possible until such time as debris accumulates along the channel in sufficient quantity to fail again. This process of gradual channel recharge may take centuries (Jakob et al., 2011).

Photo 14. WP 51. view down upper reach of debris flow track. Note scoured rock channel.

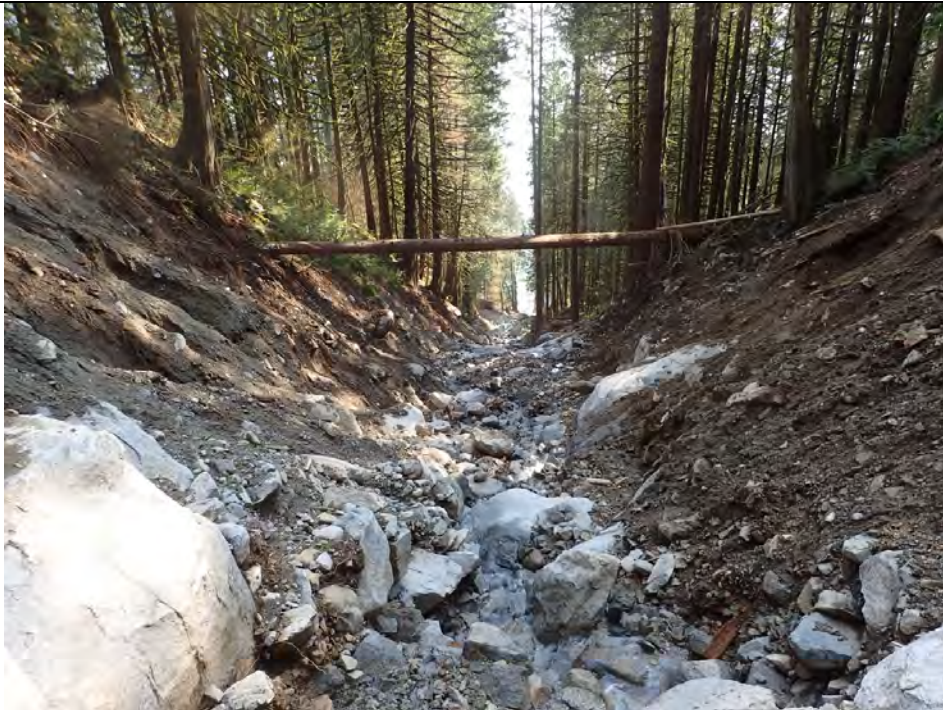
At select stations along the path, the cross-sectional area within the trimline of the event was measured (Photos 14-15). Using the cross-section perimeter scoured and an estimate of the depth of scour (0.25-1 m), a representative scour area could be estimated. This area was multiplied by the length of each channel segment between observation points; and then all segments added to provide an estimate of the debris flow volume, which was found to be between 2866-11,462 m³, most likely about 7164 m³ (Table 12). The average apparent channel yield was 15 m³/m.

Photo 15. WP41. Note thick till deposits. Assume 0.25-1 m scour across scoured perimeter.

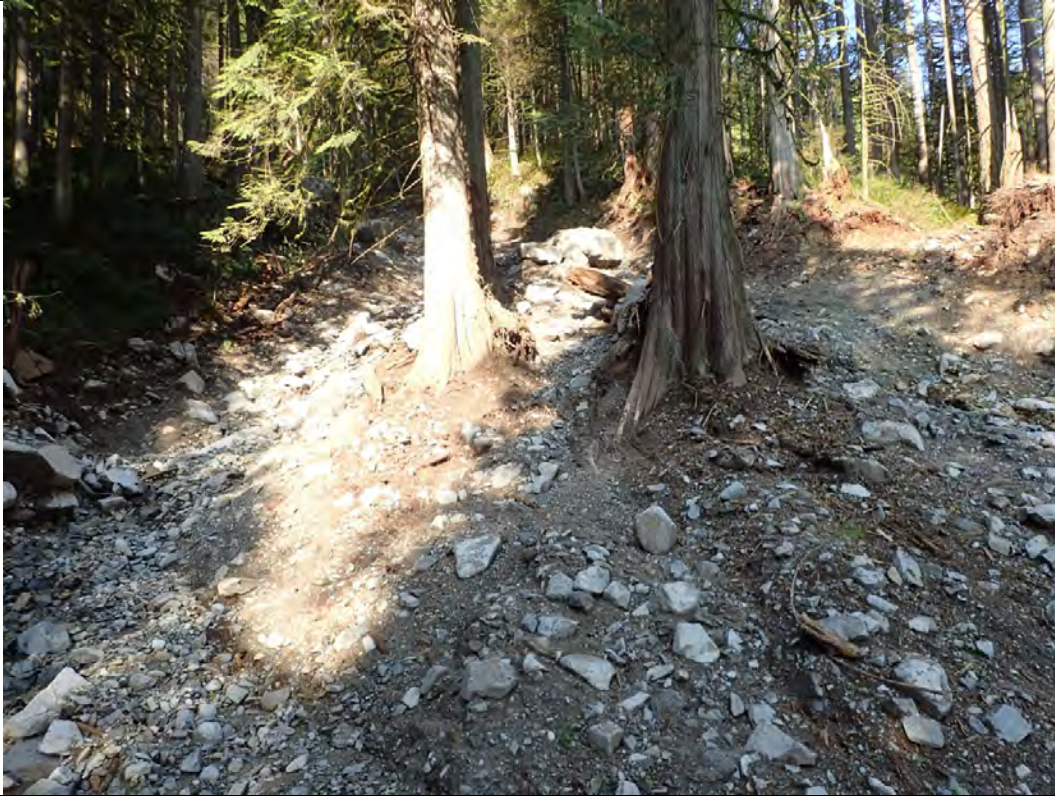
Photo 16. WP36. Lot 7. Cedar clump split debris flow causing avulsion to south.

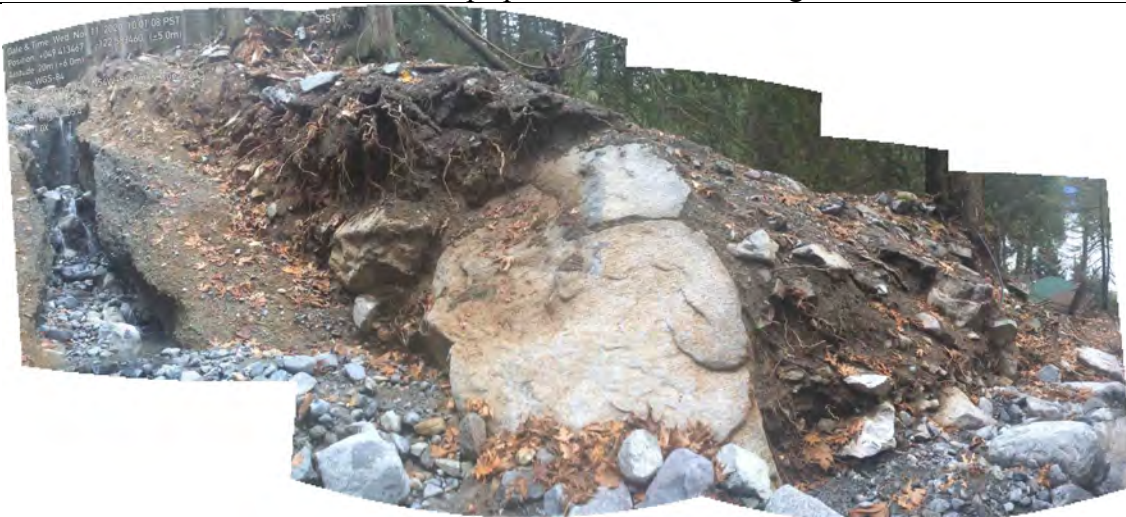
There is evidence for early Holocene sedimentation (WPs 34, 84; Table 7) exposed by the 2020 debris flow. In this section an eroded trench reveals unweathered slope-parallel dipping, stratified sandy gravel, overlain by a humic stained and weathered, unsorted debris flow diamicton that thickens from 1-2 m upslope to several metres downslope toward the beach. Charcoal samples (WPs 84, 85; Table 7) were located from the base of the humic/weathered debris and radiocarbon dating could provide some indication of chronology of debris flow activity. Samples have not been submitted for dating, as the cost was out of scope of the contract.

Photo 17. WP34. Basin 3. Debris cone left bank section in cone deposits. From lower left: grey, slope-parallel bedded paraglacial cone delta gravels; onlapped from center to right, by downslope thickening wedge of humic-stained Holocene debris flow diamict.

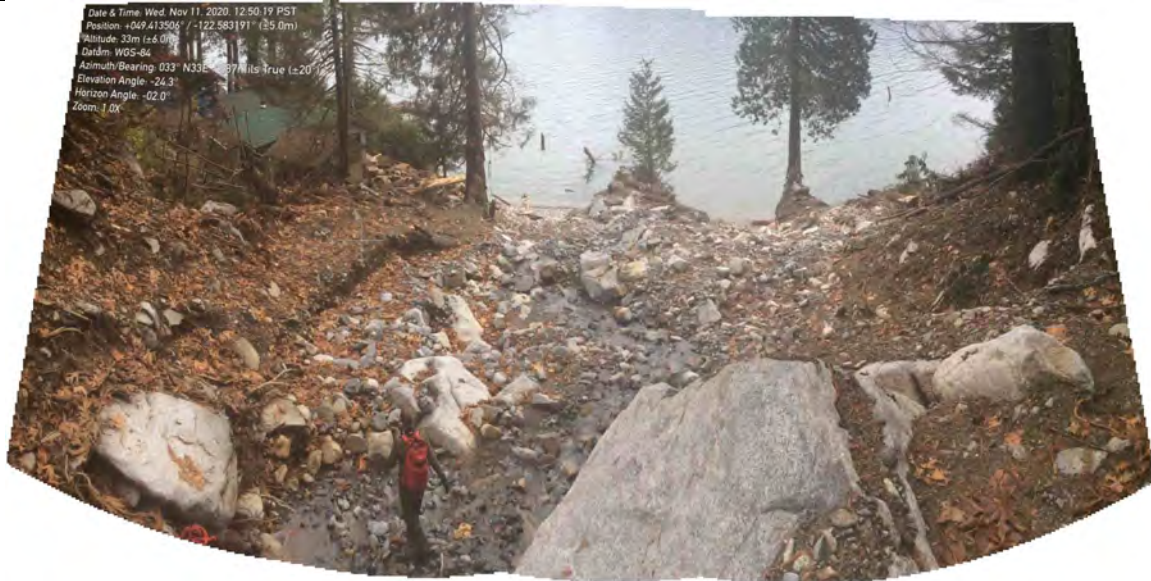
Photo 18. WP33-34. View east along lower track to Lot 6 (left)(near miss) and Lot 7 (right)(destroyed house not visible as it had been burnt during cleanup).

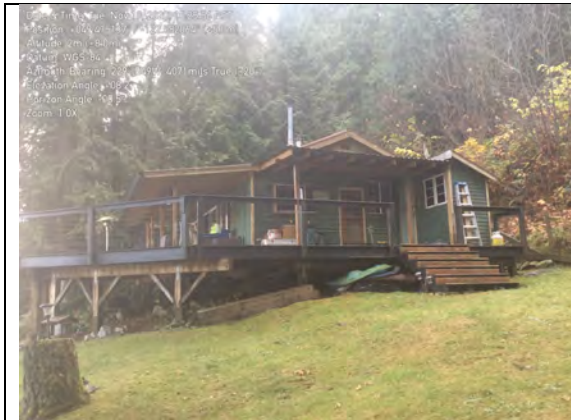
Photo 20. WP168. Cabin on Lot 1. The south edge of the active braided creek channel from Basin 1 adjacent with the north side of the lot.

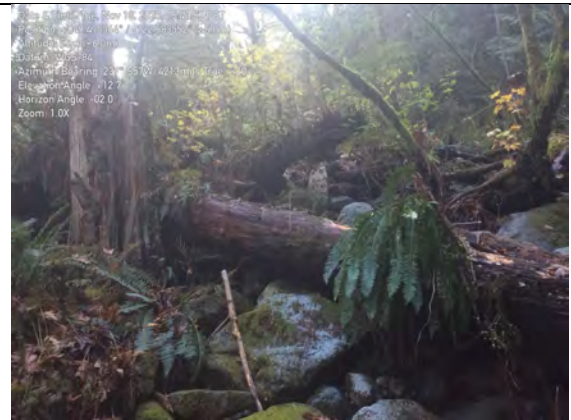
Photo 21. WP171, wood and boulder jam above Lots 1-3, potential avulsion point.

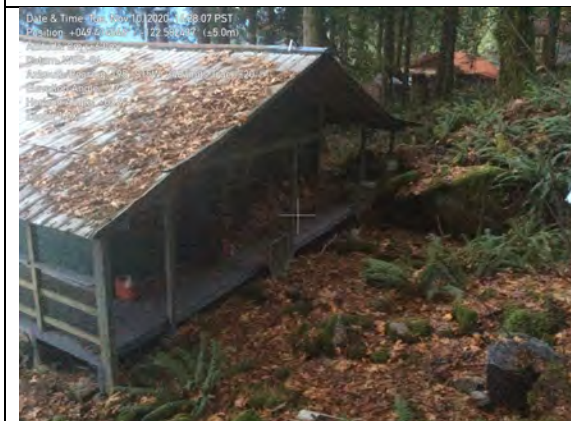
Photo 22. WP185. Cabin on Lot 3. View south to back wall. Note large angular block at SW corner.

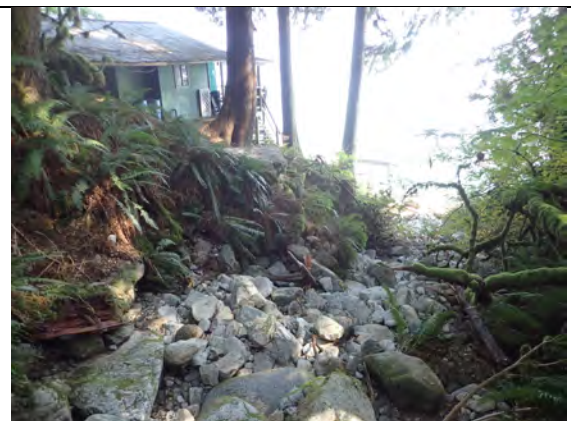
Photo 23. WP185. Cabin on Lot 3. View east down Basin 2 creek. Note only 2 m relief to south side of cabin on left bank.

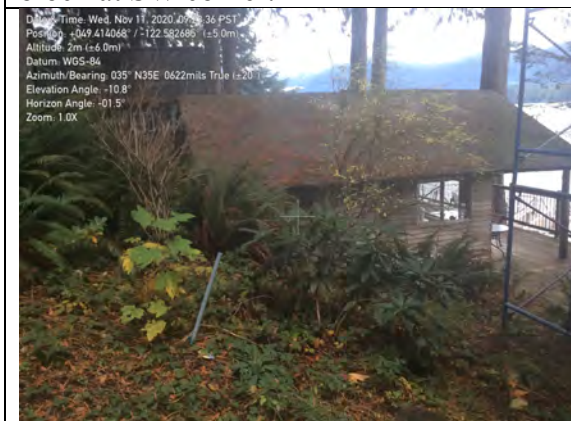
Photo 24. WP74. Lot 4. View northeast. Cabin notched into top of foreshore slope representing truncated cone toe.

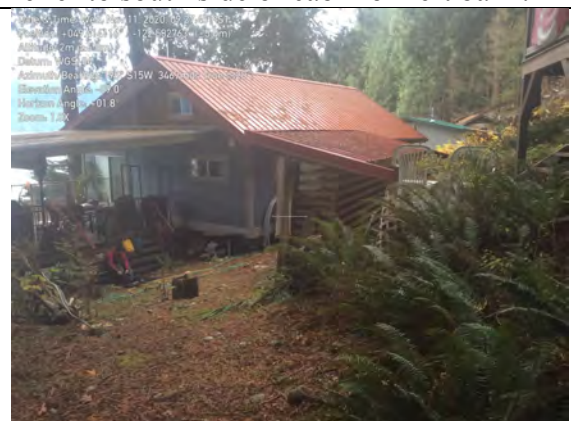
Photo 25. WP75. Lot 5. View SE to cabin built at crest of foreshore slope.

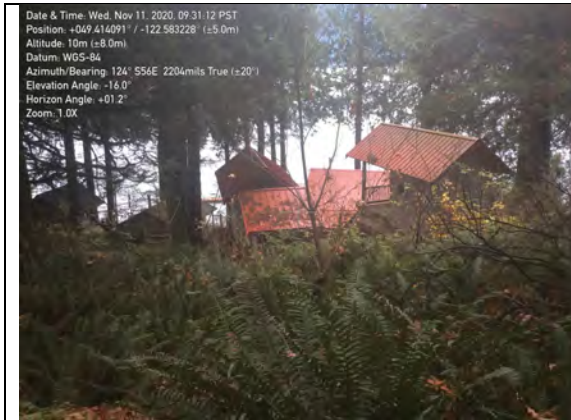
Photo 26. WP75. Lot 5. View east to cluster of accessory cabins. South edge of 30% sloping Basin 2 creek debris cone.

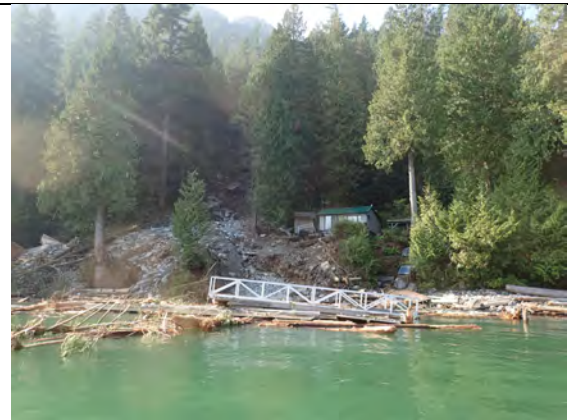
Photo 27. WP32. Lot 6. View west showing north (right) edge of debris flow track which tore porch off cabin. Cabin otherwise intact.

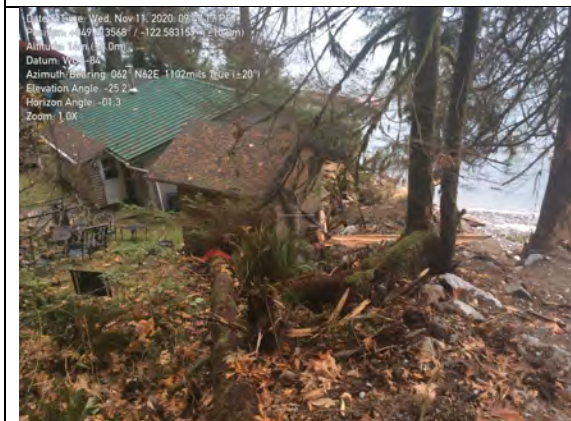
Photo 28. WP32. Lot 6. View down along lower north side of 2020 track, just missing cabin and accessory building.

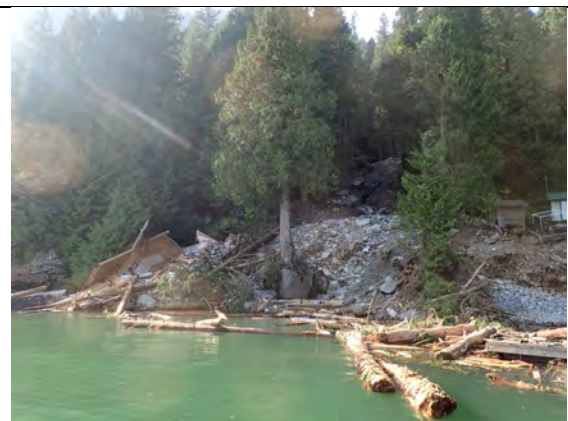
Photo 29. WP32. Lot 7. View east to south (left) edge of 2020 debris flow track and destroyed cabin, since burnt as part of cleanup activity on the lot.

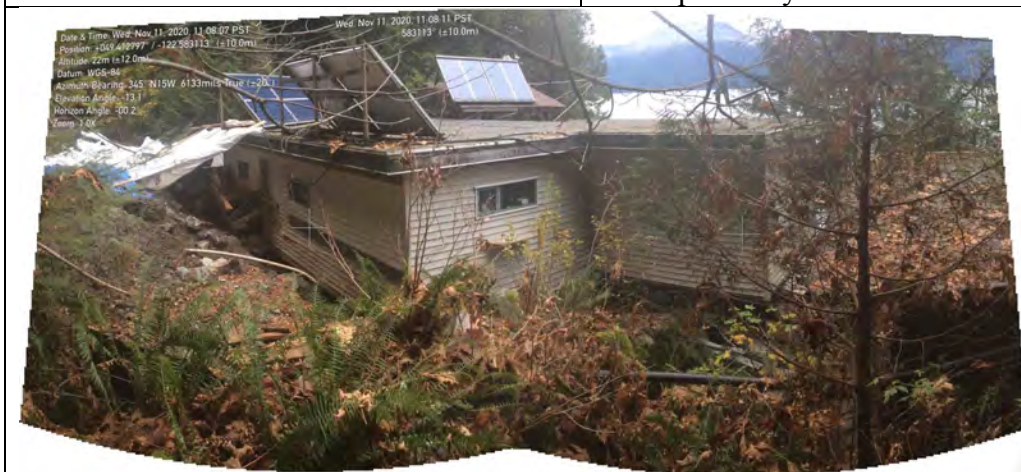
Photo 30. WP97. Lot 8. Back of cabin affected by 2020 afterflow slurry, accumulated to 1 m depth. In 1990, this cabin was knocked off its foundation and then reset in its present position (see Appendix 2)

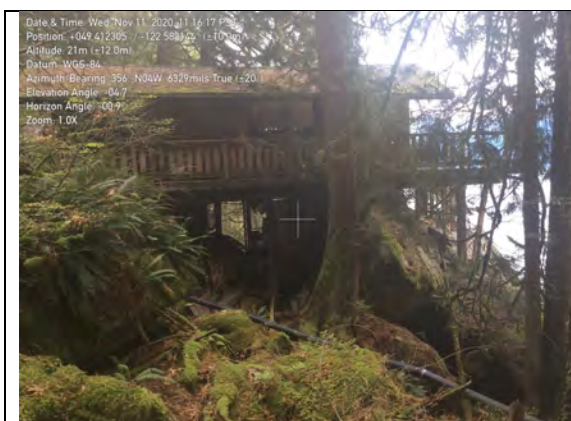
Photo 31. WP99. Cabin on Lot 9. House built on talus, aCk, 60%, 5-10 m sized blocks

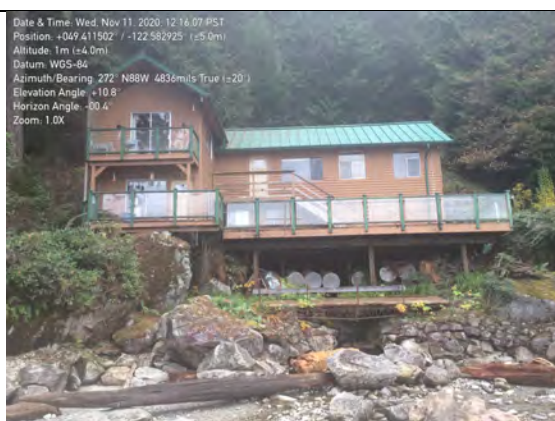
Photo 32. Cabin on Lot 10. The 1990 debris flow just missed (<10 m) the north (right) side of this building. Note the box culvert & creek beneath the cabin.

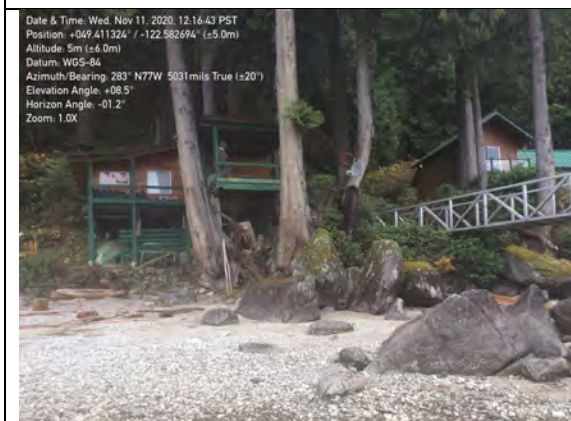
Photo 33. Lot 11. South edge of rockfall talus at beach. Cabin tucked into steep slope.

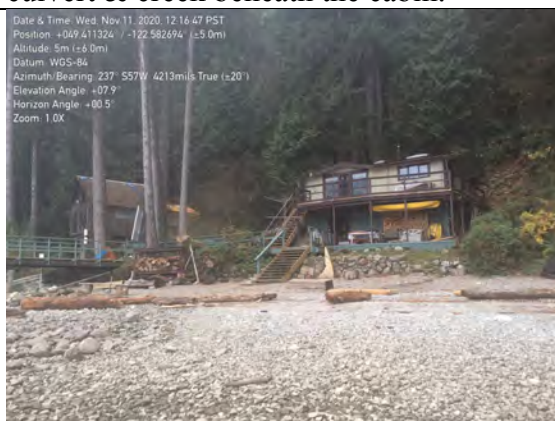
Photo 34. Lot 12. Cabin tucked into foot of steep hill. Back of cabin is a small creek/ncd diverted by concrete flume. Note littoral is armoured by boulders and vulnerable to wave attack.

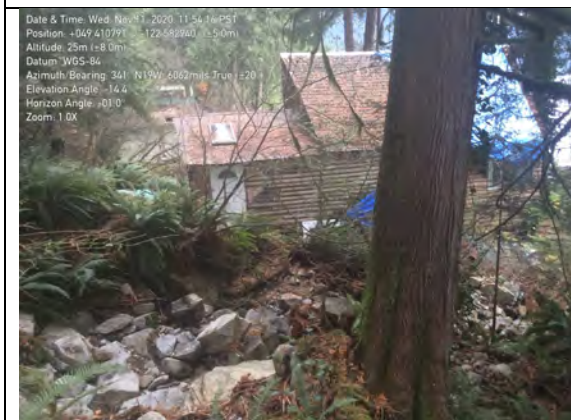
Photo 35. Lot 13. Note creek passes directly beside south wall of cabin.

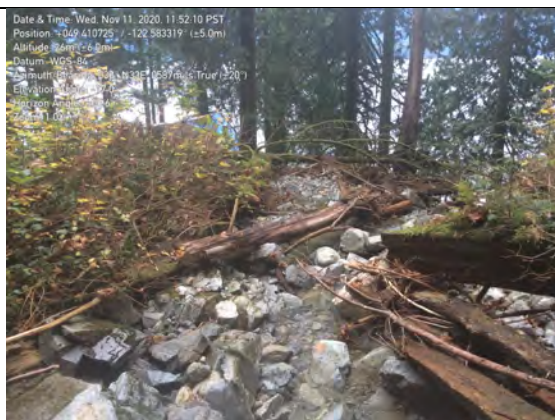
Photo 36. Lot 13. View from debris jam at head of small cone. Note tarped roof visible to left of channel downstream..

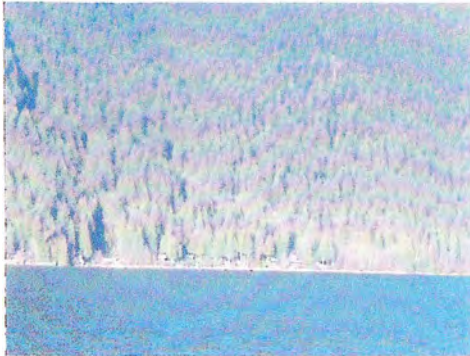
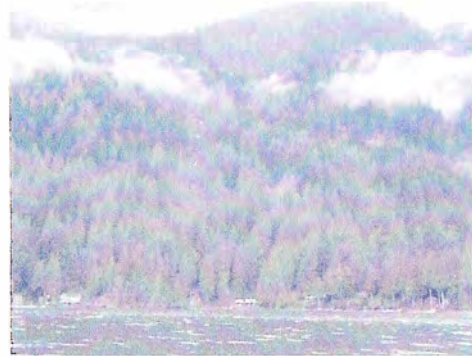
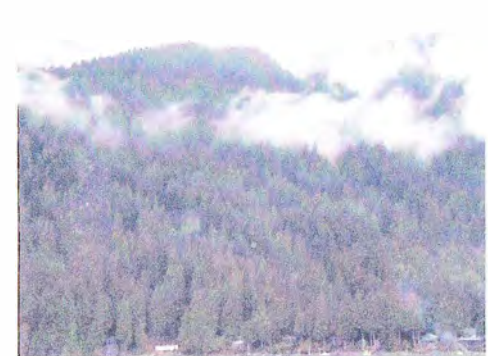
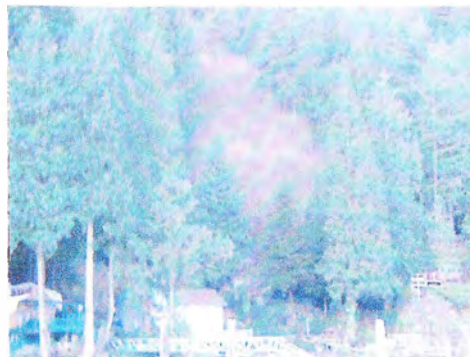
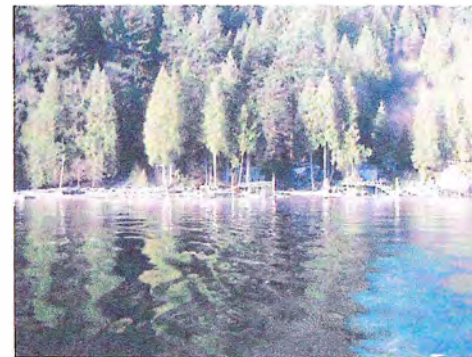
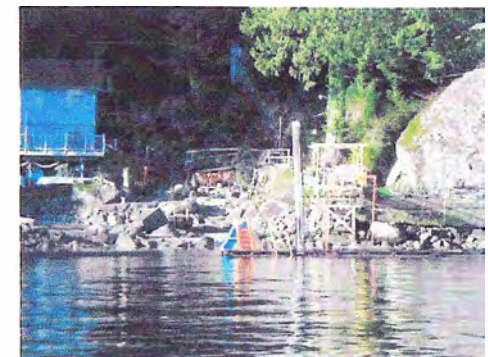
Appendix 2. Slide that hit Moonshine Bay in 1990

These are photos of the area that was hit by a large slide in the fall of 1990 the slide hit lots G of DL 6914 and separated and went around Lot and hit Lot of Moonshine Bay

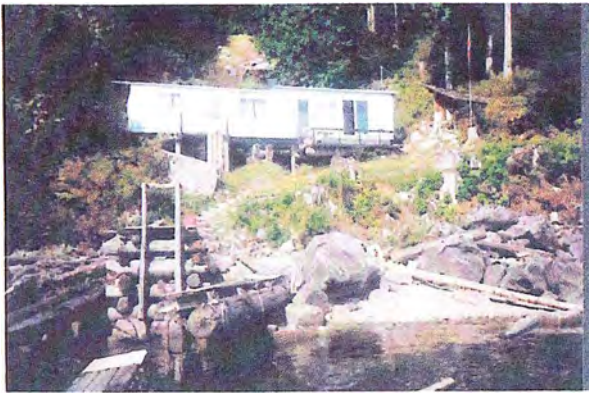
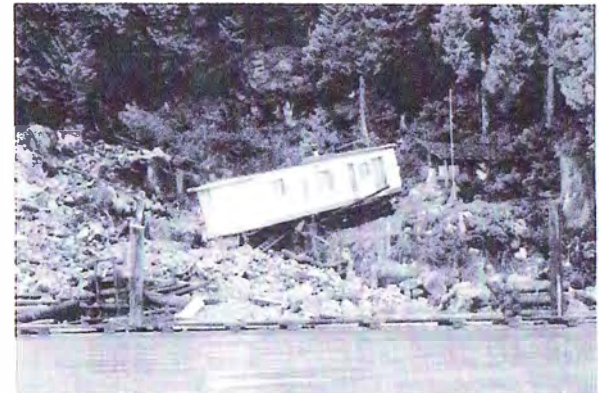
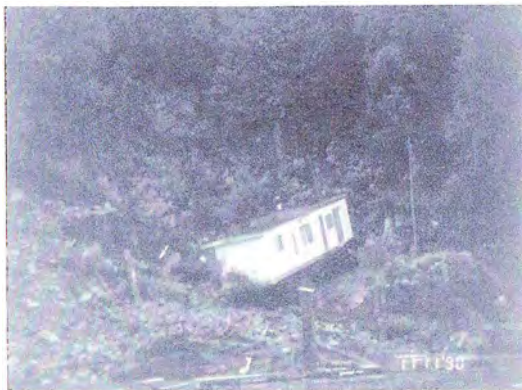
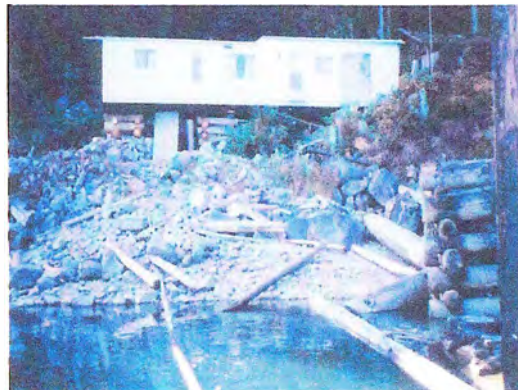
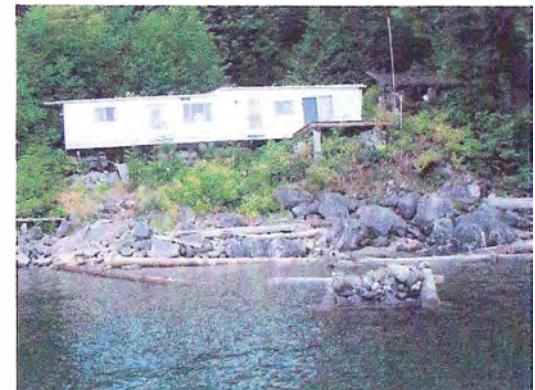
App 2, cont'd. Slide that hit Moonshine Bay in 1990

The photo on the top left shows the trailer on Lot G DL 6914 before the slide. The photos on the top right and bottom left show being hit by the slide and the photo on the bottom middle is after the slide and the trailer placed on cribbing again. **Note trailer is level.** The photo on the bottom right is of the trailer in 2001 when I purchased it. **Note it has settled on the left end** due to unstable soil conditions.
