# 2022 GVS&DD Environmental Management and Quality Control

## ANNUAL REPORT

Liquid Waste Committee – September 13, 2023

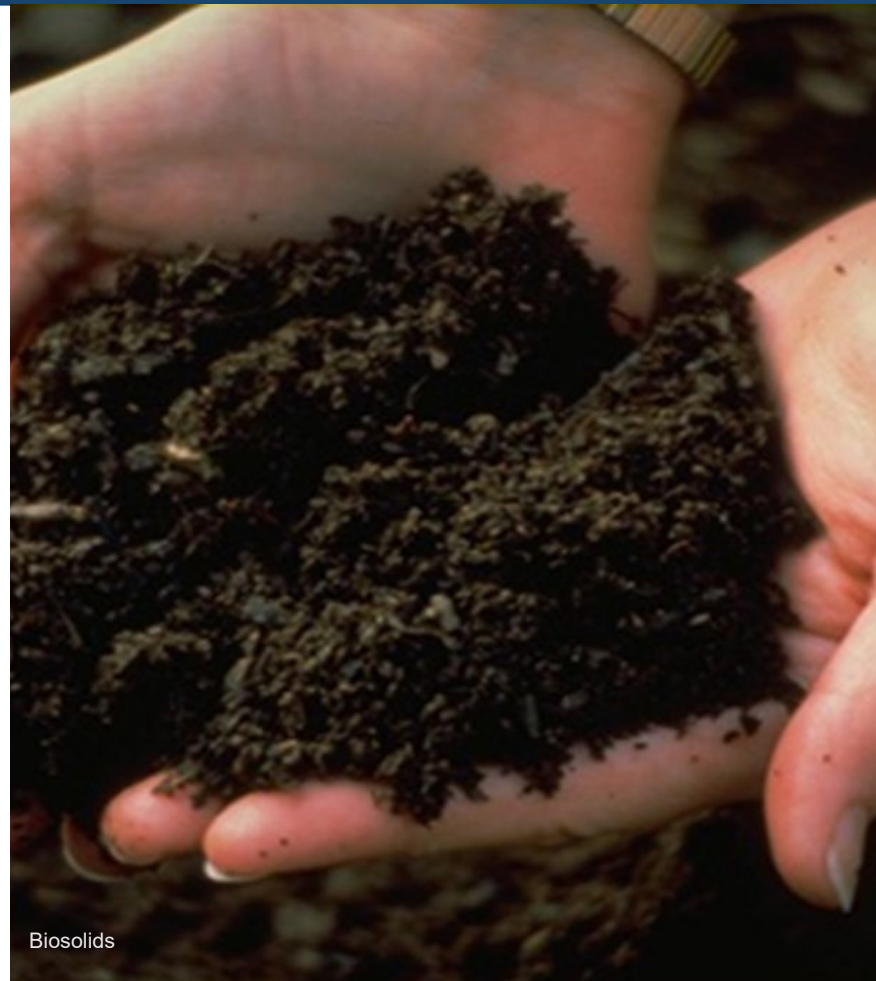
Biosolids

- Almost 15,000 laboratory analyses performed to determine biosolids quality
- Metal concentrations and fecal coliform counts in biosolids generally well below regulatory limits
- Produced over 67,000 bulk tonnes of biosolids and beneficially used 100%
