Greater Vancouver Water District

Capilano River Fish Stranding Study

April 21, 2020

Ecofish Research Ltd.

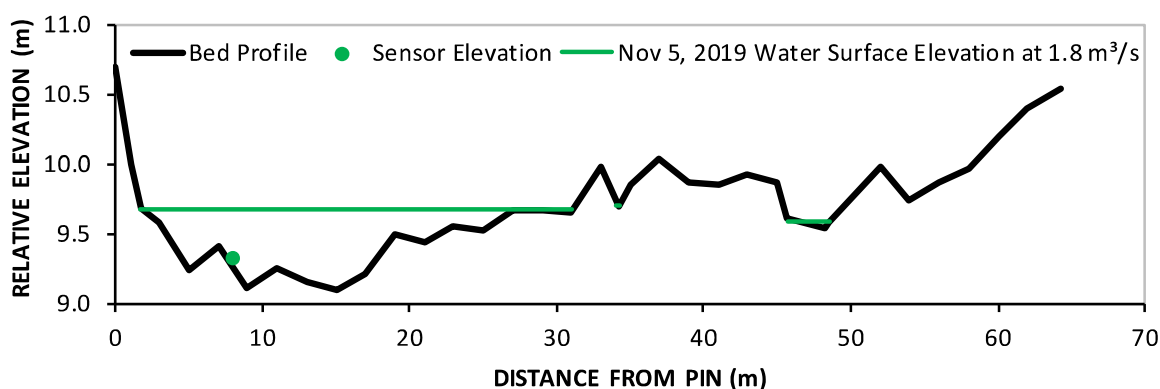
Figure 1. Bed profile plot of CAP-DSSD01, surveyed as distance from river left on November 5, 2019. Green line represents the water surface elevation.

The boulder and cobble substrate create large interstitial spaces where fish may become trapped when water levels drop. The bars and side channel at this site also create the potential for isolated pools to form, increasing stranding risk. The stranding sensitive habitat at this site is concentrated on mid channel bar and on river right.

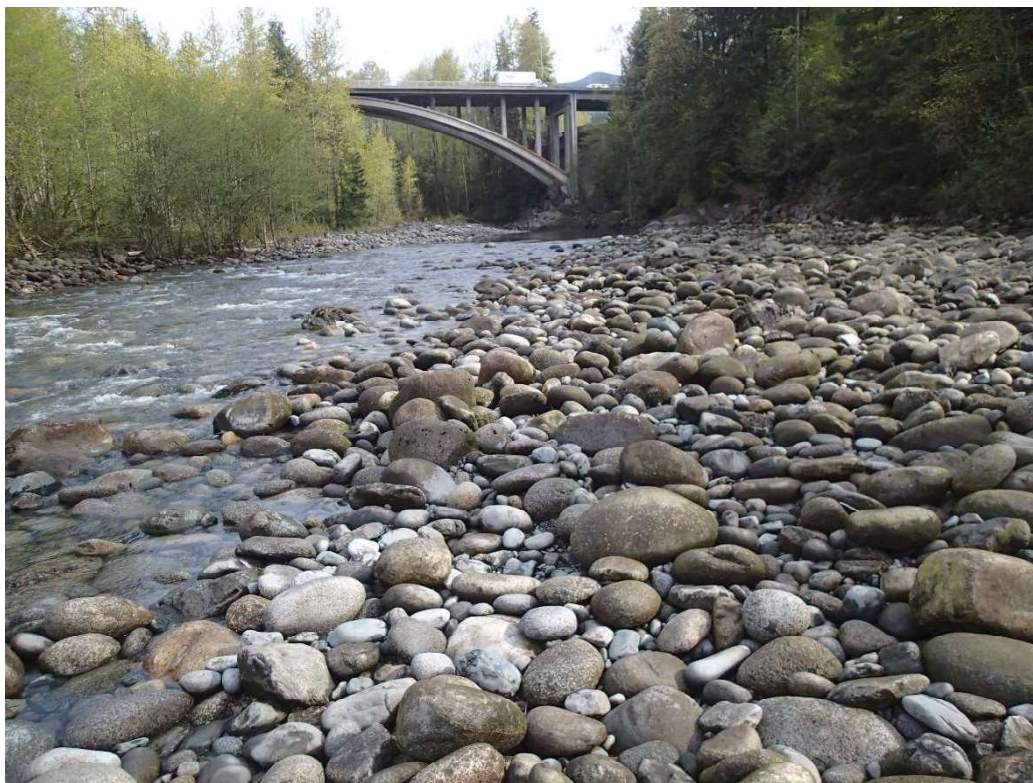
Figure 4. Looking upstream at CAP-DSSD02, April 25, 2019.

Habitat values at CAP-DSSD02 are similar to those at CAP-DSSD01, with boulder and cobble substrate dominant and side bars present at low flows (Figure 4). Rearing habitat is of good quality but limited; one large pool provides good overwintering habitat. The site likely primarily provides migratory habitat. As with CAP-DSSD01, there is a high stranding risk due to large interstitial spaces between boulders and the potential for isolated pools to form in the side channel. The stranding sensitive habitat is concentrated on river left at this site.

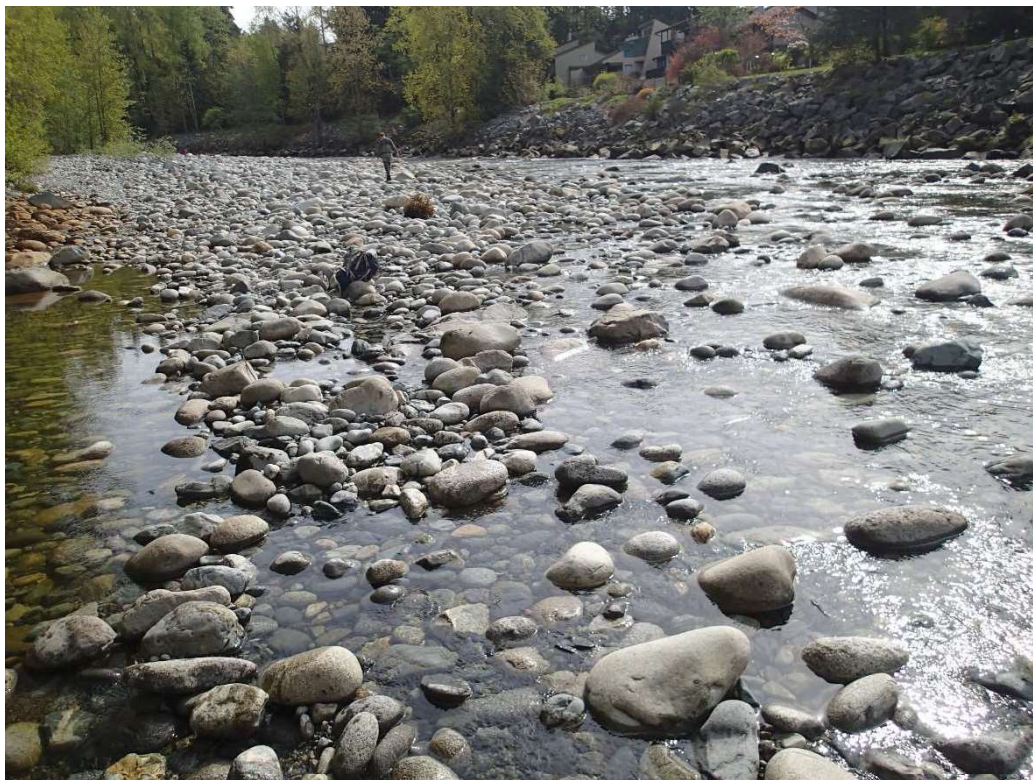
Figure 6. Looking upstream at CAP-DSSD03, April 25, 2019.

CAP-DSSD03 is also dominated by boulder and cobble habitat. Some high quality rearing habitat is present. Again, interstitial spaces and the presence of a side bar and side channel create stranding risk

at this site (Figure 6). The stranding sensitive habitat is concentrated on river right and margins of the central bar at this site.

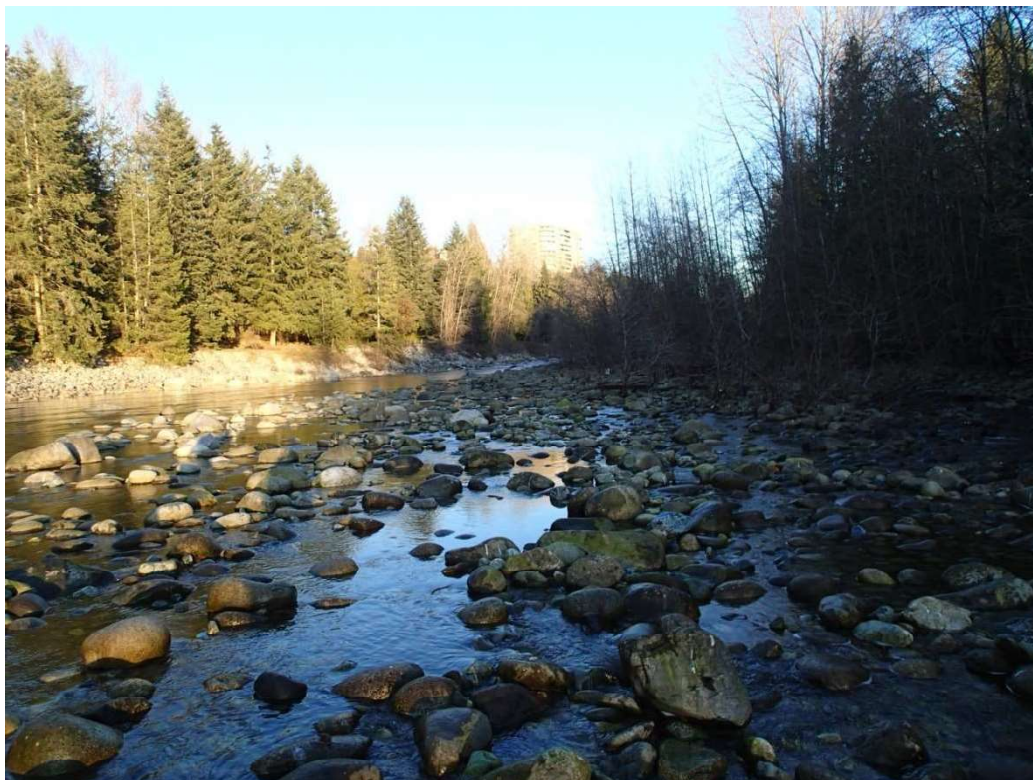
Figure 10. Looking upstream at CAP-DSSD05, November 28, 2019.

Consistent with the other SSMSs, CAP-DSSD05 is dominated by boulder and cobble substrate, creating interstitial spaces with potential for stranding. No overwintering or spawning habitat was observed at this site, and a moderate amount of good quality rearing habitat. A side channel at this site creates the potential for stranding in isolated pools. The stranding sensitive habitat is concentrated in the center of the channel and at river right at this site.

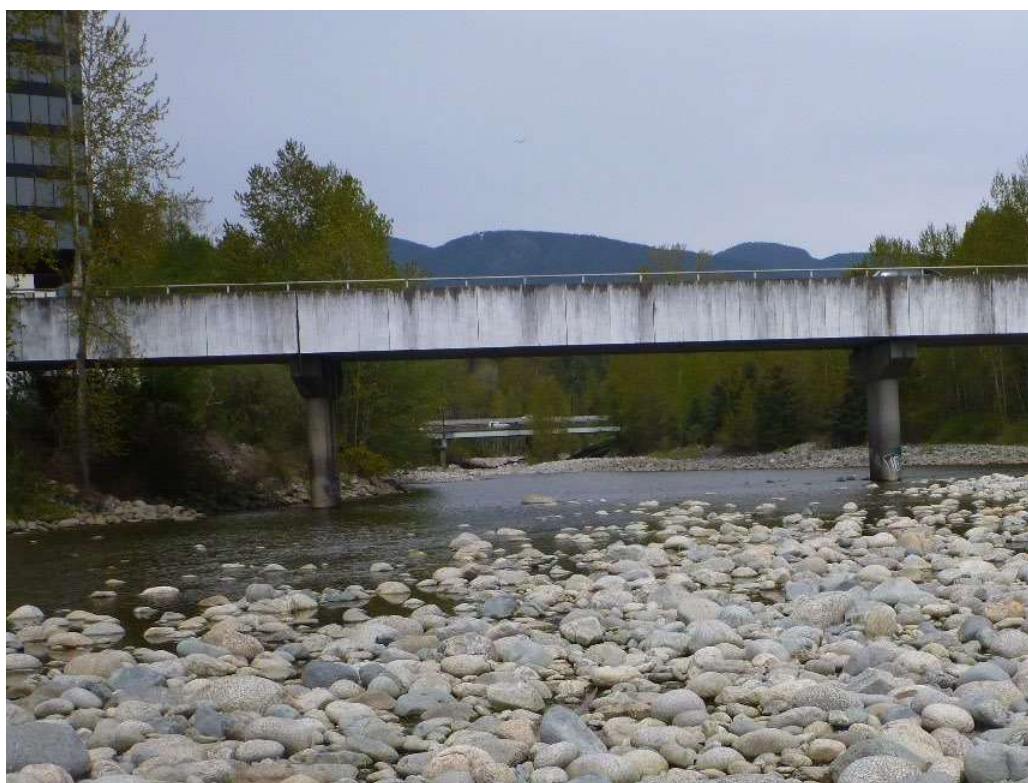
Figure 11. Looking upstream at CAP-DSSD06, April 25, 2019.

CAP-DSSD06 was established during the April 25 stranding survey, but was not searched during later tests. CAP-DSSD06 is tidally influenced, hence inundated at high tides regardless of flow rates in the Capilano River. As a result, this site is at a low risk for stranding at high tide, and at low tide it may be difficult to determine whether fish were stranded due to operational flow changes or due to the retreating tide. CAP-DSSD06 shares the boulder and cobble dominated substrate and other general habitat attributes of the primary SSMSs (Figure 11). The stranding sensitive habitat is concentrated on river right at this site.

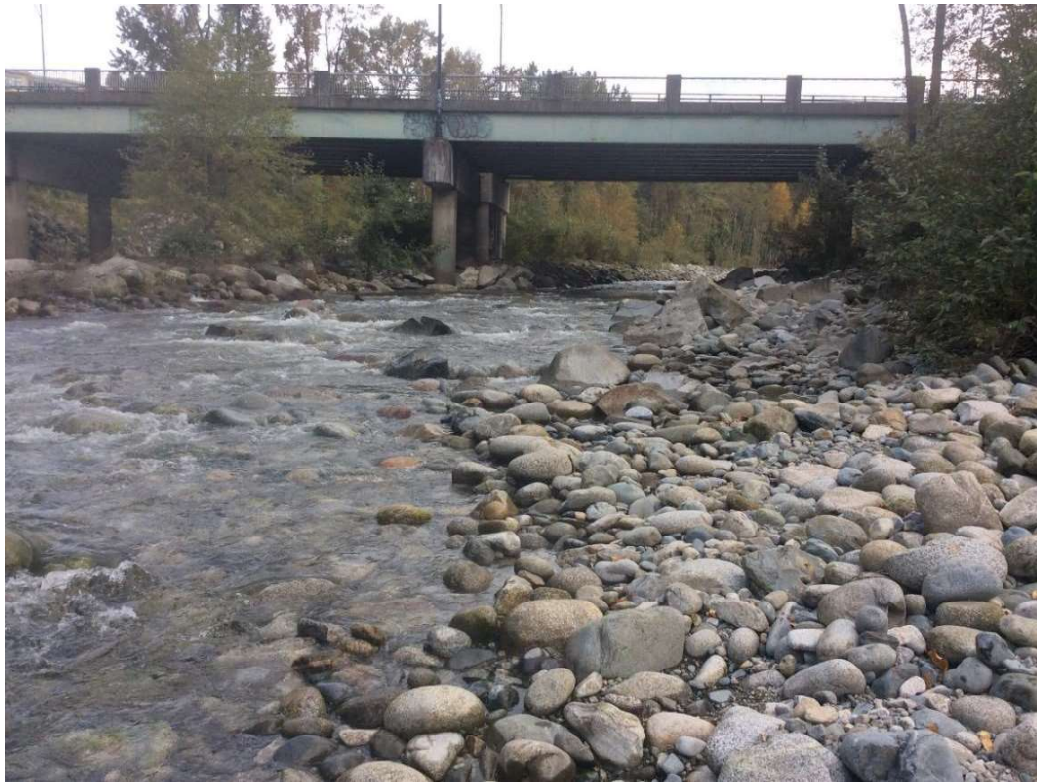
Figure 12. Looking upstream at CAP-DSSD07, October 1, 2019.

CAP-DSSD07 is located underneath the Marine Drive bridge. In terms of stranding risk, ramping rates at this site are less of a concern than the occurrence of low flows (Figure 12) because there is a secondary channel located here that may become disconnected from the mainstem and dewatered when water levels are low. This can occur naturally but is also potentially a result of flow regulation of the Capilano River. CAP-DSSD07 was searched only during the May 7 and October 1 stranding surveys. The stranding sensitive habitat is concentrated on river left at this site.

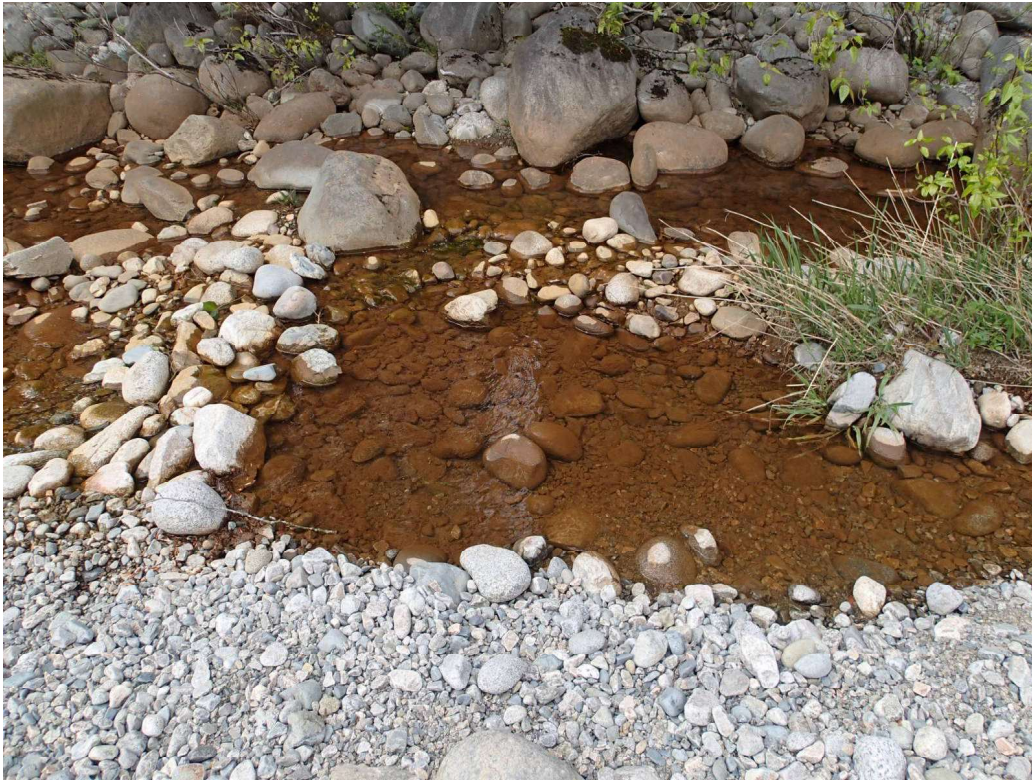
Figure 15. Isolated area with >20 Coho Salmon fry near CAP-DSSD03, April 25, 2019.

At the three sites furthest upstream, extensive interstitial spaces were observed, some of which remained wetted through sub-surface flow. Four of the six sites searched (i.e., CAP-DSSD01, CAP-DSSD02, CAP-DSS03 and CAP-DSS04) had side channel habitat that became isolated or dewatered during the event.

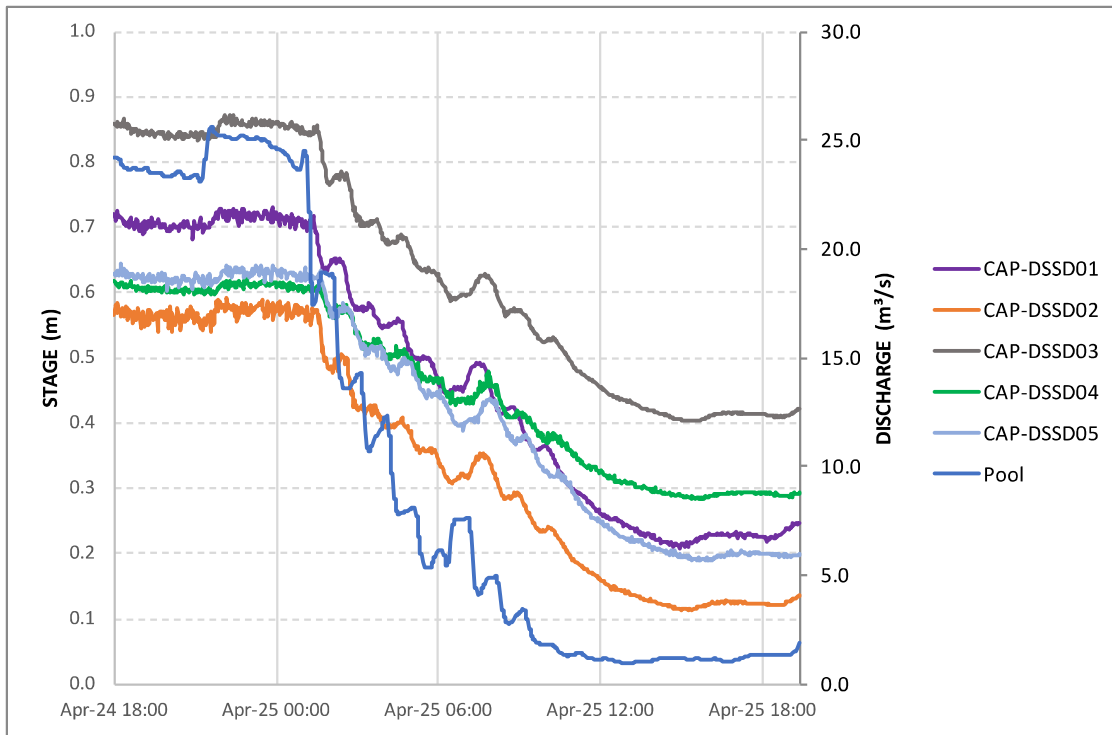
Figure 16. Stage and discharge at GVWD hydrometric station (“Pool”) and each SSMS during the April 25, 2019 shutdown. Discharge at SSMSs is estimated using rating curves in Figure 14.

The first stranding survey occurred during a planned ramp-down at the CLD on April 25, 2019 that was initiated by raising the CLD Drum Gate. This operation caused a flow decrease from 24.3 m³/s at 01:06 PDT to 1.00 m³/s at 13:00 PDT as measured at the Pool gauge (Table 5 and Figure 16). This flow change resulted in a maximum ramping rates ranging from -7.3 cm/hr at CAP-DSSD04 to -10.1 cm/hr at CAP-DSSD02 (Table 5 and Figure 17). Fish stranding searches were initiated at 08:00 PDT and continued until 19:15 PDT (i.e., after the stage minimum of the ramping test was confirmed). Twelve broad-based searches were conducted in total at the five primary SSMSs and at CAP-DSSD06, covering a total area of 9,800 m², with a total time of five hours and ten minutes spent conducting broad-based searches. Additionally, 43 hotspot searches were conducted, covering a total area of 860 m², with a total of ten hours and 26 minutes spent conducting hotspot searches.

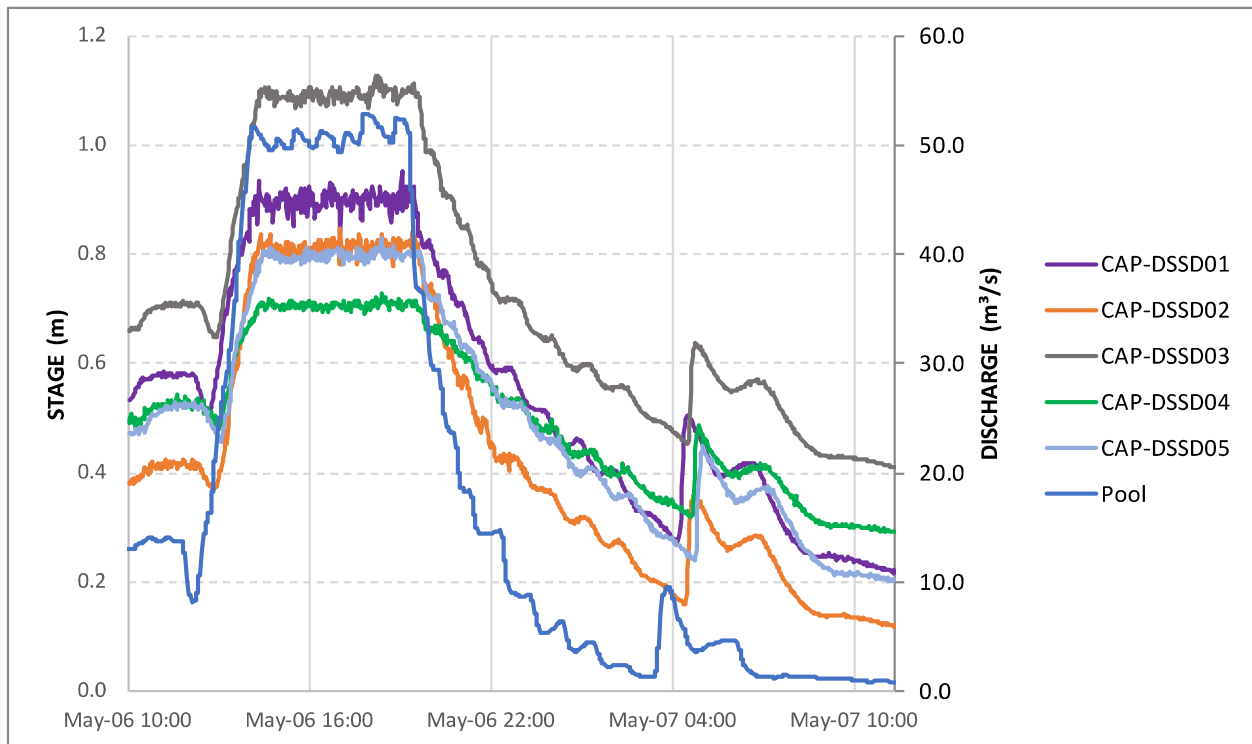
Figure 18. Stage and discharge at GVWD hydrometric station (“Pool”) and each SSMS during the May 7, 2019 shutdown. Discharge at SSMSs is estimated using rating curves in Figure 14.

The second stranding survey occurred during a planned ramp-down at the CLD on May 7, 2019 that was initiated by raising the drum gate. The main flow decrease occurred overnight, with ramp-down beginning on May 6 at a flow of 52.0 m³/s at 19:14 PDT and decreasing to 1.34 m³/s at 03:06 PDT on May 7. There was a subsequent increase in flow and another ramp-down beginning May 7 from 9.54 m³/s at 03:54 PDT and decreasing to 3.65 m³/s at 04:48 PDT (Table 5 and Figure 18). This flow change resulted in a maximum ramping rates ranging from -7.8 cm/hr at CAP-DSSD04 to -20.8 cm/hr at CAP-DSSD02 (Table 5 and Figure 19). Fish stranding searches were initiated at 08:00 PDT on May 7 and continued until 13:25 PDT that day.

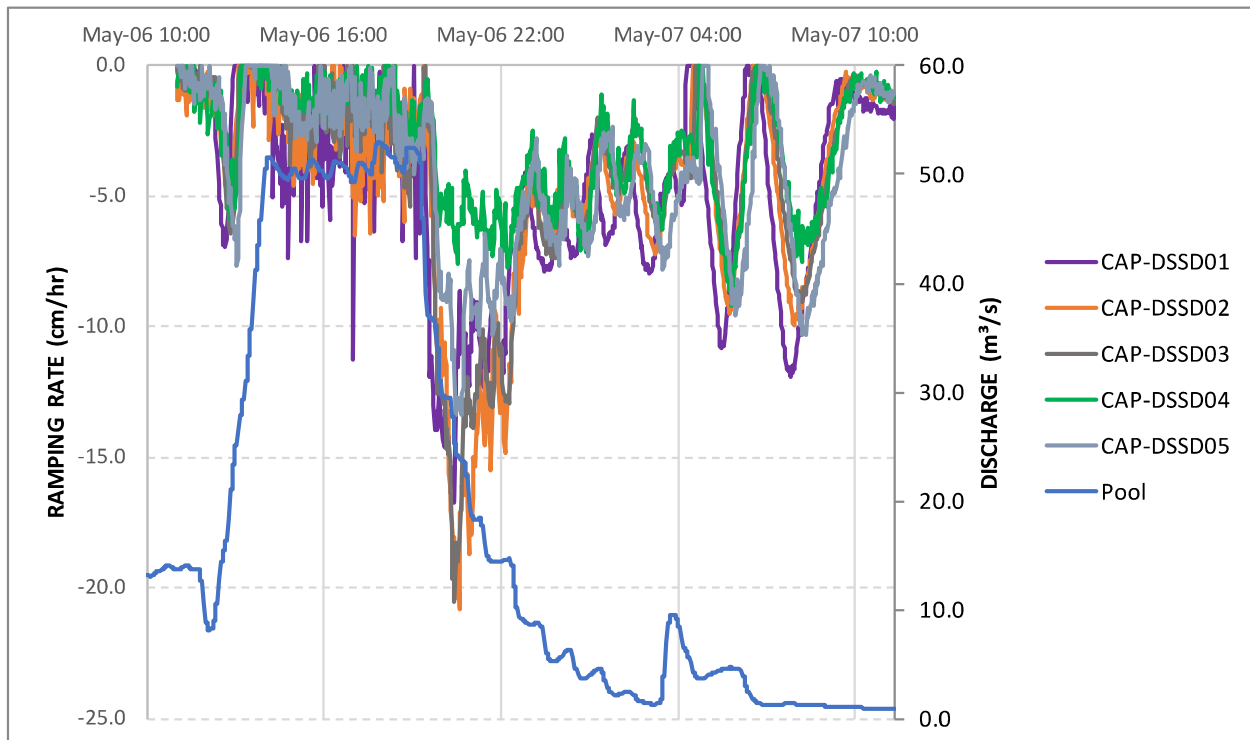
Figure 19. Ramping rate at each SSMS and discharge at GVWD hydrometric station (“Pool”) during the May 7, 2019 shutdown.

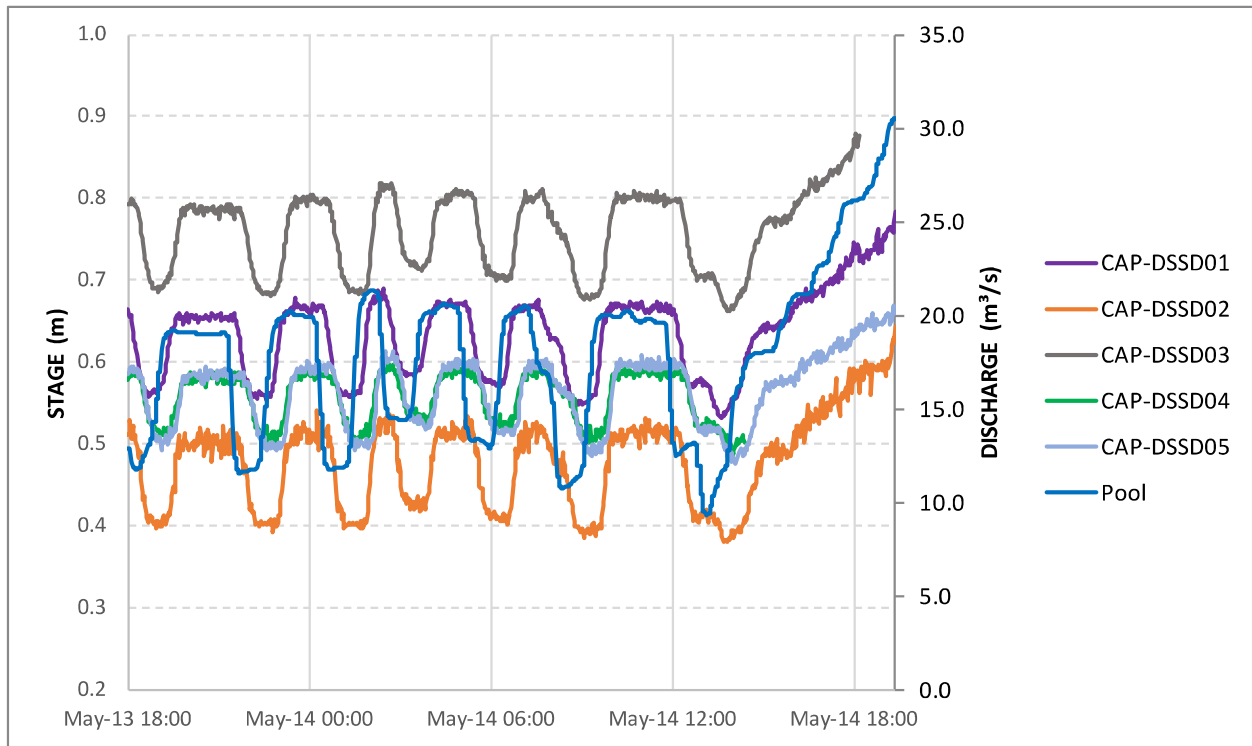
Figure 20. Stage and discharge at GVWD hydrometric station (“Pool”) and each SSMS during the May 14, 2019 shutdown. Discharge at SSMSs is estimated using rating curves in Figure 14.

The third stranding survey occurred during a planned ramp-down on May 14, 2019, which was initiated by raising the drum gate. A stranding survey was deemed warranted due to the recent release of 450,000 Coho Salmon smolts by the Capilano River Hatchery on May 10, 2019. Flow was variable in the 24 hours prior to the planned ramp-down event, which began at 11:44 PDT (flow = 19.7 m³/s) and lasted until 13:06 PDT when a minimum flow of 9.34 m³/s was recorded (Table 5 and Figure 20) before flows began to rise naturally in response to recent rain. This flow change resulted in maximum ramping rates ranging from -7.6 cm/hr at CAP-DSSD04 to -11.7 cm/hr at CAP-DSSD02 (Table 5 and Figure 21). Fish stranding searches were initiated at 15:09 PDT on May 14 and continued until 17:23 PDT on the same day.

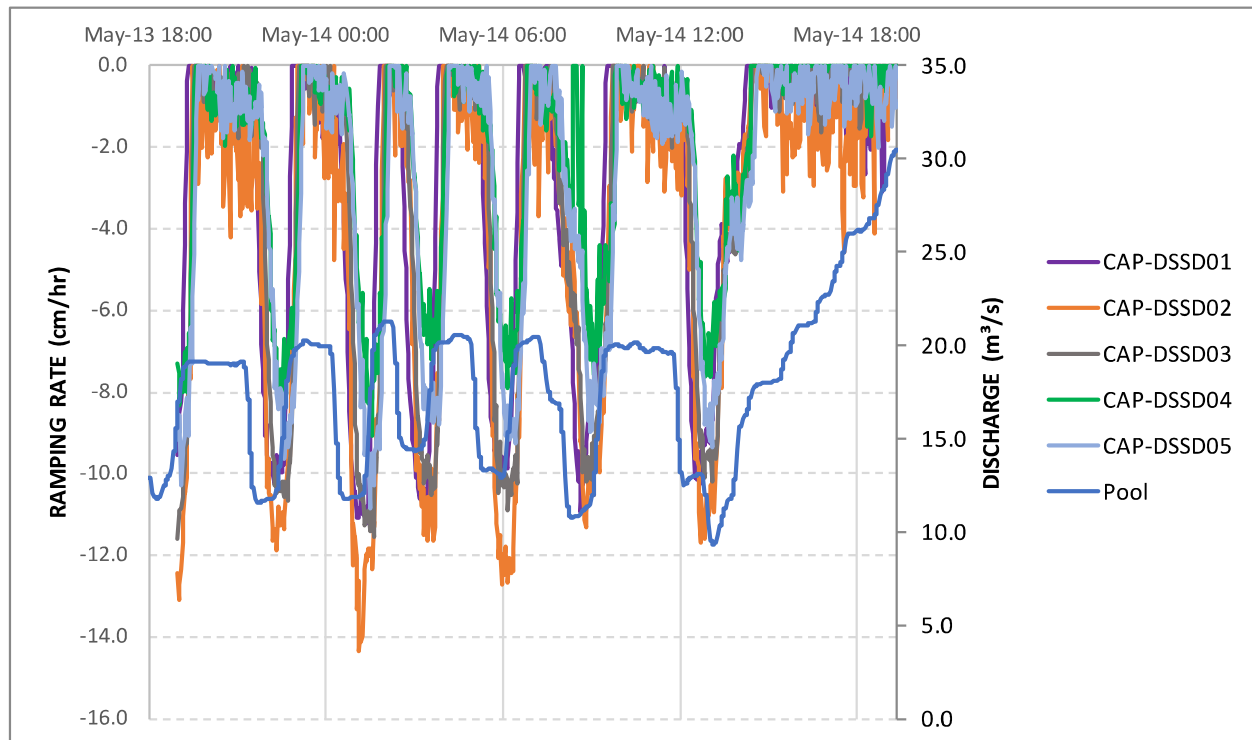
Figure 21. Ramping rate at each SSMS and discharge at GVWD hydrometric station (“Pool”) during the May 14, 2019 shutdown.

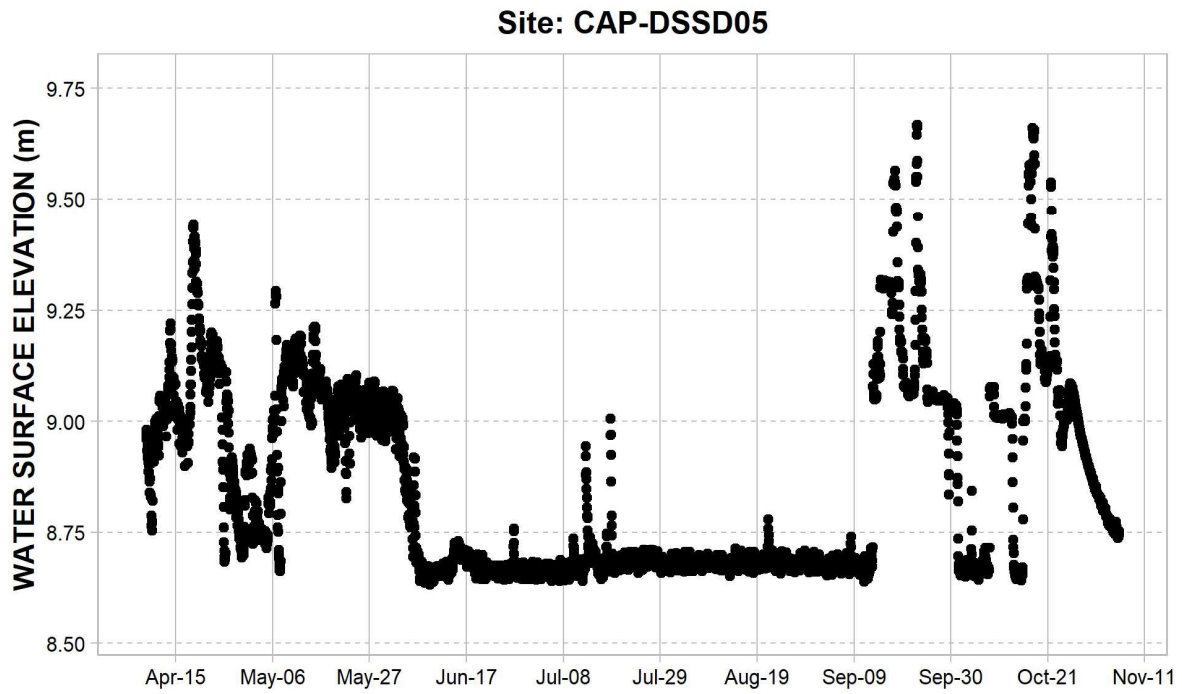
Figure 5. Relative Water Surface Elevation at CAP-DSSD05 from April 8, 2019 to November 5, 2019.
