# Greater Vancouver Water District

## Seymour River Fish Stranding Study

February 1, 2022

**Ecofish Research Ltd.**

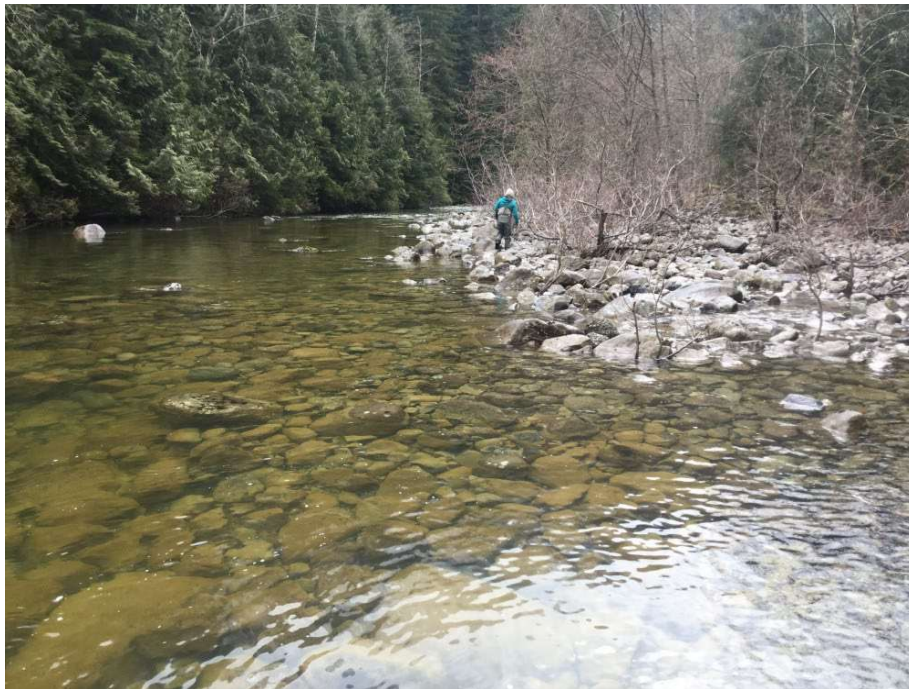
**Figure 2. Looking downstream at SEY-DSSD01, April 3, 2020.**

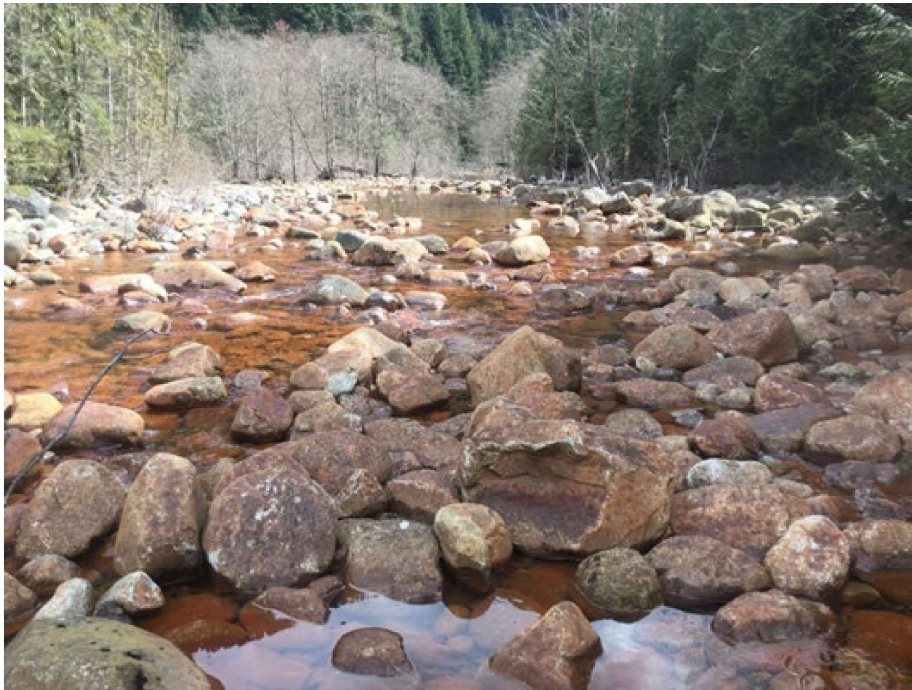
Figure 3. Looking downstream at SEY-DSSD01A, April 3, 2020.

A secondary site (SEY-DSSD01A) located in a site-channel adjacent to SEY-DSSD01 was also visited and searched, though no survey was completed. The channel featured low-flow and shallow habitat. The substrate was a mix of cobble and boulder with many interstitial spaces (Figure 3).

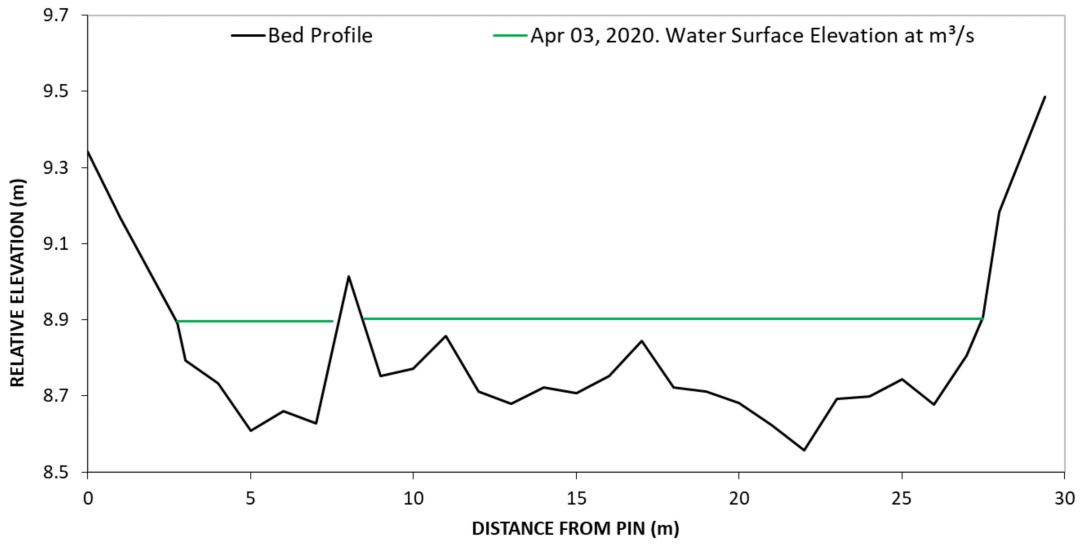
Figure 4. Bed profile plot of SEY-DSSD02, surveyed as distance from river left on April 3, 2020.

The Seymour River at SEY-DSSD02 was broad and shallow, with one main channel and a small side channel on river left (Figure 5). The substrate was dominated by cobble and boulders. There was a high stranding risk due to large interstitial spaces between boulders, and the potential existed for isolated pools to form in the side channel. Stranding sensitive habitat was concentrated on river left at this site. Rearing and spawning habitat were abundant and of moderate quality. The shallow nature of the site provided poor overwintering habitat that was also not suitable for migratory life stages.

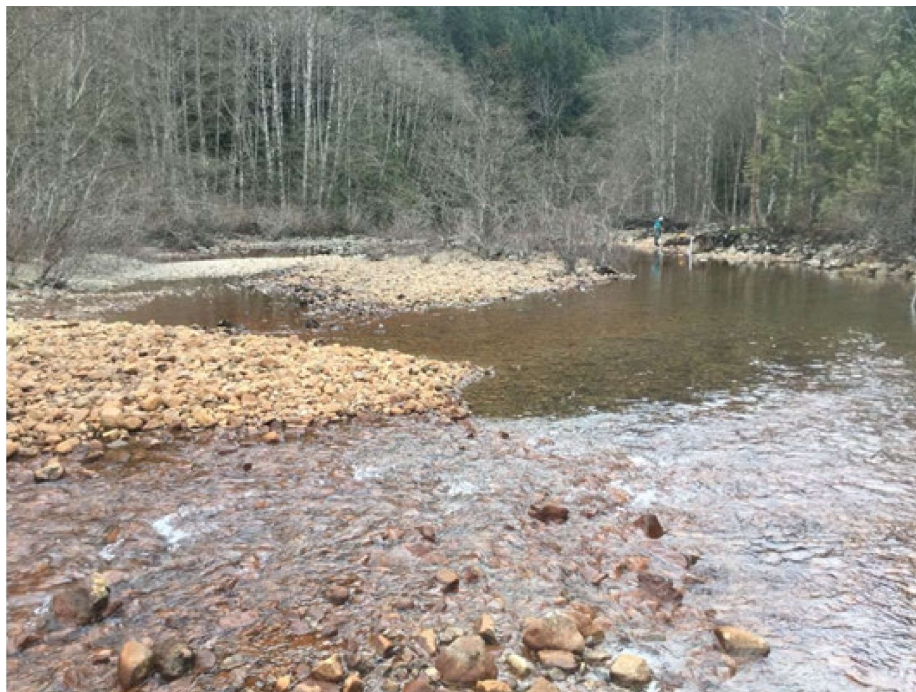
Figure 5. Looking downstream at SEY-DSSD02, April 3, 2020.

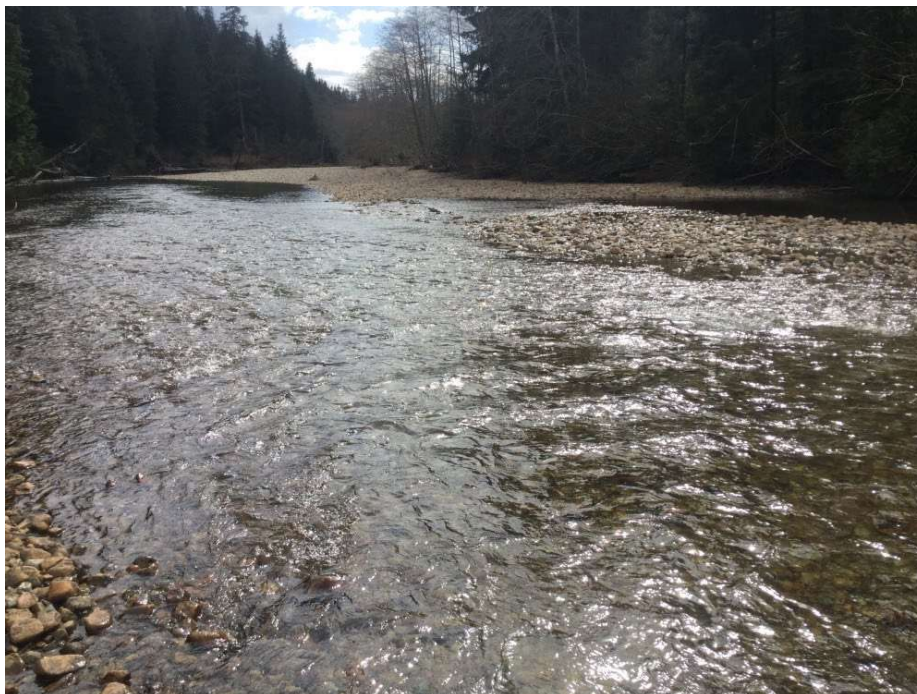
**Figure 7. Looking downstream at SEY-DSSD03, April 3, 2020.**

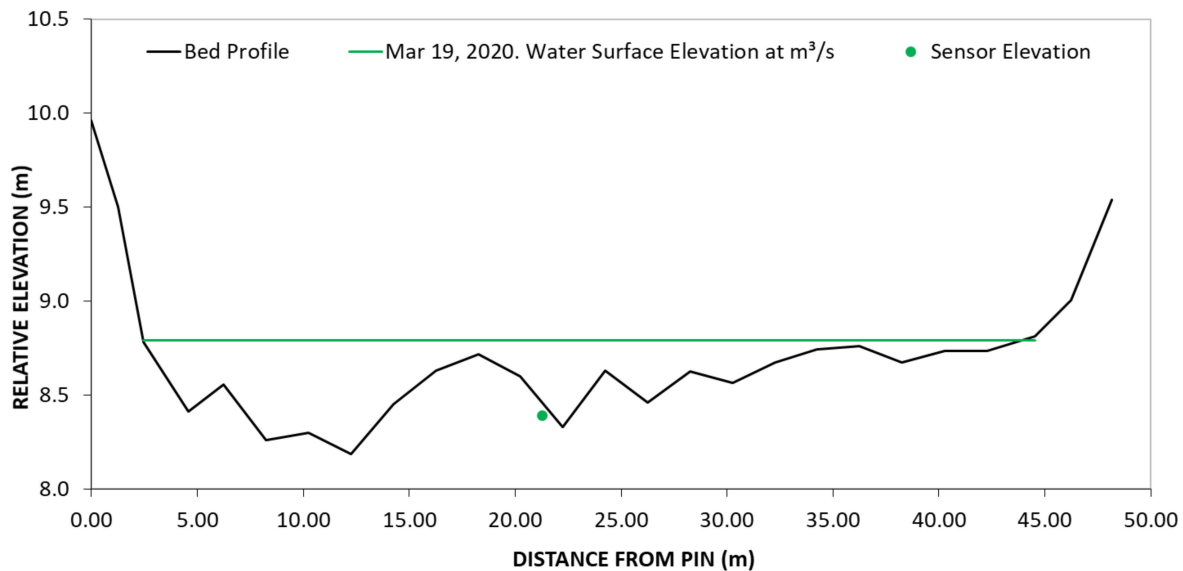
**Figure 8. Bed profile plot of SEY-DSSD04, surveyed as distance from river left on March 19, 2020.**

SEY-DSSD04 was located approximately midway between the SFD and the Seymour River estuary. By this point the river has received the input of several tributaries that may attenuate stage changes due to flow release from SFD. The substrate at this site was dominated by boulder and cobble. This site contained overwintering and rearing habitat of moderate quality and quantity but had little habitat suitable for spawning or migratory life stages. As with the other sites, the presence of interstitial spaces and the potential for isolated pools created a high-risk stranding site (Figure 9). Stranding sensitive habitat was concentrated closer to the river right bank.

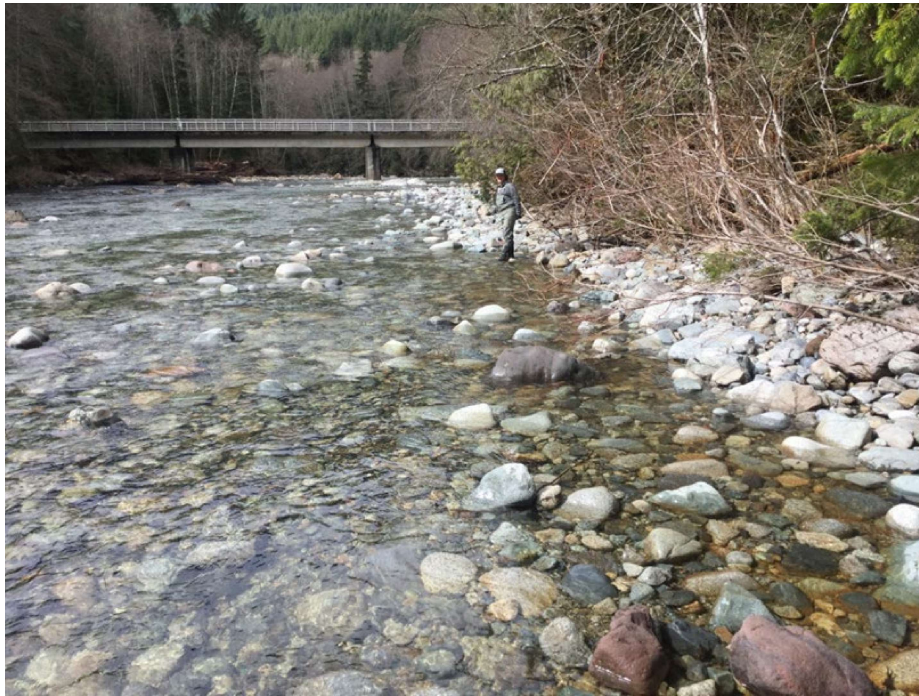
**Figure 9.** Looking downstream at SEY-DSSD04, April 3, 2020.

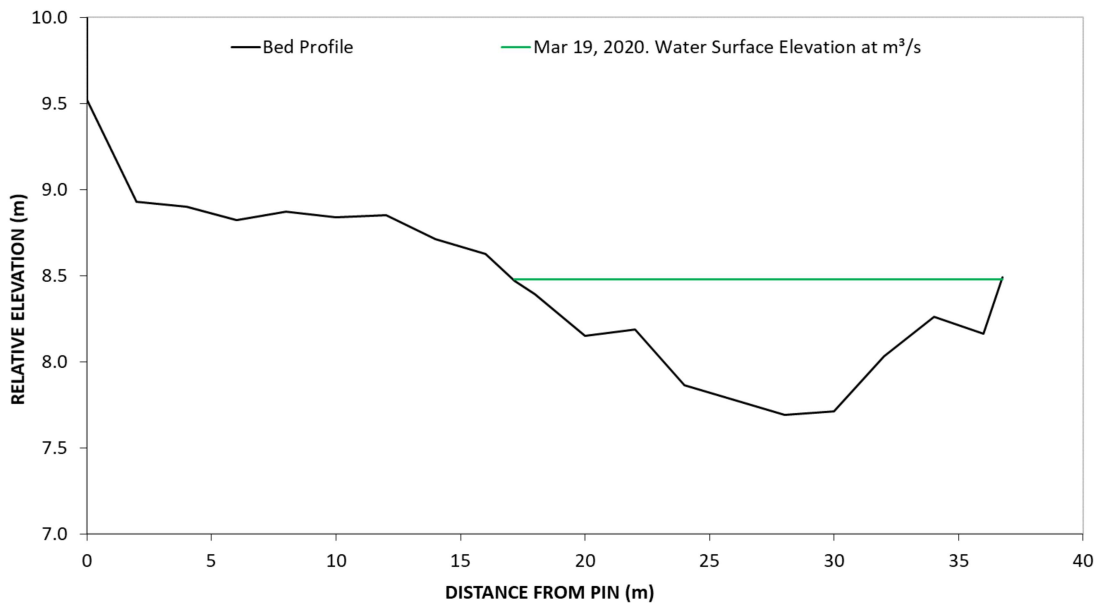
Figure 10. Bed profile plot of SEY-DSSD05, surveyed as distance from river left on March 19, 2020.

SEY-DSSD05 was roughly 230 m downstream of SEY-DSSD04. Consistent with other sites, SEY-DSSD05 was dominated by boulder and cobble substrate, creating interstitial spaces with potential for stranding. The mid-channel of this site was over 1 m deep; however, the site featured a long, low-gradient bar on river left, where stranding could occur. This site was appropriate for overwintering, but provided poor quality habitat for spawning, rearing and migratory life stages.

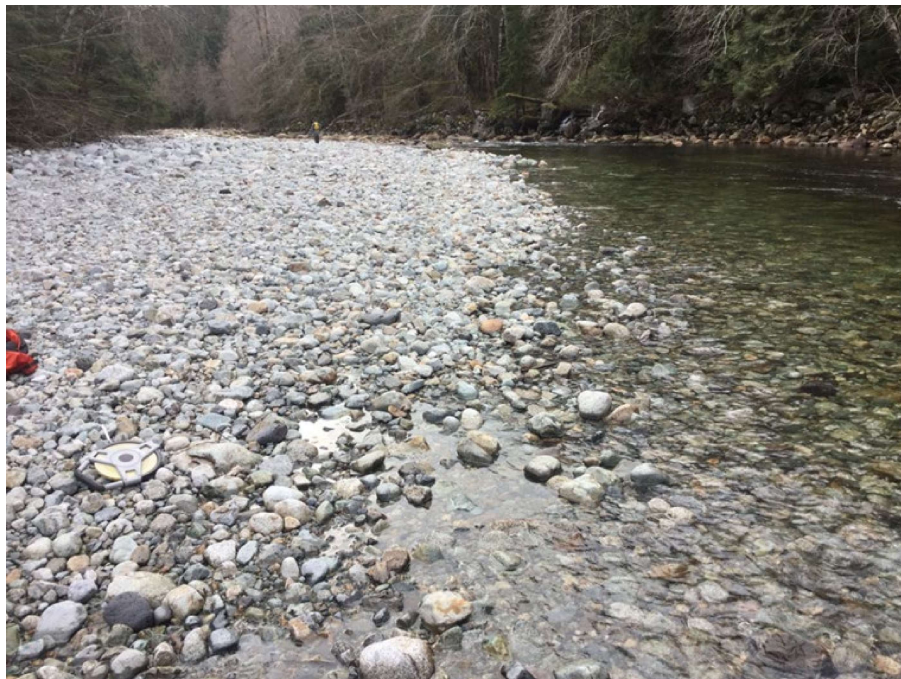
Figure 11. Looking downstream at SEY-DSSD05, April 3, 2020.

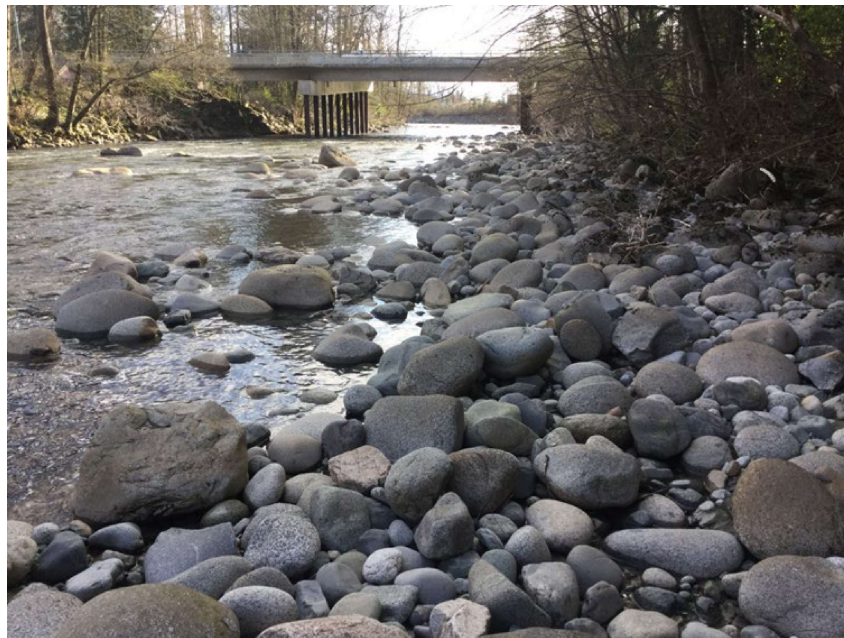
**Figure 13.** Looking downstream at SEY-DSSD06, April 3, 2020.

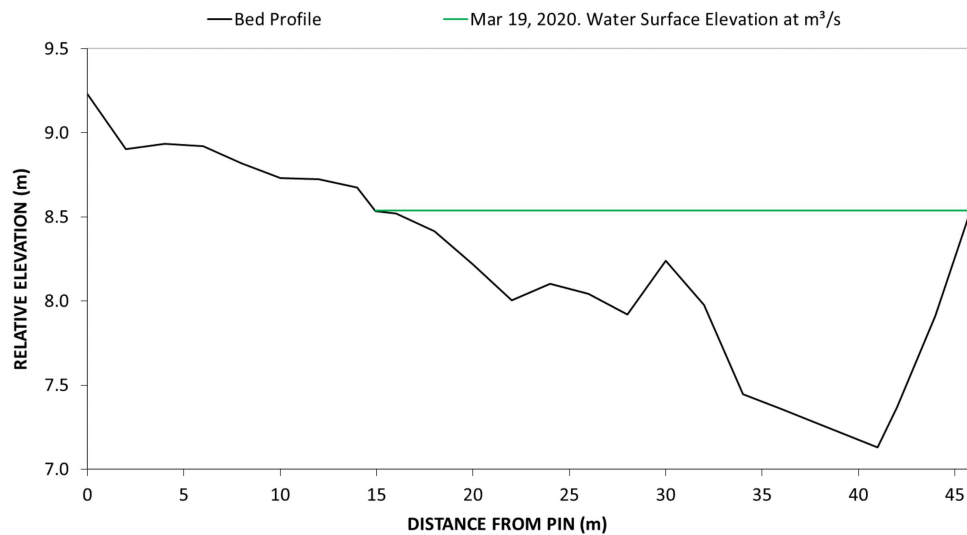
**Figure 14.** Bed profile plot of SEY-DSSD07, surveyed as distance from river left on March 19, 2020.

SEY-DSSD07 was located approximately 320 m downstream of SEY-DSSD06, but was still upstream of tidal influence. This site featured an extensive low-gradient gravel bar on the river left. There was more gravel present than at upstream sites, but cobble and boulder were still common. Depressions within the boulder/cobble substrate could form isolated pools at low water levels. Habitat at this site was good quality for overwintering, rearing, and migratory life stages, but poor for spawning.

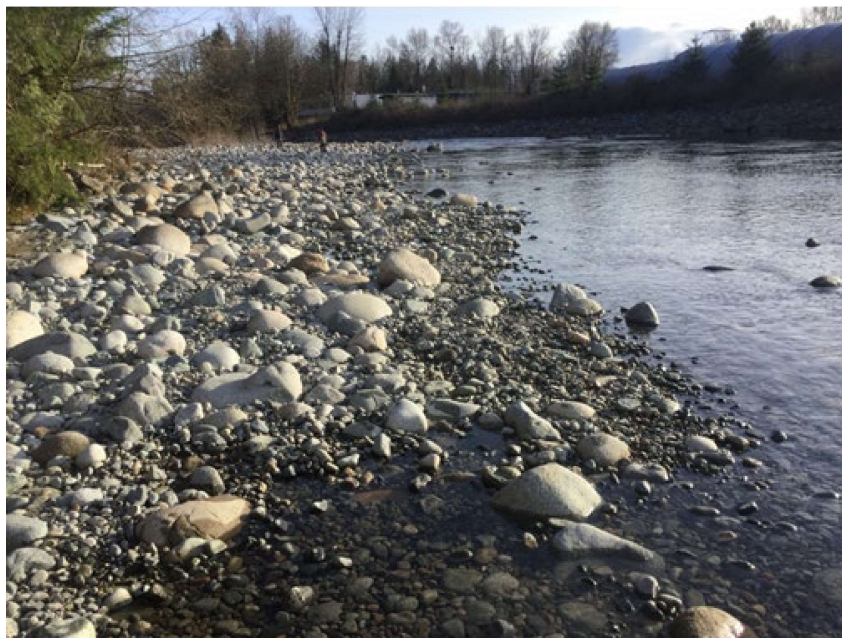
**Figure 15.** Looking downstream at SEY-DSSD07, April 3, 2020.

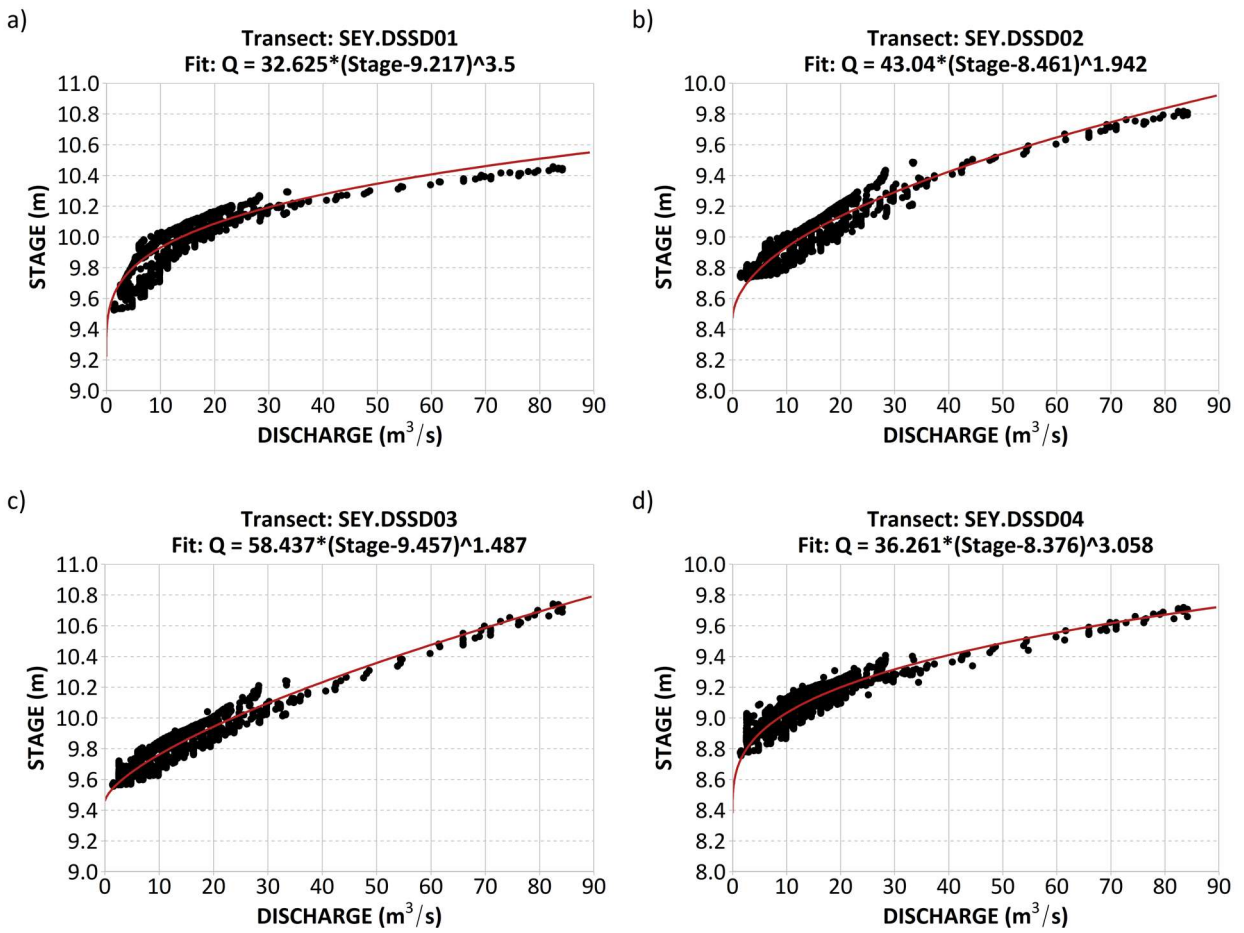
Figure 17. Stage-discharge relationships measured at stranding sensitive monitoring sites in the Seymour River.

Figure 17. Continued (2 of 2).

The stage data from the SSMSs were plotted against a subset of data (March 17, 2021 to July 15, 2021; orange highlight in Figure 16) from the SFD gauge which ranged from approximately 1.44 m<sup>3</sup>/s to 84.16 m<sup>3</sup>/s (March 17, 2021 to July 15, 2021; orange highlight in Figure 16) to develop the stage-discharge relationships shown in Figure 17. The parameters and flow ranges for the rating curves at each site are provided in Table 4.

**Table 4.** Rating parameters for stage-discharge curves at SSMSs in the Seymour River (Figure 17). See Section 2.2 for parameter descriptions.
