**Northwest Hydraulic Consultants Ltd.**

NHC Reference 3008460  
May 10, 2024

**Re:** **Barnston Island Dike Assessment Update 2023**  
**Preliminary Report, Final**

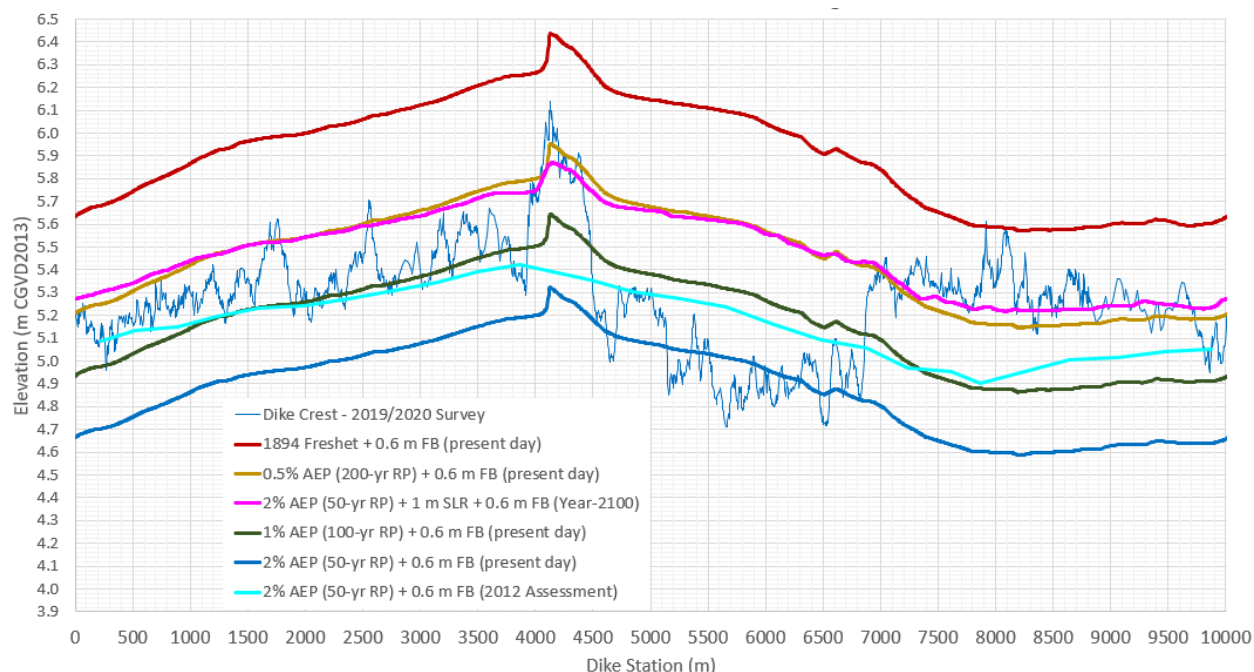
**Figure 3 Existing dike crest profile and simulated design flood elevations including 0.6 m freeboard**

Figure 3 compares surveyed dike crest elevations and simulated flood levels. The dike crest elevations are based on a provincial survey of Lower Mainland dikes completed in 2019/2020. There is generally good agreement between the NHC 2012 dike survey and the more recent provincial survey, with no significant indication of dike settlement. Minor elevation differences are likely due to selected survey points.

As a result of climate change, sea levels are rising and Fraser River flood flows are projected to increase by end-of-century, the future time span typically adopted for current flood protection design. Figure 3 also includes a preliminary profile for the end-of-century 50-year (2% AEP) flood plus 0.6 m freeboard, assuming a 10% increase in Fraser River discharge due to impacts of climate change (NHC, 2023) and 1 m of sea level rise (SLR). Simulated future 50-year water levels at Barnston Island were approximately 0.5 m to 0.6 m higher than present-day, roughly corresponding to the current 200-year flood levels. If these climate change effects are realized, the standard of protection of Barnston Island's existing dike can be expected to significantly decrease over time.

EGBC guidelines require that impacts of climate change be considered when assessing and mitigating flood hazards (EGBC, 2018). Based on hydraulic modelling of climate change scenarios, the end-of-century Fraser 50-year profile is expected to exceed the present-day 100-year profile (Figure 3). Designing for a standard greater than the present-day 50-year provides an allowance for future increases in water levels. Although the recommended crest profile would exceed the present Provincial standard for agricultural dikes, it is expected to be an efficient use of funding, considering the crest level of most of the dike. Ideally, the entire dike would be raised to withstand the end-of-century 50-year flood, to meet agricultural standards.

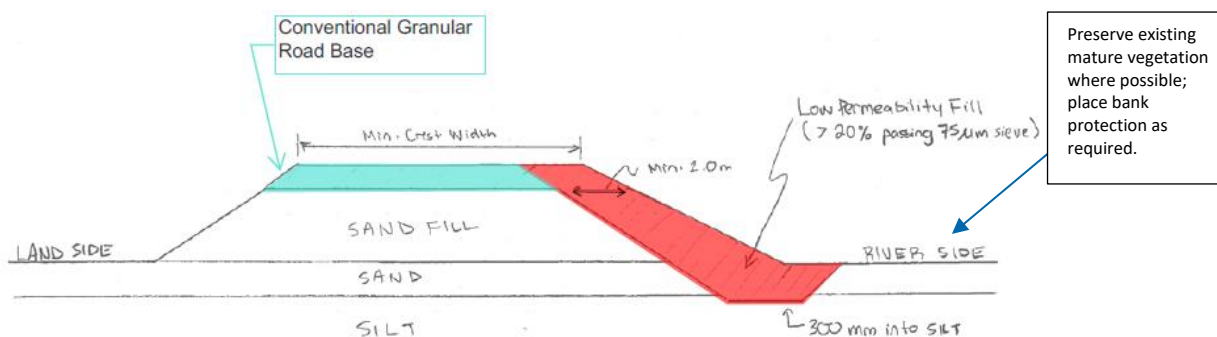
**Figure 8** Typical section for conceptual dike raise, adapted from 2012 Assessment Preliminary Geotechnical Assessment Report (Thurber Engineering Ltd., 2013)

NHC estimated material quantities and costs for the recommended raise. The assumed upgrade design was based on recommendations in the Barnston Island Dike Assessment Preliminary Geotechnical Assessment Report (Thurber Engineering Ltd., 2013), part of the 2012 Assessment. To mitigate seepage, it was recommended that low-permeability fill be placed on the river side of existing dike fill down to a silt layer, located below existing grade at El. 2.6 m to 3.0 m +/-, based on available drill logs (Figure 8).

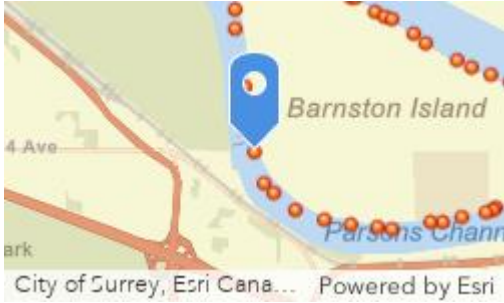
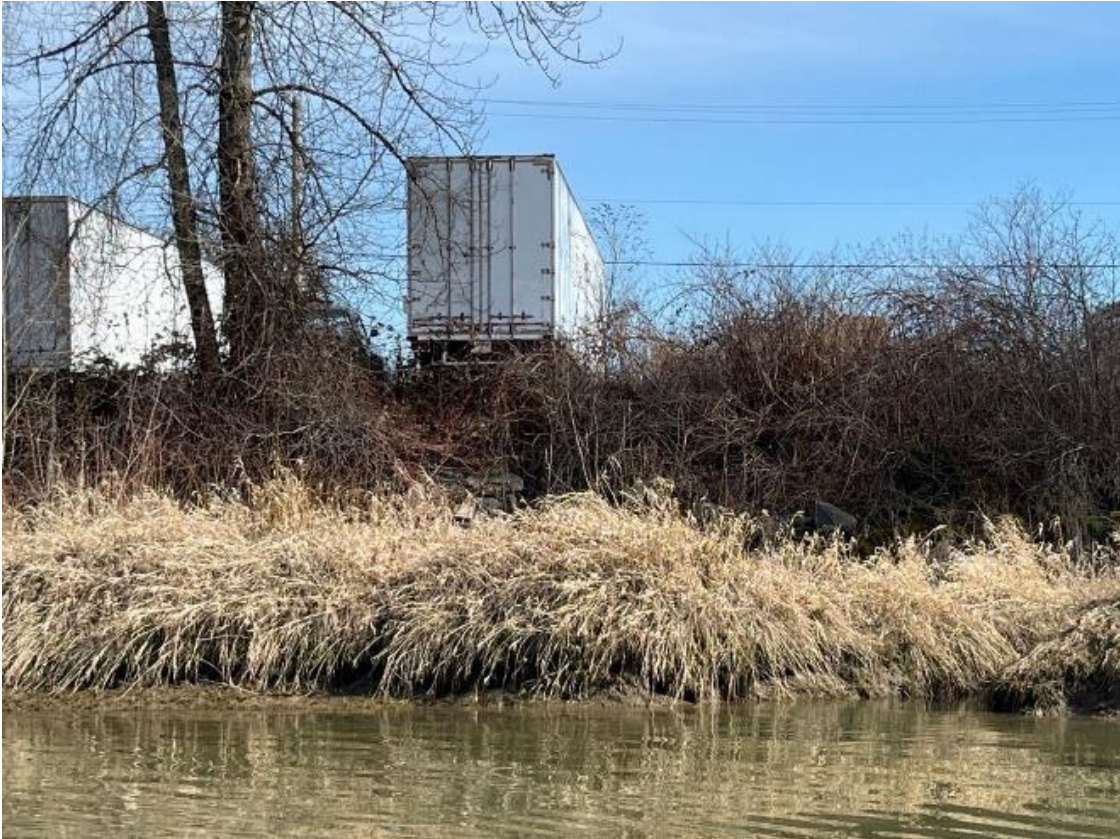
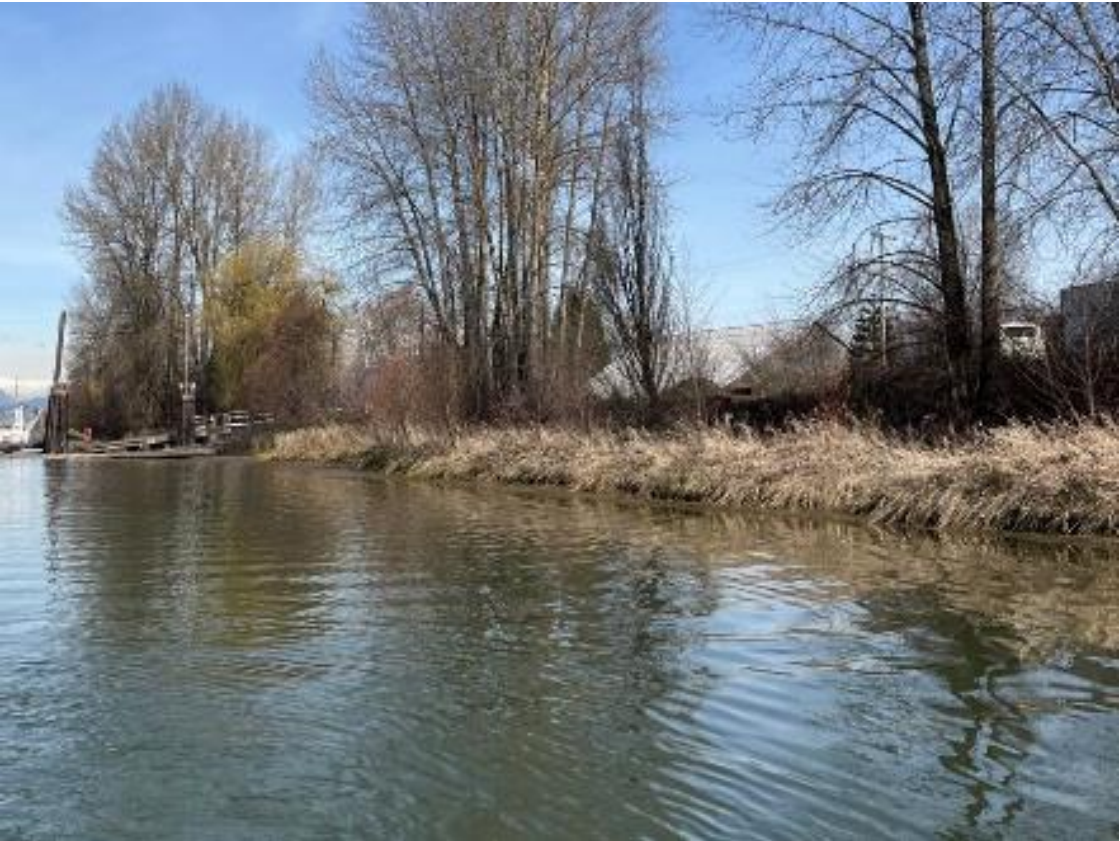
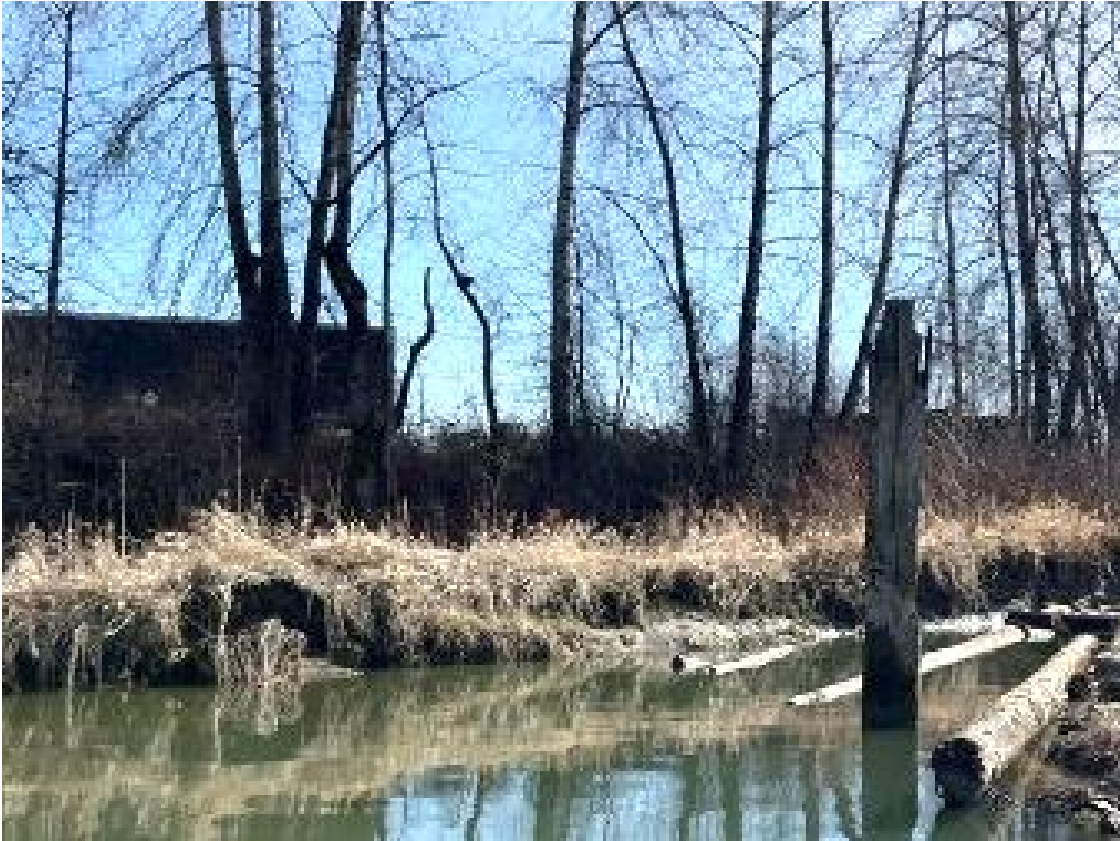
<b>Dike Station</b> 0+100	<b>Inspection Location</b>

<b>Active Erosion</b> Yes	<b>Bank Protection</b> Yes
<b>Notes</b> Lower bank is sandy with grassy vegetation. Toe is over-steepened. Old riprap present above lower bank, protecting what appears to be a fill pad just east of ferry landing. Bank is covered with blackberry bushes and difficult to inspect.

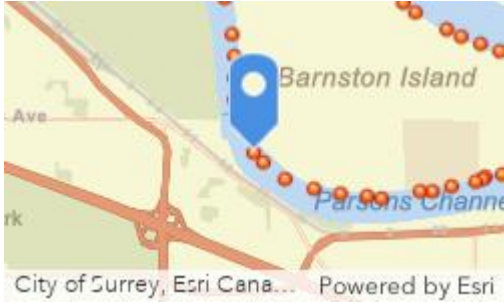
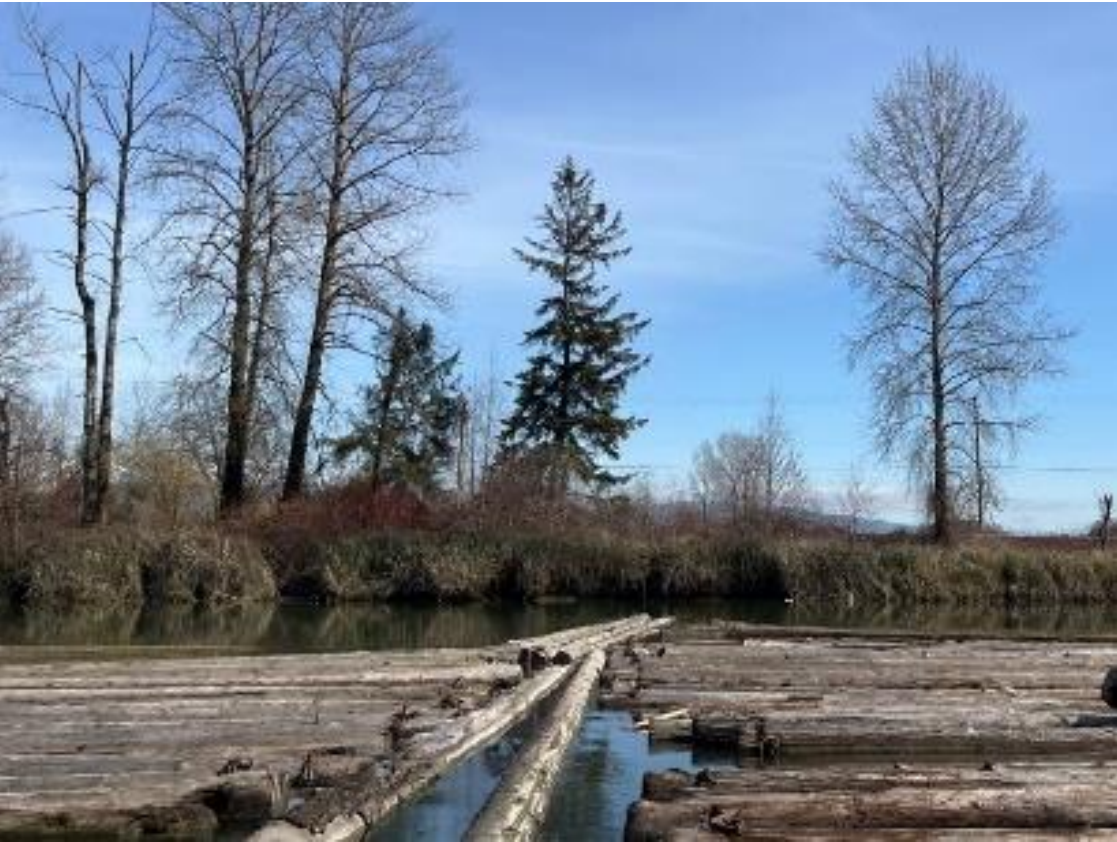
<div>Dike Station</div> <div>0+400</div>	<div>Inspection Location</div> <div>

</div>
<div>Active Erosion</div> <div>Yes</div>	<div>Bank Protection</div> <div>No</div>
<div>Notes</div> <div>Bank is generally steep and showing signs of erosion. Some mature trees are present between bank and dike.</div>

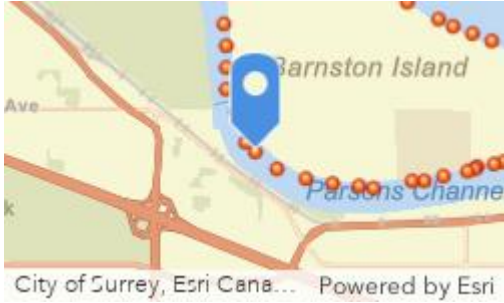
<div>Dike Station</div> <div>0+525</div>	<div>Inspection Location</div> <div>

</div>
<div>Active Erosion</div> <div>Yes</div>	<div>Bank Protection</div> <div>No</div>
<div>Notes</div> <div>Sandy bank covered with grassy vegetation, localized near-vertical banks. Mature vegetation grows between eroding bank and dike.</div>

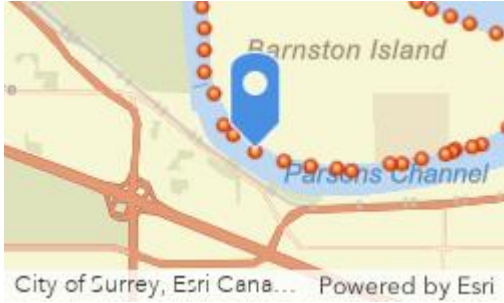
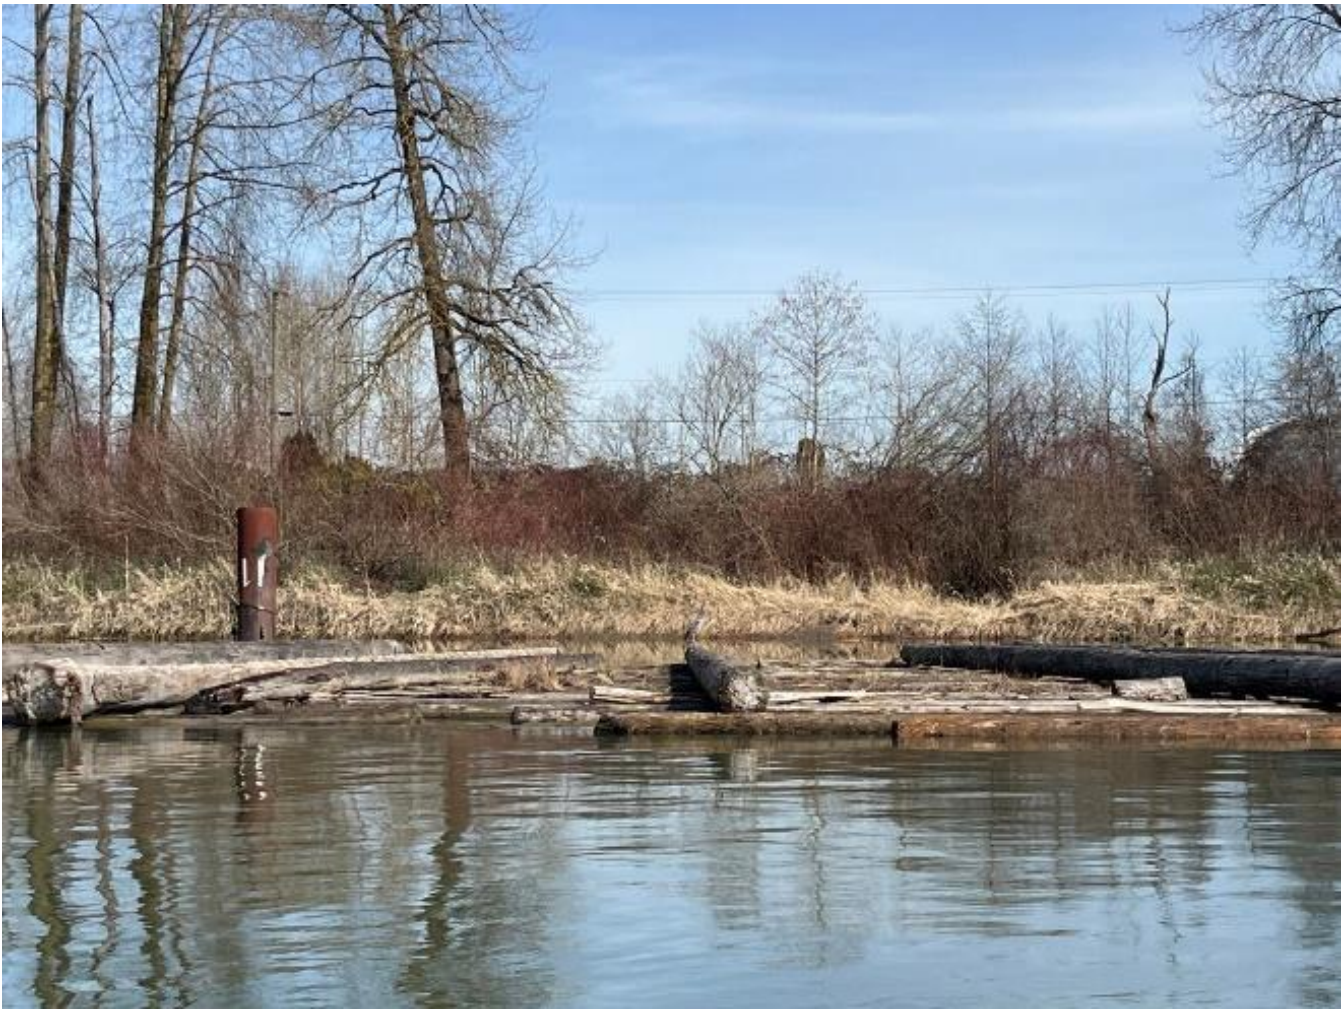
<div>Dike Station</div> <div>0+800</div>	<div>Inspection Location</div> <div>

</div>
<div>Active Erosion</div> <div>No</div>	<div>Bank Protection</div> <div>No</div>
<div>Notes</div> <div>Bank is well-vegetated, no visible erosion</div>

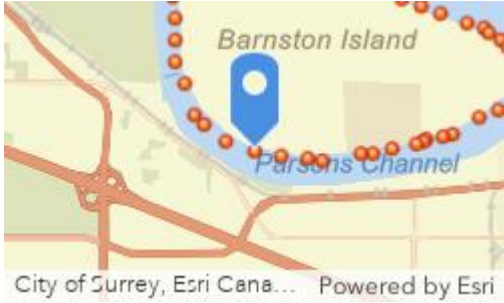
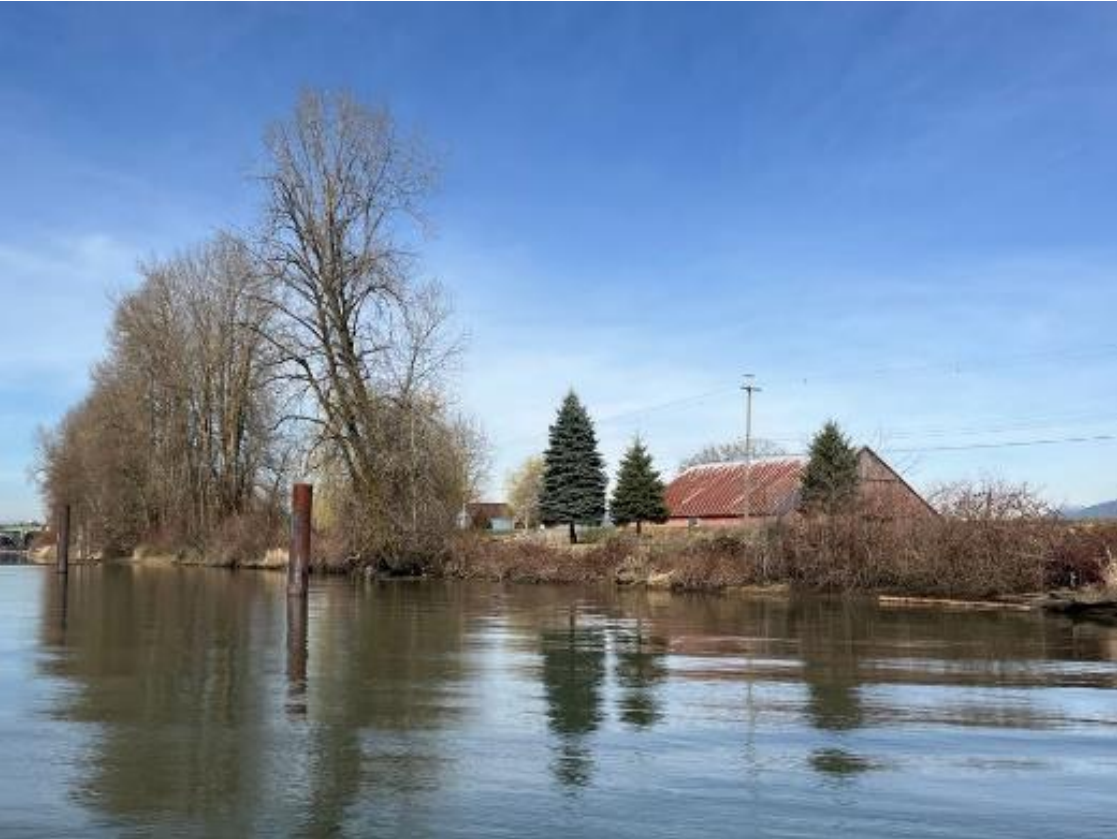
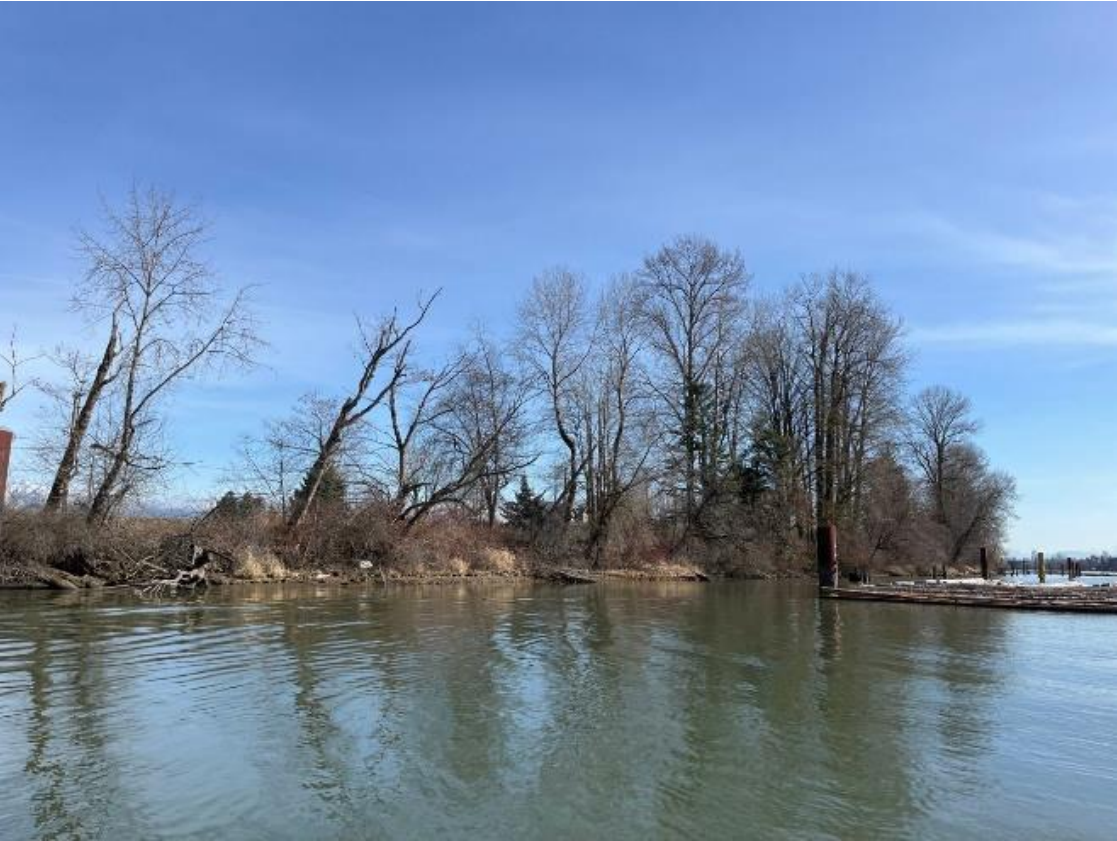
<div>Dike Station</div> <div>1+100</div>	<div>Inspection Location</div> <div>

</div>
<div>Active Erosion</div> <div>Yes</div>	<div>Bank Protection</div> <div>No</div>
<div>Notes</div> <div>Undercut banks and leaning trees. Some trees along bank in 2012 photos are no longer present.</div>

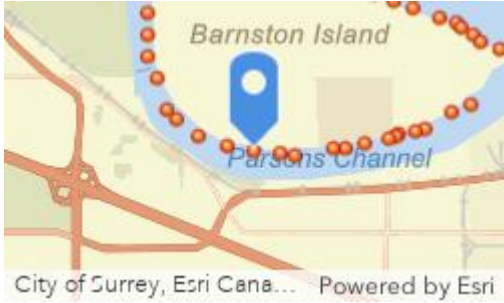
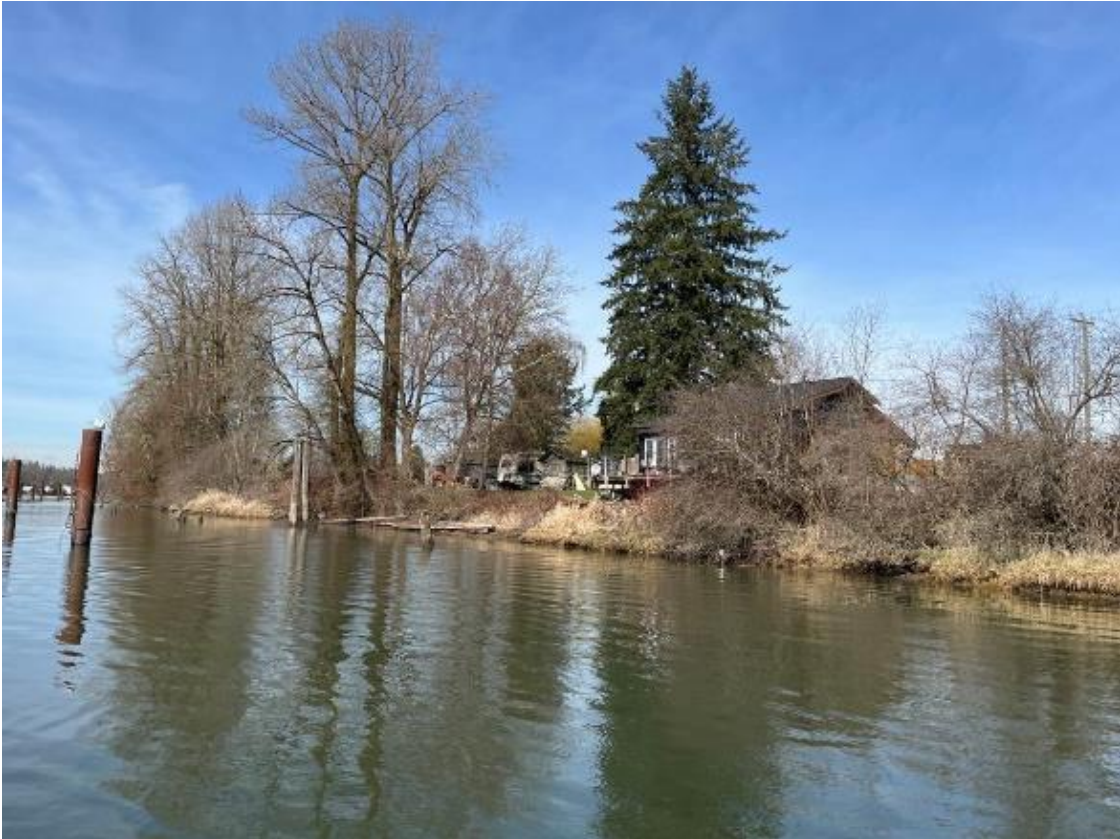
<div>Dike Station</div> <div>1+375</div>	<div>Inspection Location</div> <div>

</div>
<div>Active Erosion</div> <div>Yes</div>	<div>Bank Protection</div> <div>No</div>
<div>Notes</div> <div>Trees leaning toward channel. House outside dike is close to channel with steep bank.</div>

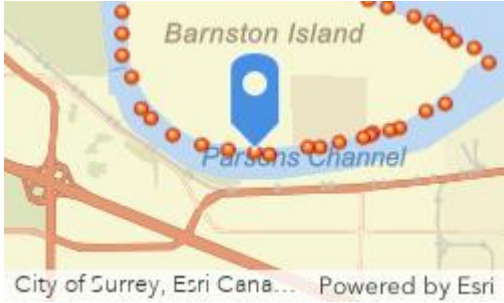
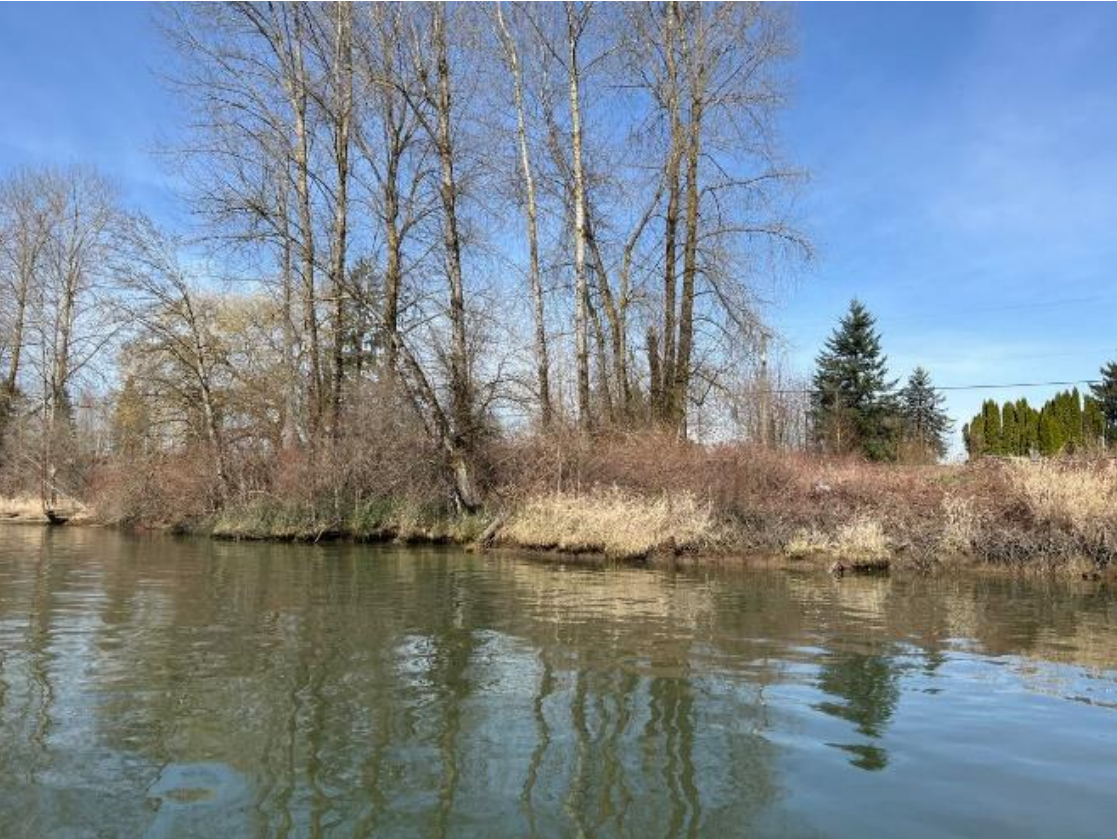
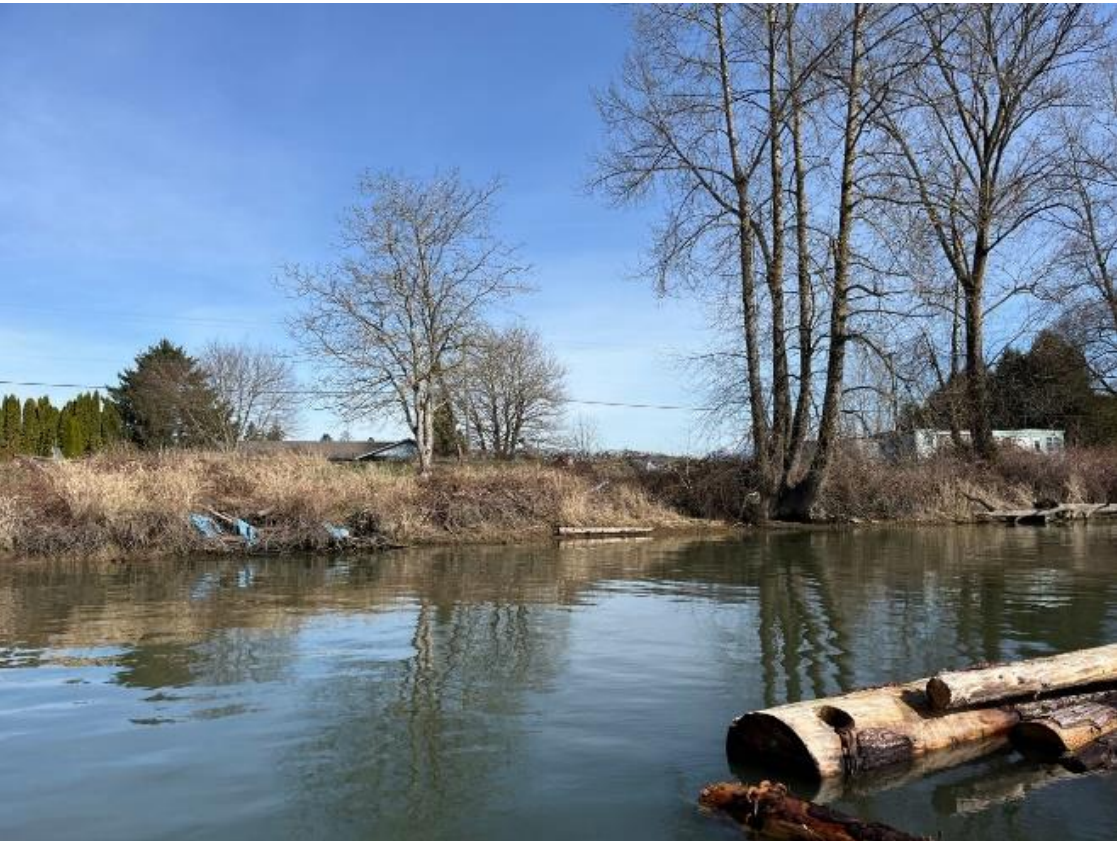
<div>Dike Station</div> <div>1+625</div>	<div>Inspection Location</div> <div>

</div>
<div>Active Erosion</div> <div>Yes</div>	<div>Bank Protection</div> <div>No</div>
<div>Notes</div> <div>Localized erosion, evidenced by undercut trees and grassy vegetation at bottom of bank</div>

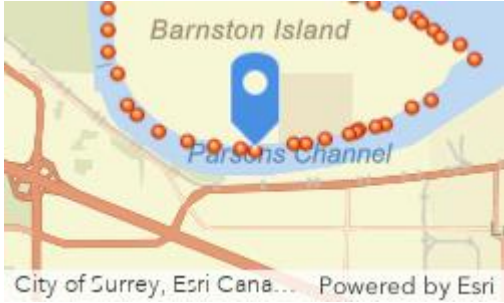
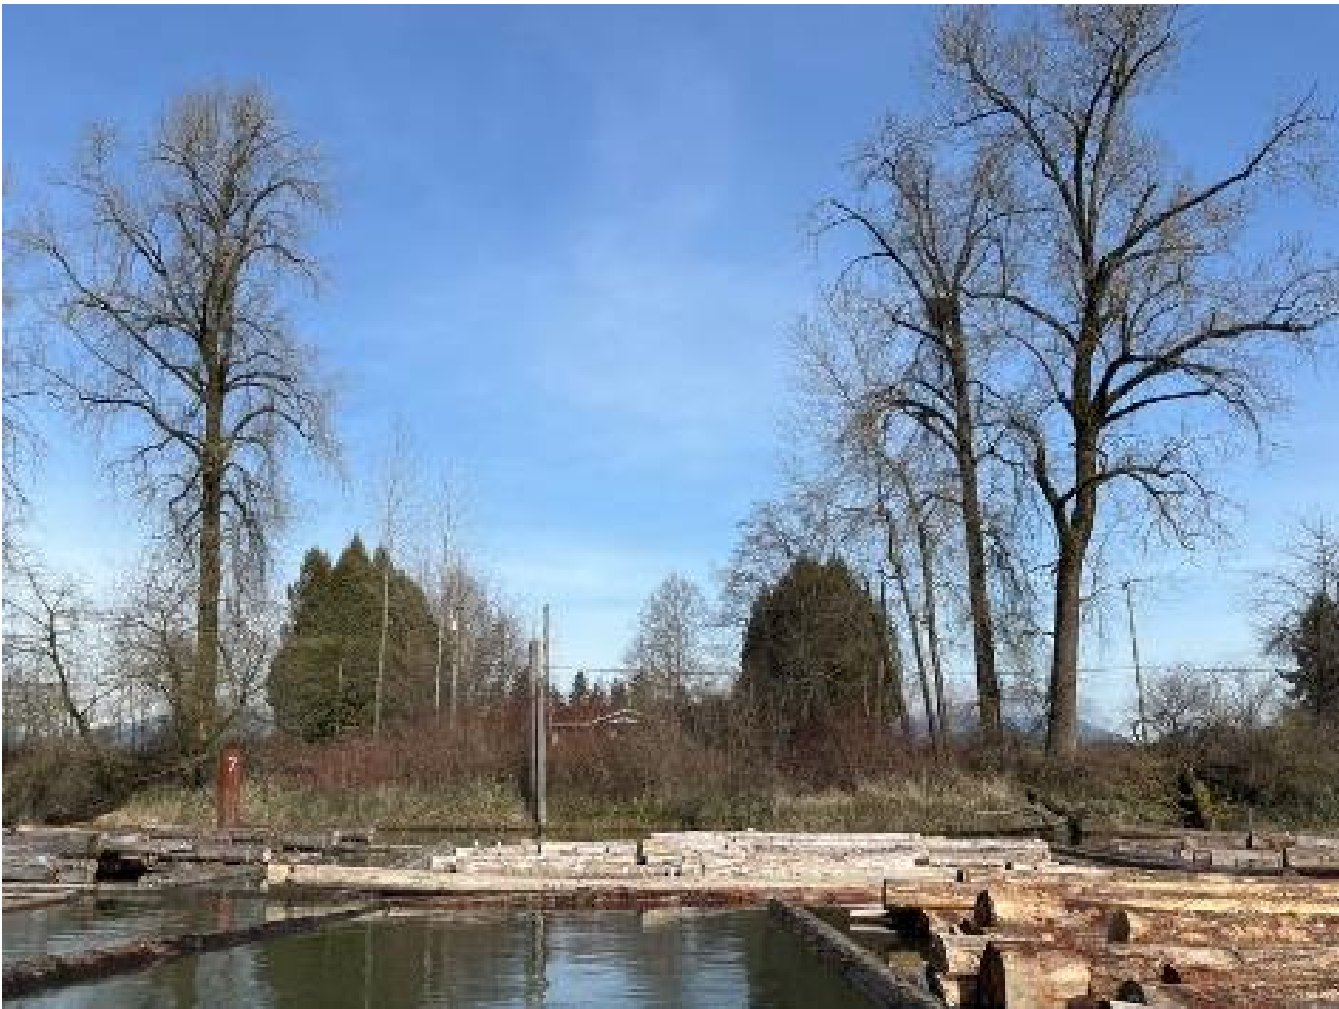
<div>Dike Station</div> <div>1+775</div>	<div>Inspection Location</div> <div>

</div>
<div>Active Erosion</div> <div>No</div>	<div>Bank Protection</div> <div>No</div>
<div>Notes</div> <div>Bank is well-vegetated and does not appear to have widespread erosion</div>

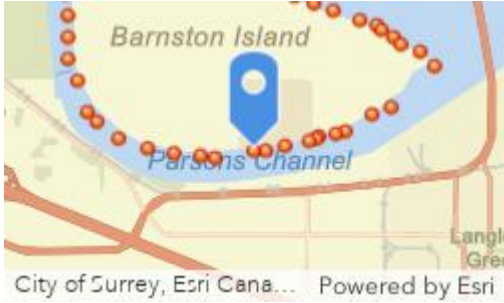
<div>Dike Station</div> <div>2+175</div>	<div>Inspection Location</div> <div>

</div>
<div>Active Erosion</div> <div>Yes</div>	<div>Bank Protection</div> <div>No</div>
<div>Notes</div> <div>Bank shows some signs of erosion, with some exposed tree roots. There is a sandy terrace at bottom of visible bank.</div>

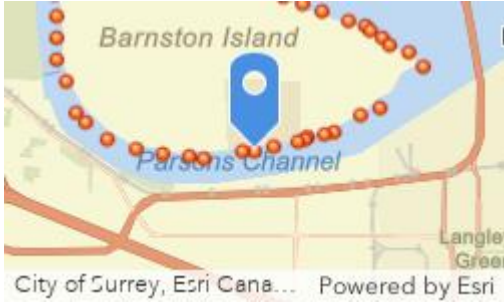
<div>Dike Station</div> <div>2+300</div>	<div>Inspection Location</div> <div>

</div>
<div>Active Erosion</div> <div>Yes</div>	<div>Bank Protection</div> <div>No</div>
<div>Notes</div> <div>Active erosion. Leaning trees.</div>

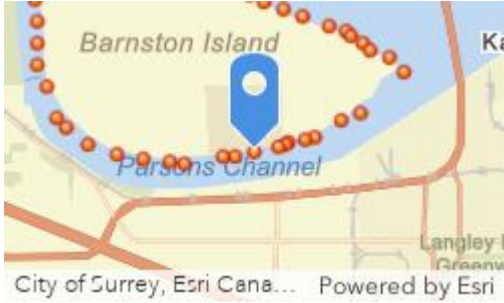
<div>Dike Station</div> <div>2+500</div>	<div>Inspection Location</div> <div>

</div>
<div>Active Erosion</div> <div>Yes</div>	<div>Bank Protection</div> <div>No</div>
<div>Notes</div> <div>Location of active erosion, potentially from foot access to the river.</div>

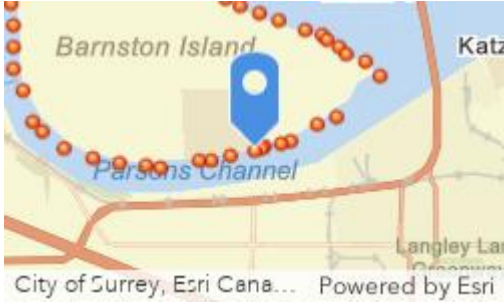
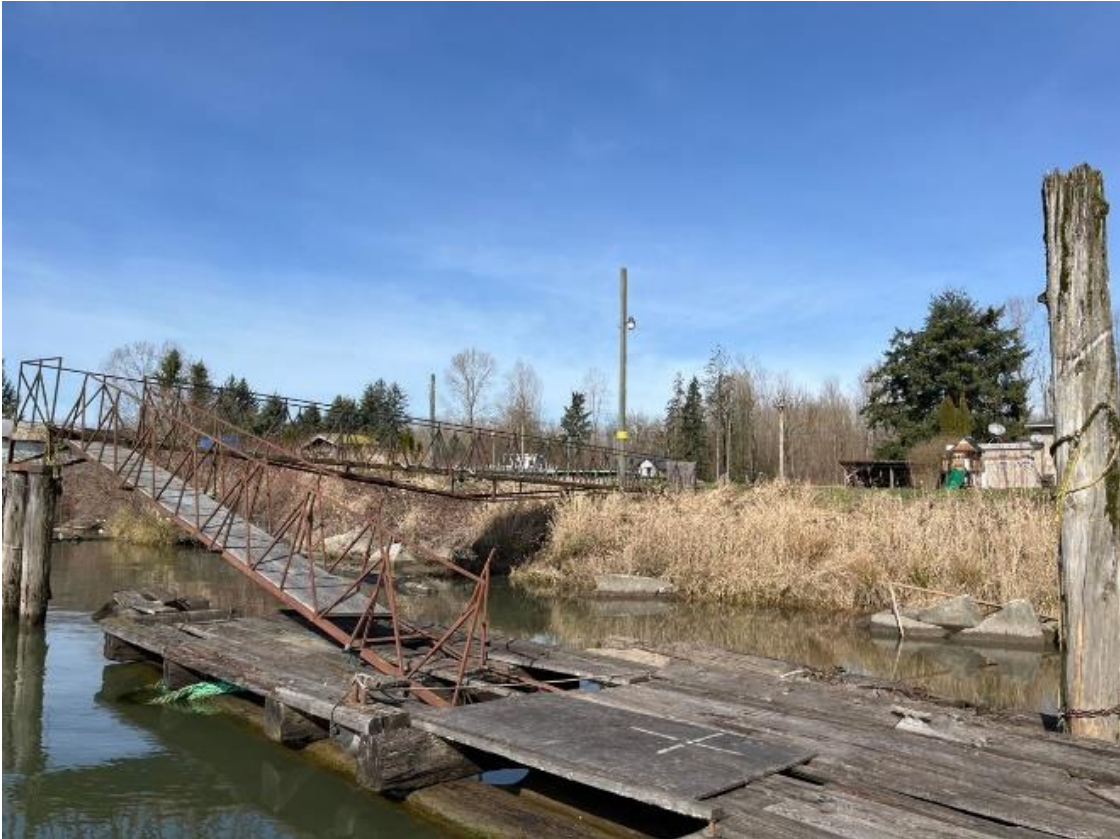
<div>Dike Station</div> <div>2+750</div>	<div>Inspection Location</div> <div>

- Along Katzie IR3 (Station 2+000 to Station 2+825), some locations are actively eroding, with failed riprap observed near Station 2+750. The dike centreline is 60 m to 70 m from bank upstream of Station 2+600, and generally within 30 m downstream of that.

</div>
<div>Active Erosion</div> <div>Yes</div>	<div>Bank Protection</div> <div>Yes</div>
<div>Notes</div> <div>Larger rock has been placed along bank. Some was either dumped in-channel or has launched. Local bank oversteepening.</div>

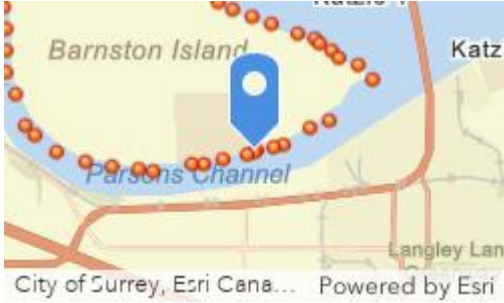
<div>Dike Station</div> <div>2+850</div>	<div>Inspection Location</div> <div>

</div>
<div>Active Erosion</div> <div>No</div>	<div>Bank Protection</div> <div>Yes</div>
<div>Notes</div> <div>Timber crib wall supports bank near power pole. Crib wall is damaged with overhanging trees.</div>

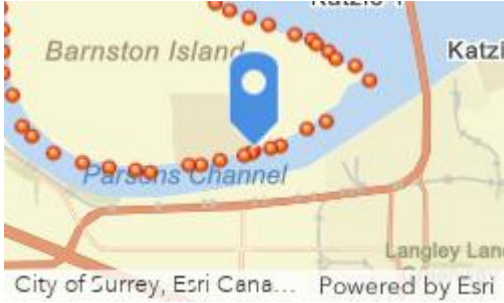
<div>Dike Station</div> <div>2+875</div>	<div>Inspection Location</div> <div>

</div>
<div>Active Erosion</div> <div>Yes</div>	<div>Bank Protection</div> <div>No</div>
<div>Notes</div> <div>Active bank erosion. Oversteepening at top of bank. Trees leaning with roots exposed.</div>

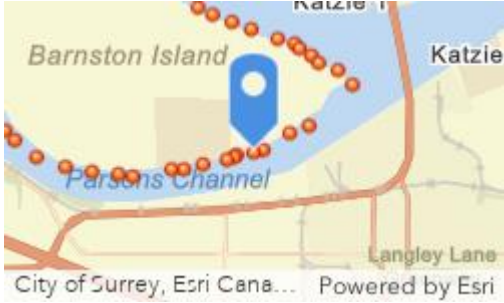
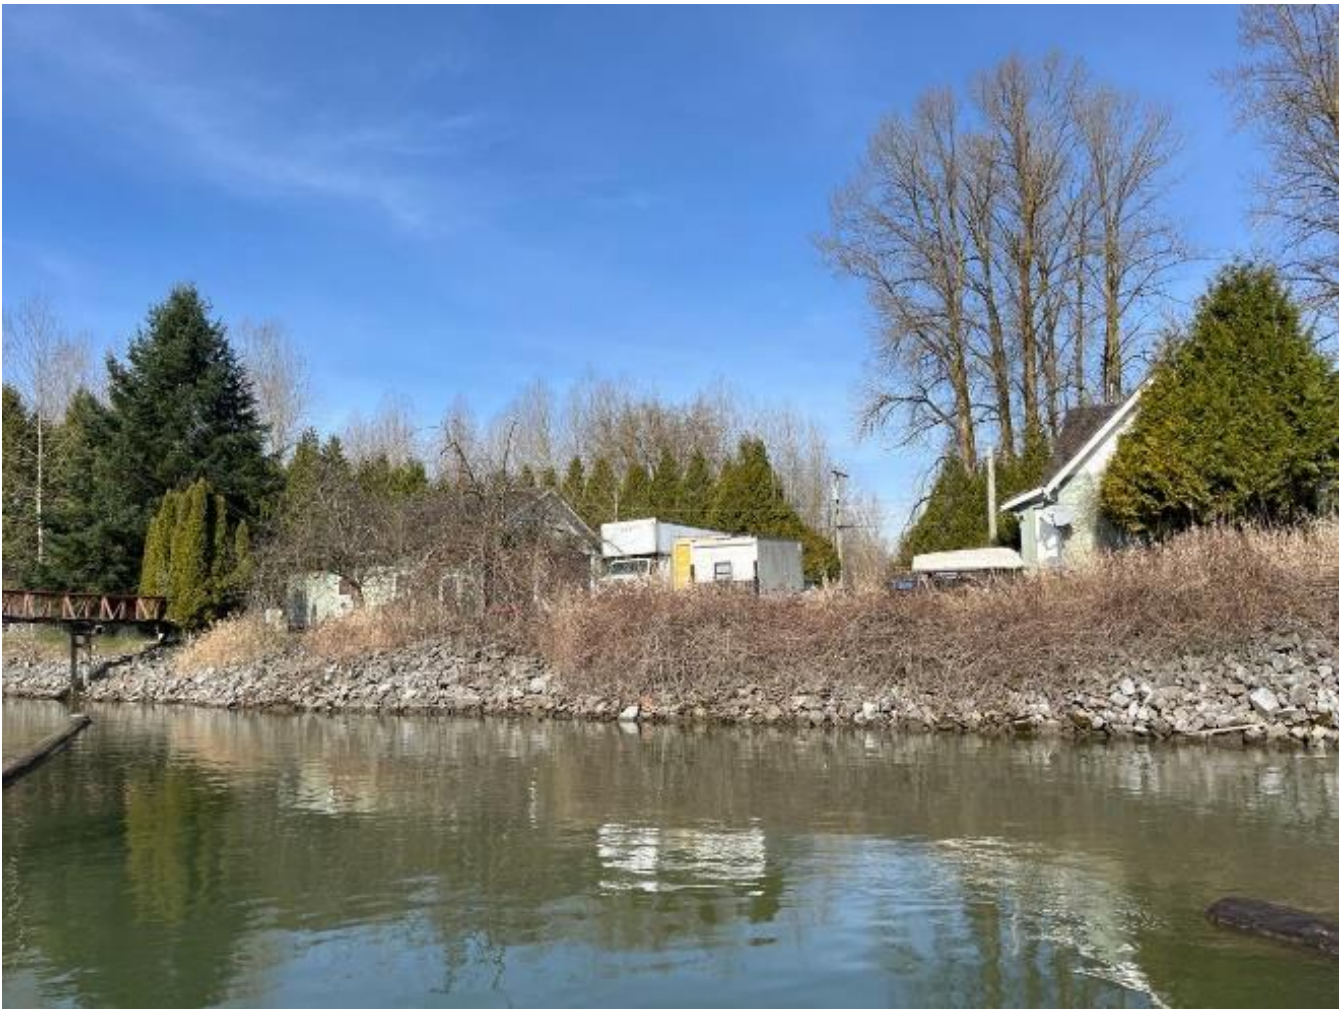
<div>Dike Station</div> <div>3+050</div>	<div>Inspection Location</div> <div>

</div>
<div>Active Erosion</div> <div>No</div>	<div>Bank Protection</div> <div>Yes</div>
<div>Notes</div> <div>Riprap consists of small rock but appears to be in good condition</div>

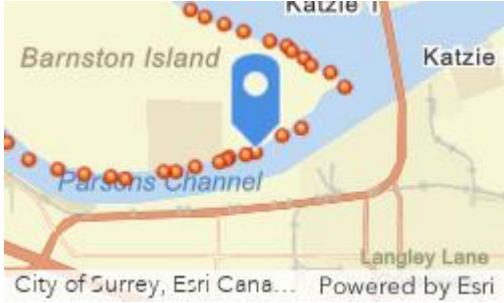
<b>Dike Station</b> 3+125	<b>Inspection Location</b>

<b>Active Erosion</b> Yes	<b>Bank Protection</b> Yes
<b>Notes</b> Old riprap in poor condition. Leaning trees suggests active erosion, and bank is oversteepened in some locations. Steep bank at upstream end of riprap

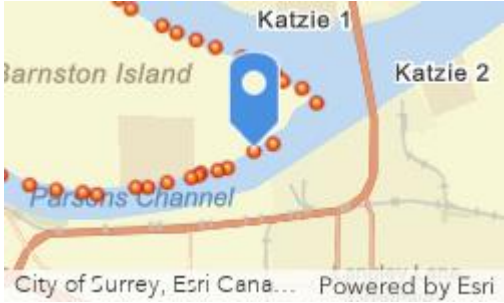
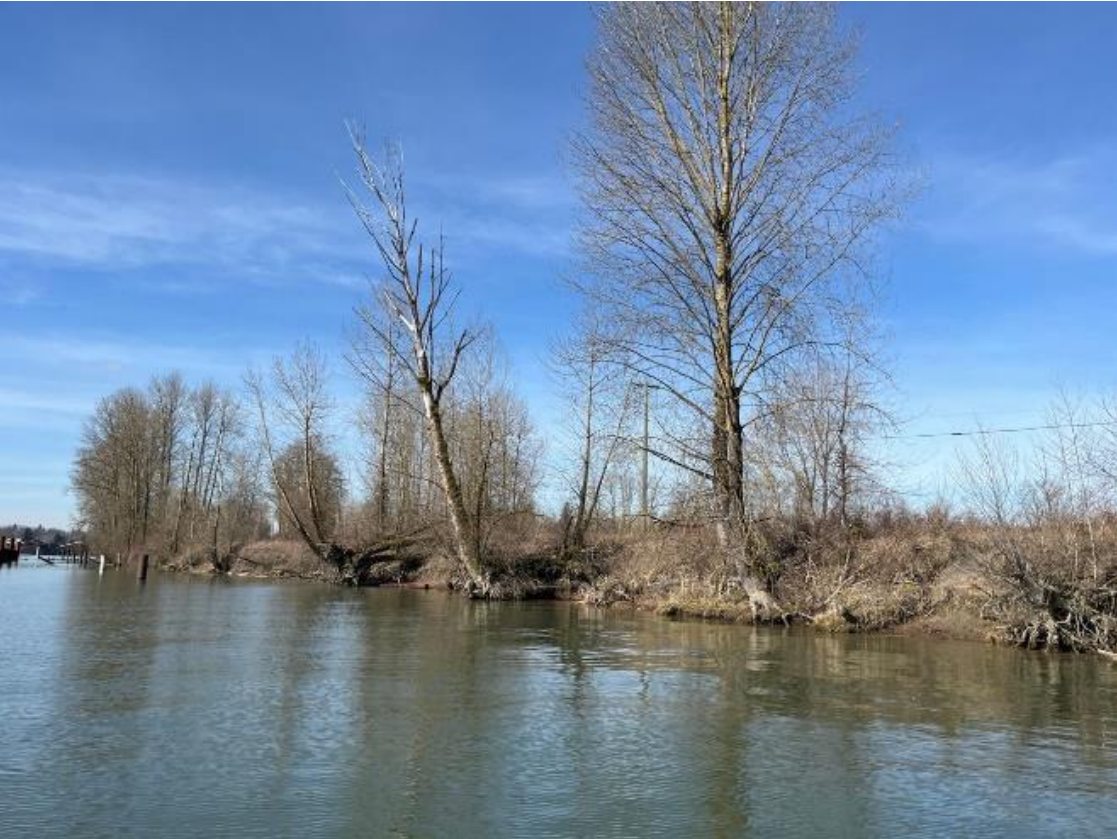
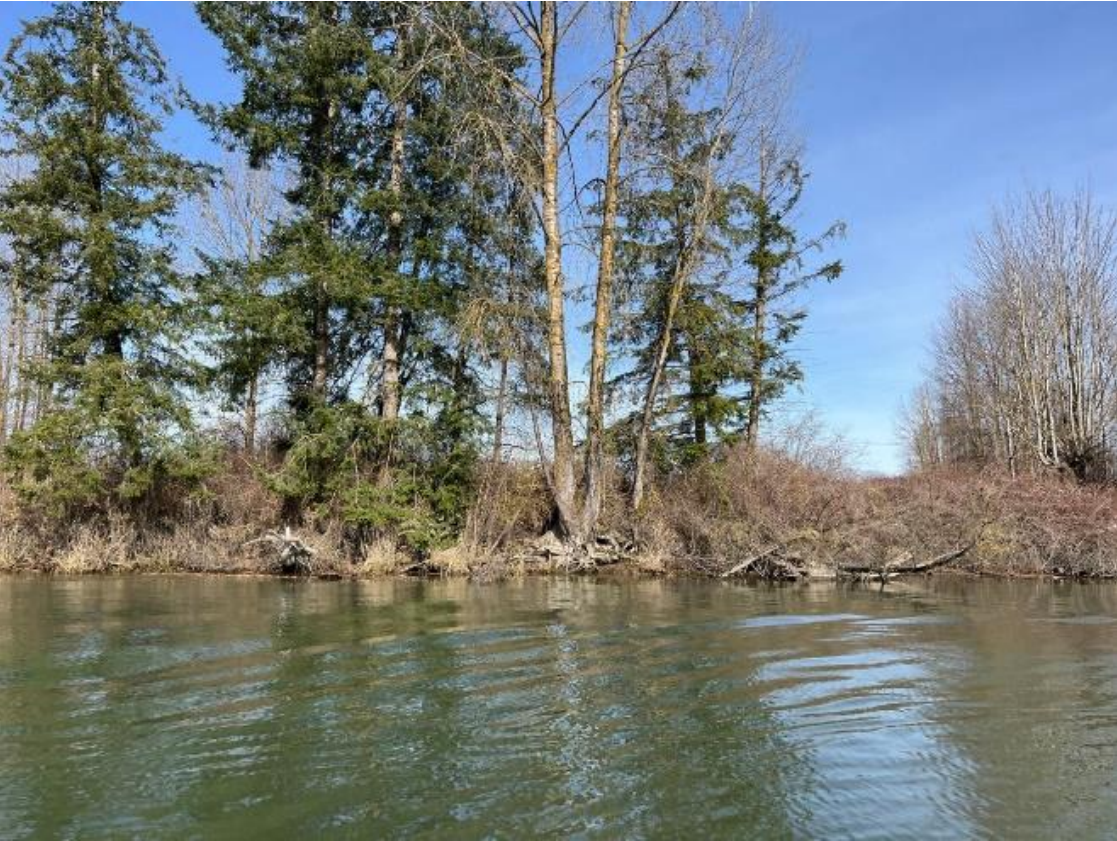
<div>Dike Station</div> <div>3+450</div>	<div>Inspection Location</div> <div>

- The riverbank is actively eroding in the vicinity of Station 3+495. This location was also noted in the 2012 Assessment. The dike centreline is 35 m from the bank, and there is minimal mature vegetation between the dike and bank.
- Near Station 2+850, a timber crib wall that supports the bank near a power pole has sustained some damage from a leaning tree.

</div>
<div>Active Erosion</div> <div>Yes</div>	<div>Bank Protection</div> <div>No</div>
<div>Notes</div> <div>Active erosion. Trees leaning toward channel, roots exposed. Sparse vegetation between bank and dike.</div>

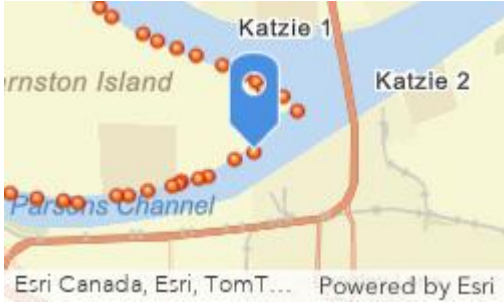
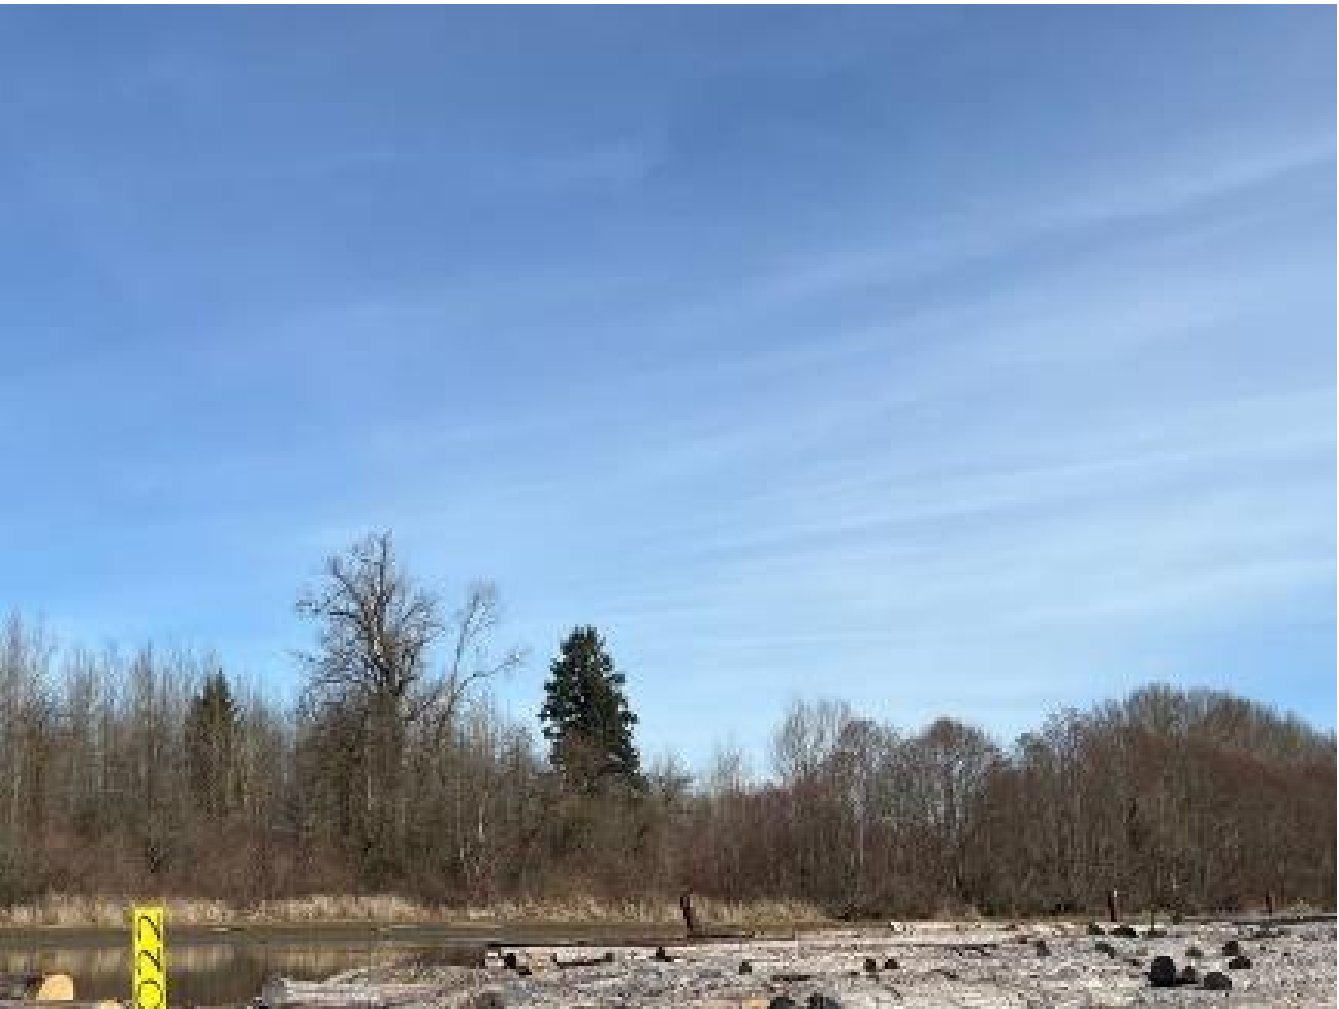
<div>Dike Station</div> <div>3+650</div>	<div>Inspection Location</div> <div>

</div>
<div>Active Erosion</div> <div>No</div>	<div>Bank Protection</div> <div>No</div>
<div>Notes</div> <div>Side channel observed in 2012. No notable updates.</div>
