**Northwest Hydraulic Consultants Ltd.**

NHC Reference 3008460  
May 10, 2024

**Re:** **Barnston Island Dike Assessment Update 2023**  
**Preliminary Report, Final**

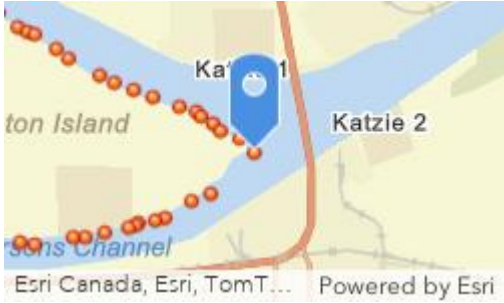
<div>Dike Station</div> <div>4+075</div>	<div>Inspection Location</div> <div>

</div>
<div>Active Erosion</div> <div>No</div>	<div>Bank Protection</div> <div>No</div>
<div>Notes</div> <div>Point bar at eastern tip of island. No notable updates; photos taken for documentation.</div>

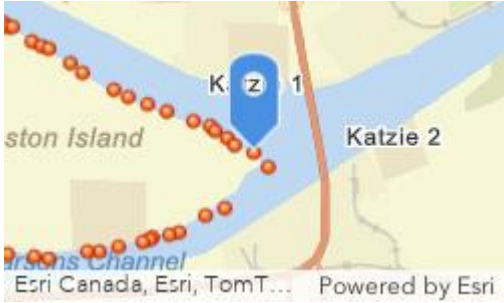
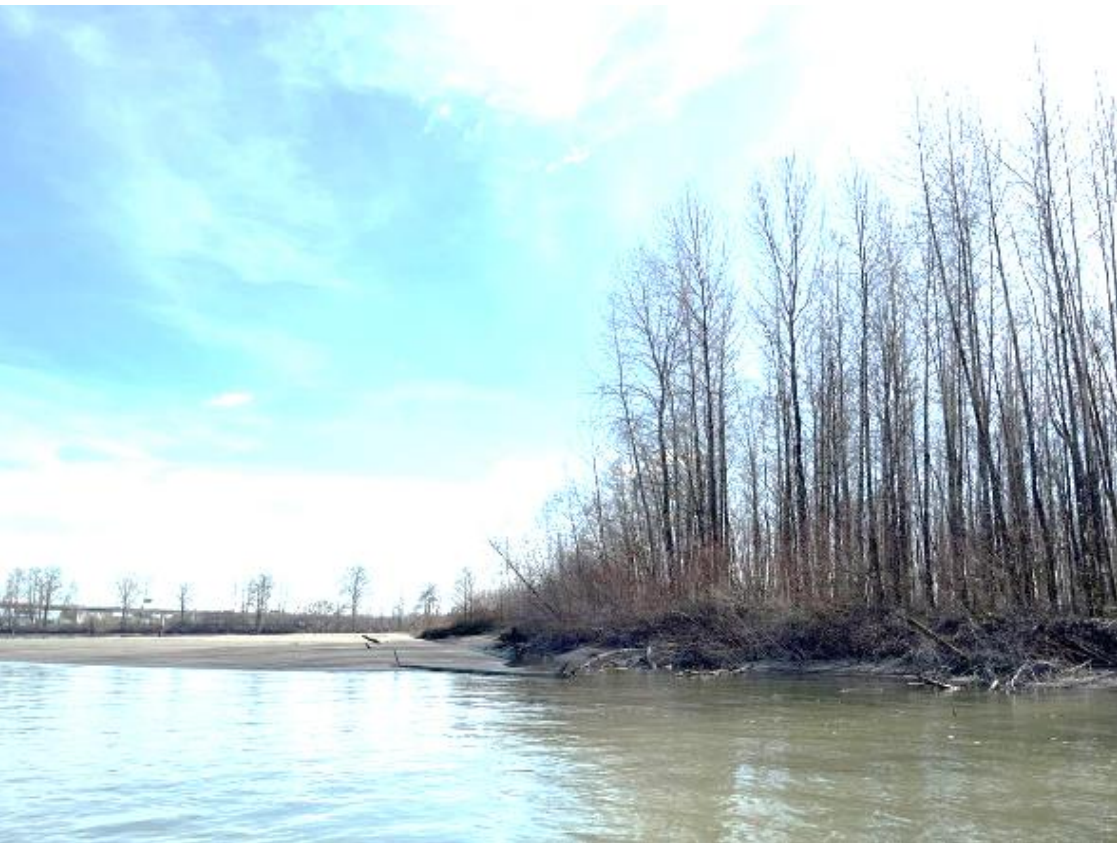
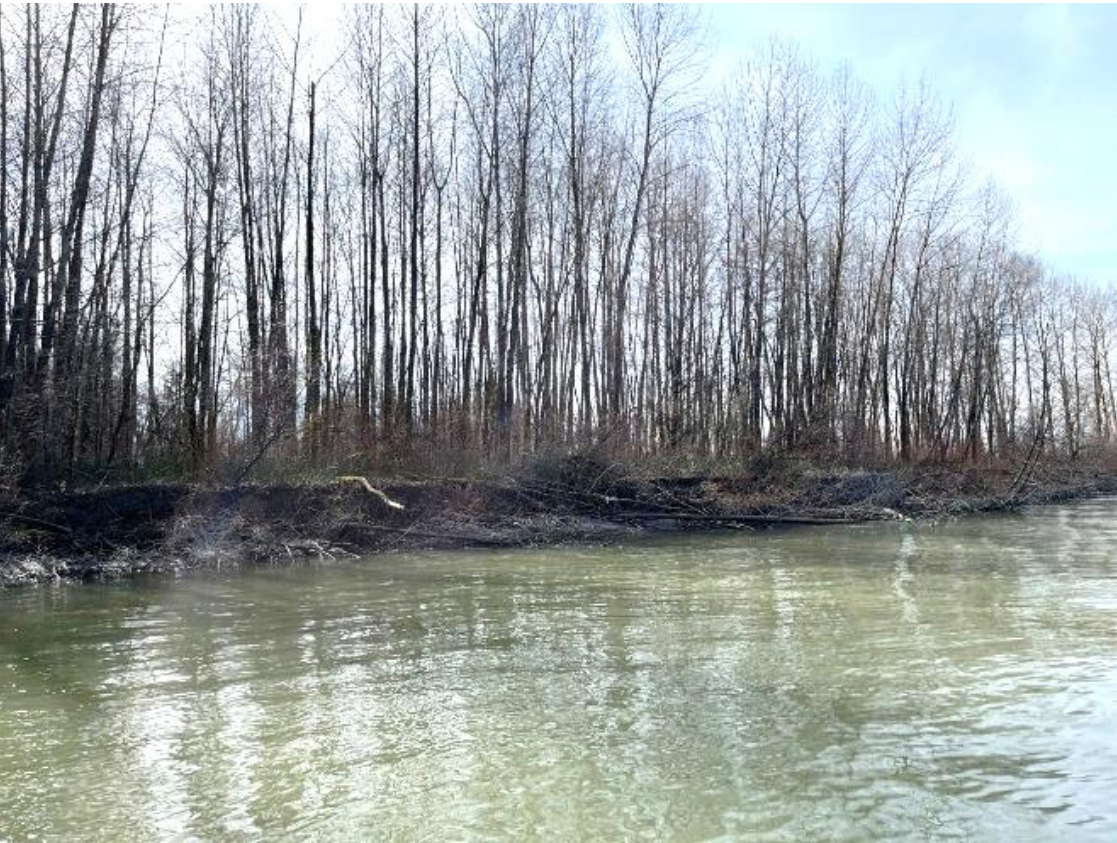
<div>Dike Station</div> <div>4+175</div>	<div>Inspection Location</div> <div>

</div>
<div>Active Erosion</div> <div>Yes</div>	<div>Bank Protection</div> <div>No</div>
<div>Notes</div> <div>Densely vegetated area. Bank is near-vertical with roots exposed. Sandy bar near upstream end of island.</div>

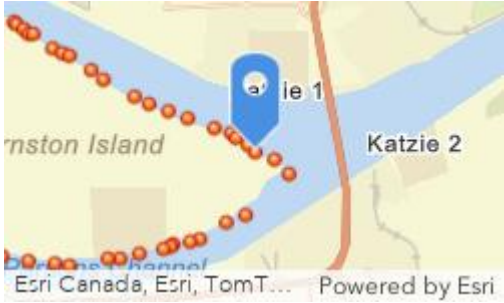
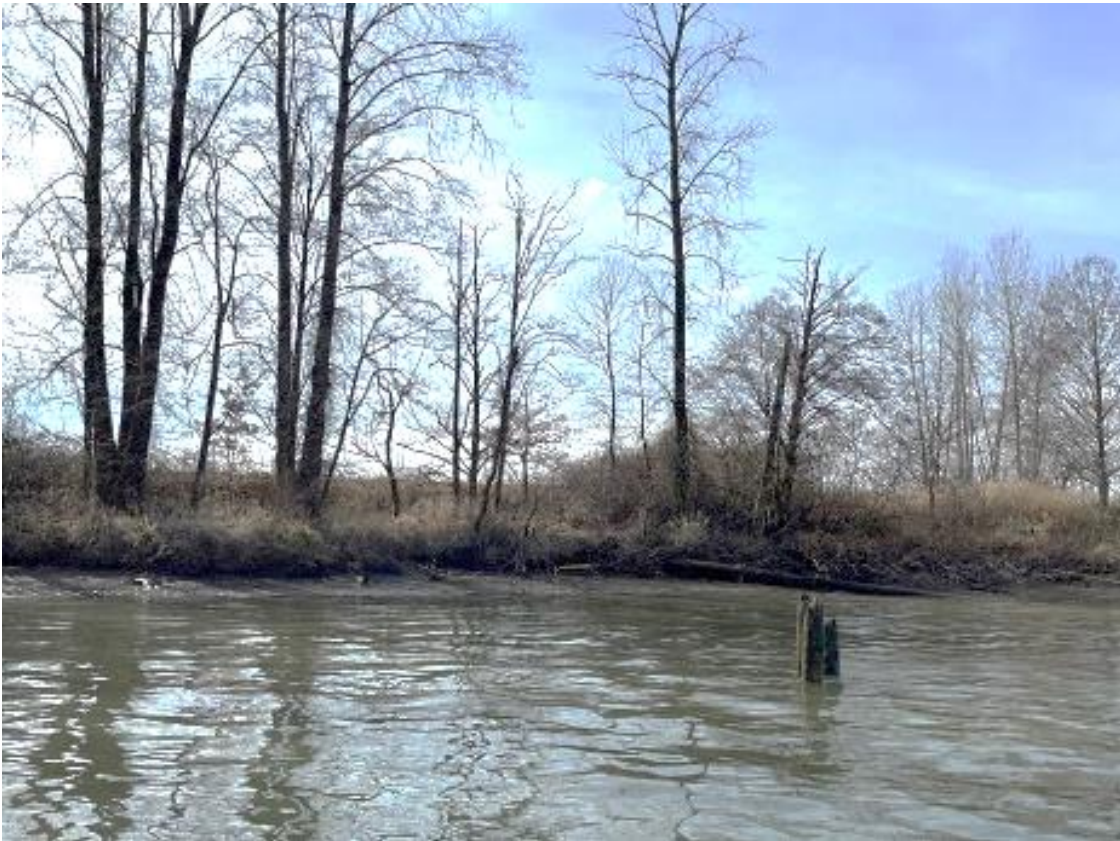
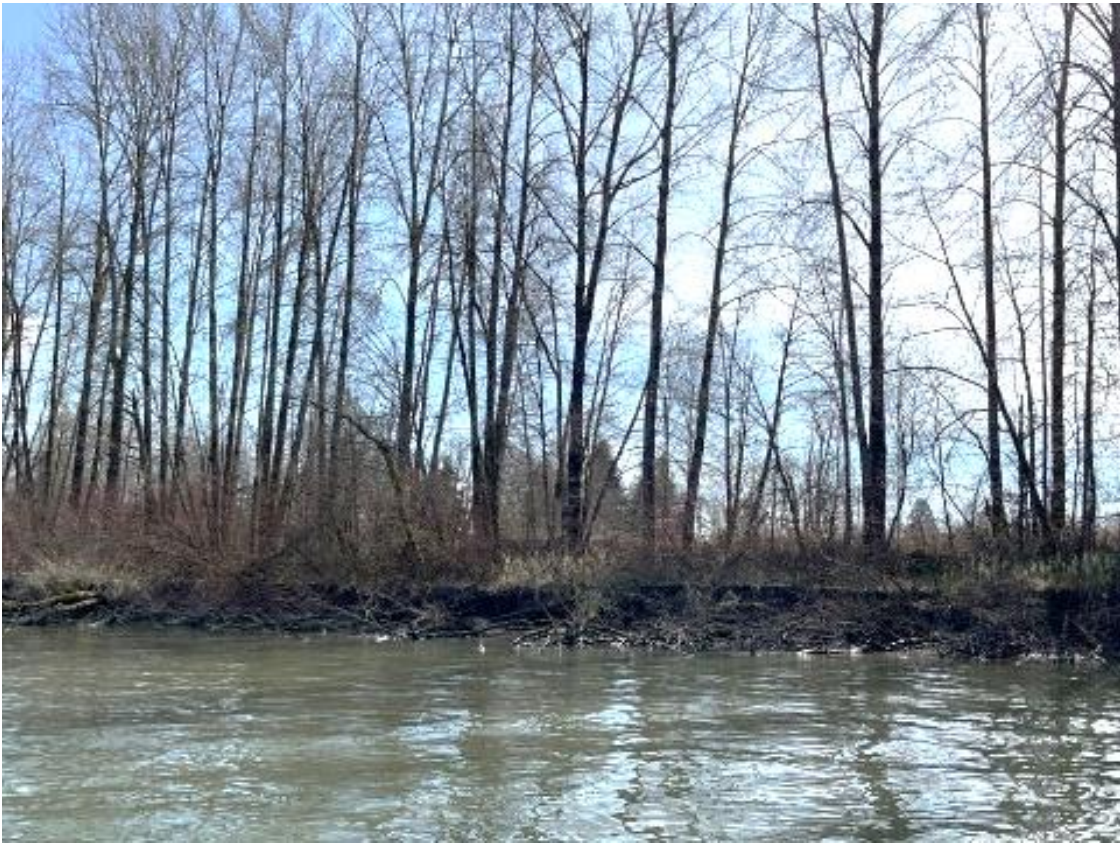
<div>Dike Station</div> <div>4+300</div>	<div>Inspection Location</div> <div>

</div>
<div>Active Erosion</div> <div>No</div>	<div>Bank Protection</div> <div>No</div>
<div>Notes</div> <div>Upper bank is near-vertical, indicating some erosion, but there is vegetation between bank and dike.</div>

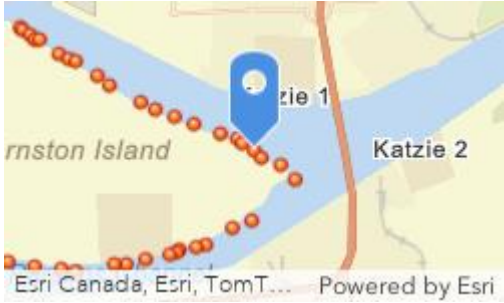
<div>Dike Station</div> <div>4+390</div>	<div>Inspection Location</div> <div>

</div>
<div>Active Erosion</div> <div>Yes</div>	<div>Bank Protection</div> <div>Yes</div>
<div>Notes</div> <div>Upstream end of riprap section. Some erosion near top of bank, potentially due to foot access down bank. This erosion was noted in the 2012 Assessment. There is minimal mature vegetation at top of bank.</div>

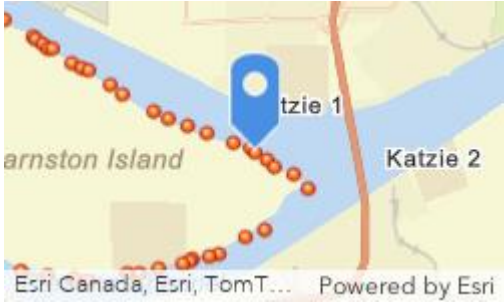
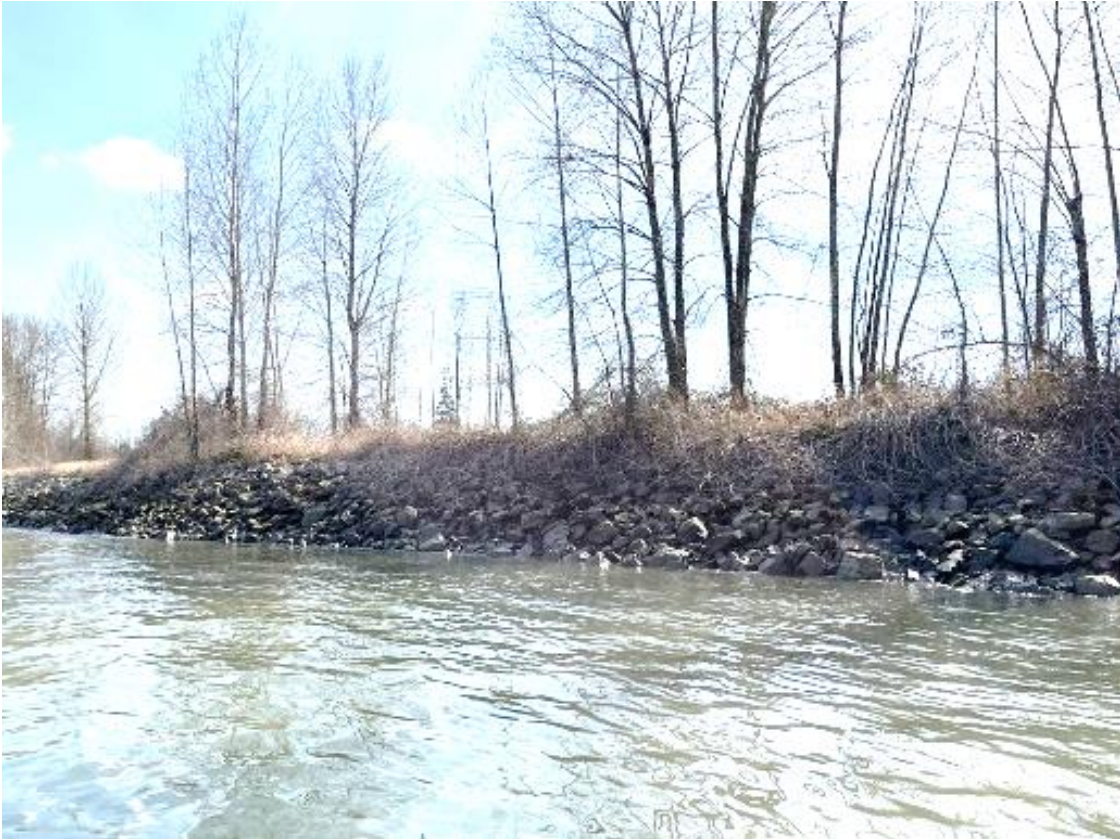
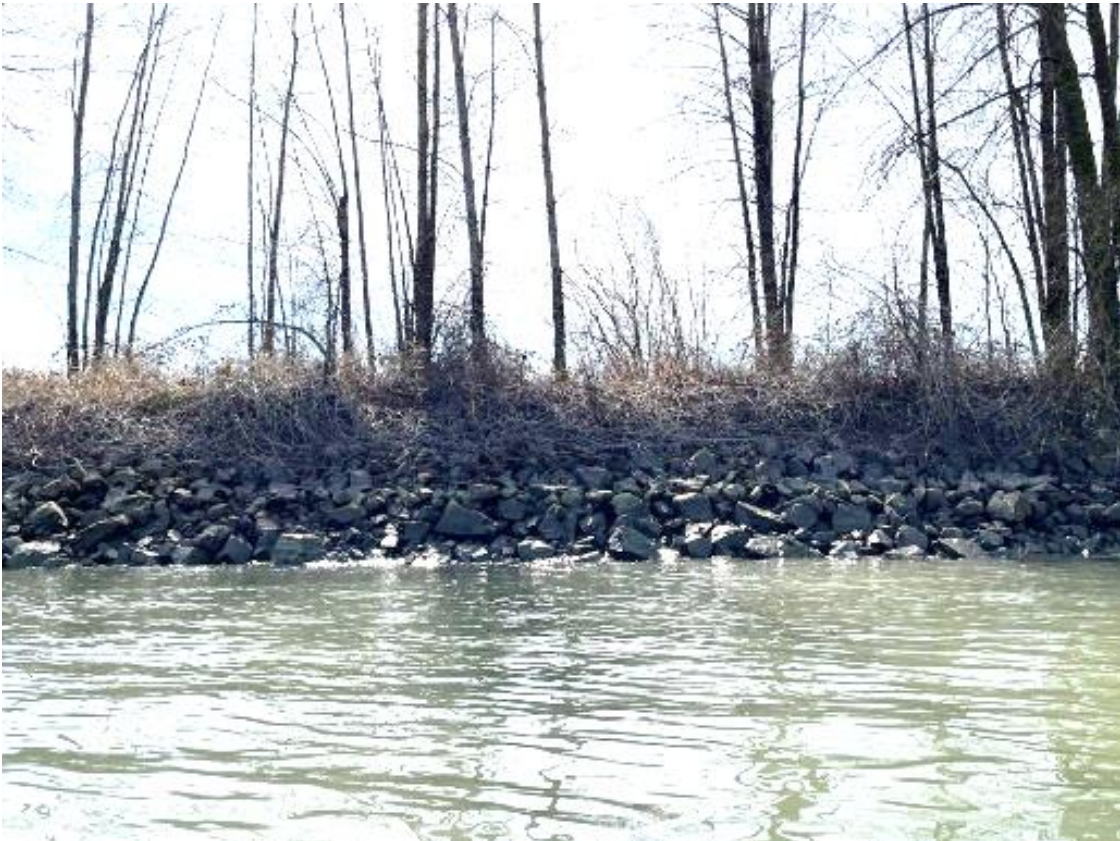
<div>Dike Station</div> <div>4+550</div>	<div>Inspection Location</div> <div>

</div>
<div>Active Erosion</div> <div>No</div>	<div>Bank Protection</div> <div>Yes</div>
<div>Notes</div> <div>Riprap is present, and appears to be in reasonably good condition.</div>

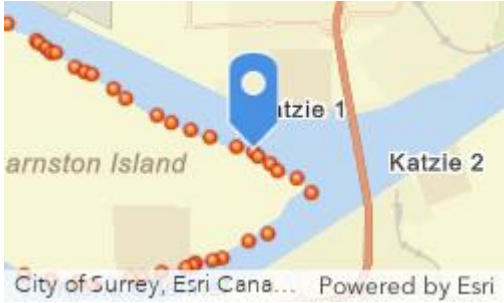
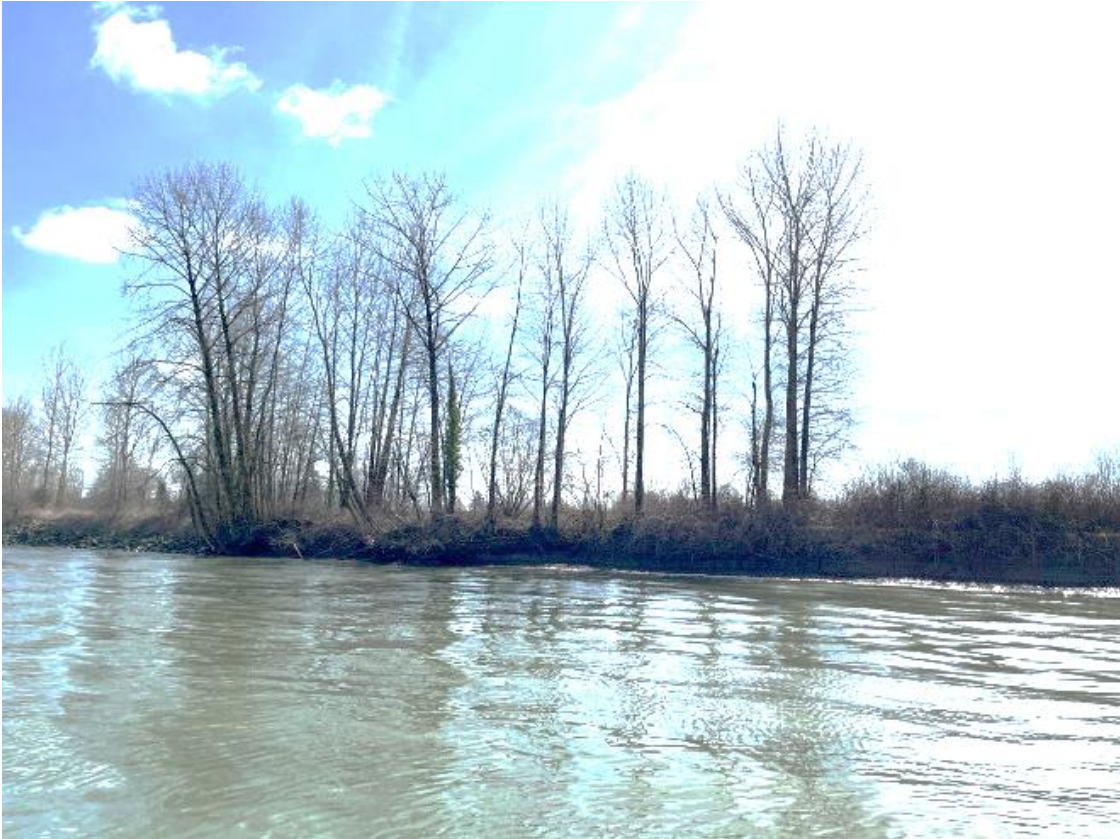
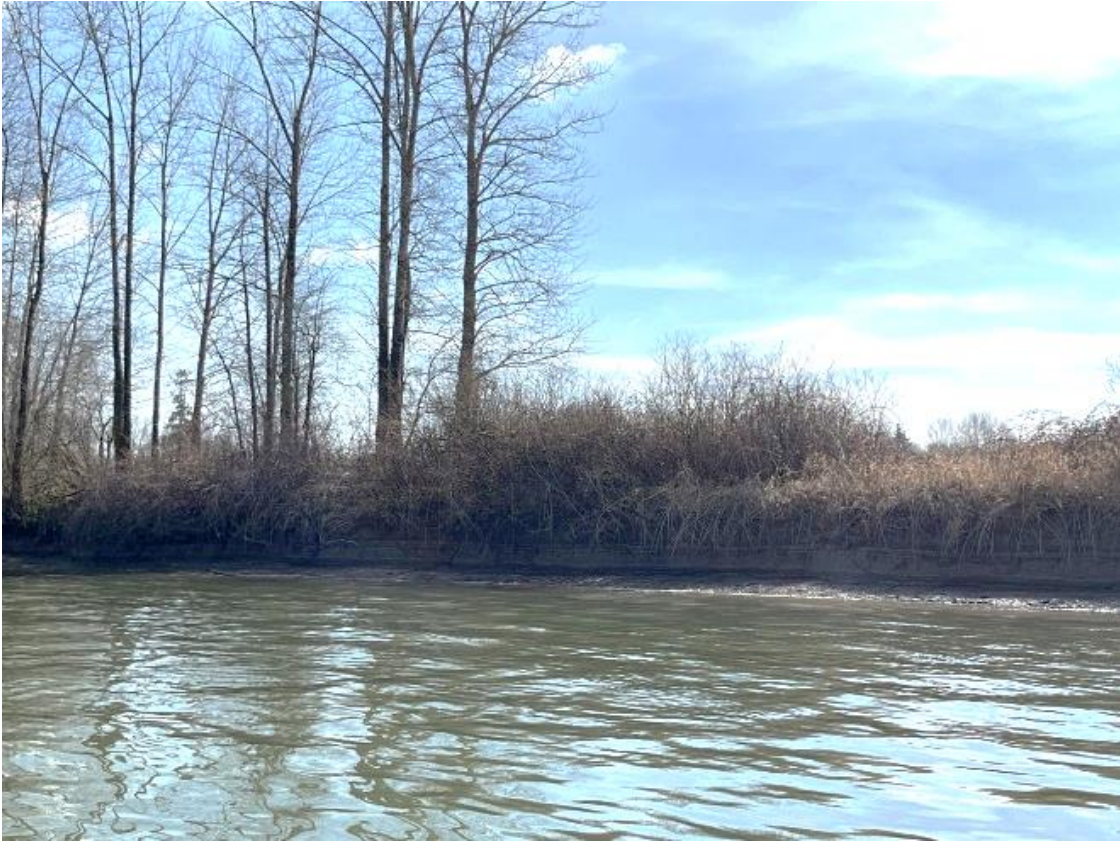
<div>Dike Station</div> <div>4+575</div>	<div>Inspection Location</div> <div>

</div>
<div>Active Erosion</div> <div>Yes</div>	<div>Bank Protection</div> <div>No</div>
<div>Notes</div> <div>Section of eroding bank (150-200 m long) downstream of riprap. A portion of this eroding bank lacks mature vegetation between the bank and dike.</div>

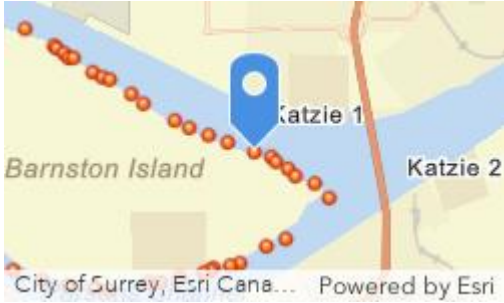
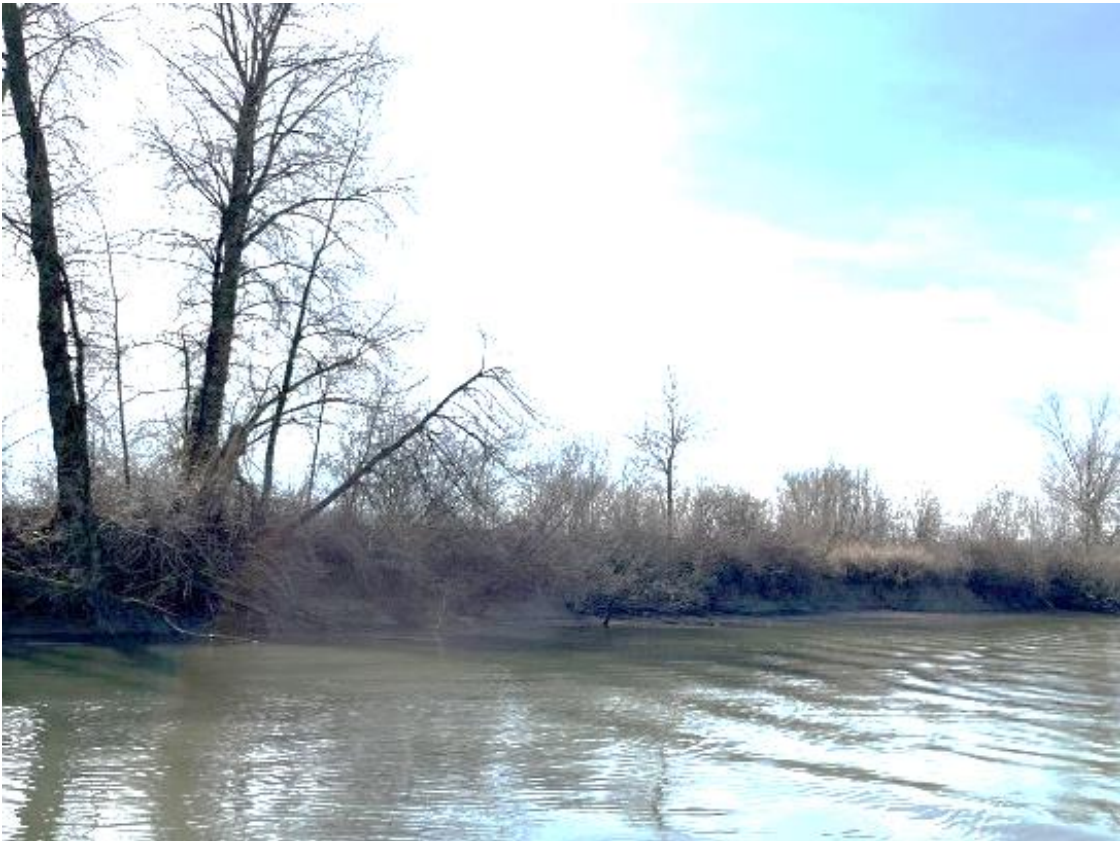
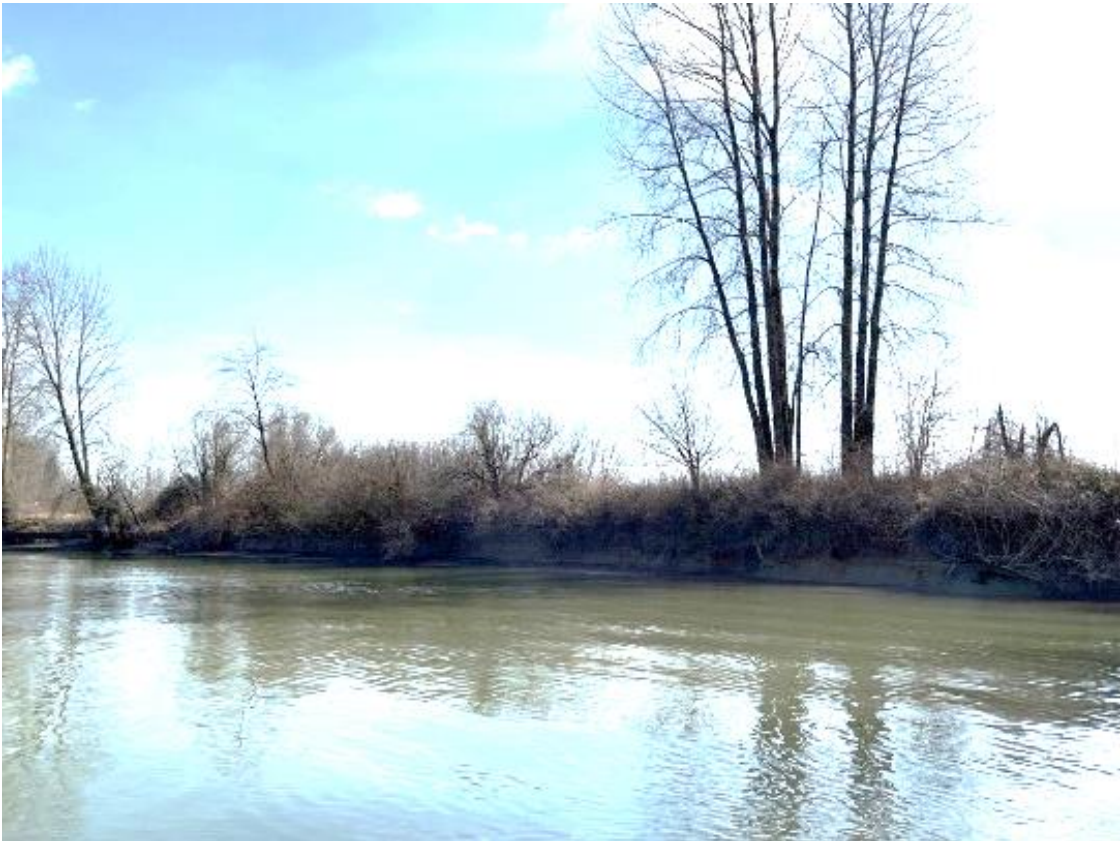
<div>Dike Station</div> <div>4+775</div>	<div>Inspection Location</div> <div>

</div>
<div>Active Erosion</div> <div>Yes</div>	<div>Bank Protection</div> <div>No</div>
<div>Notes</div> <div>Bank is steep and sandy, with roots exposed. Some mature trees and some grassy vegetation at top of bank. Bank drops off steeply below water, according to boat depth sounder</div>

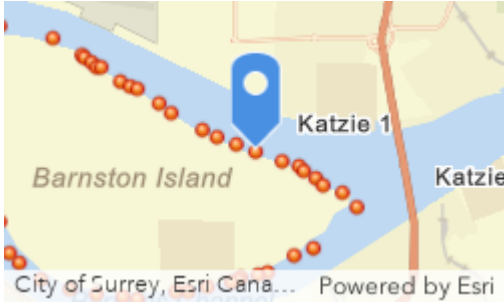
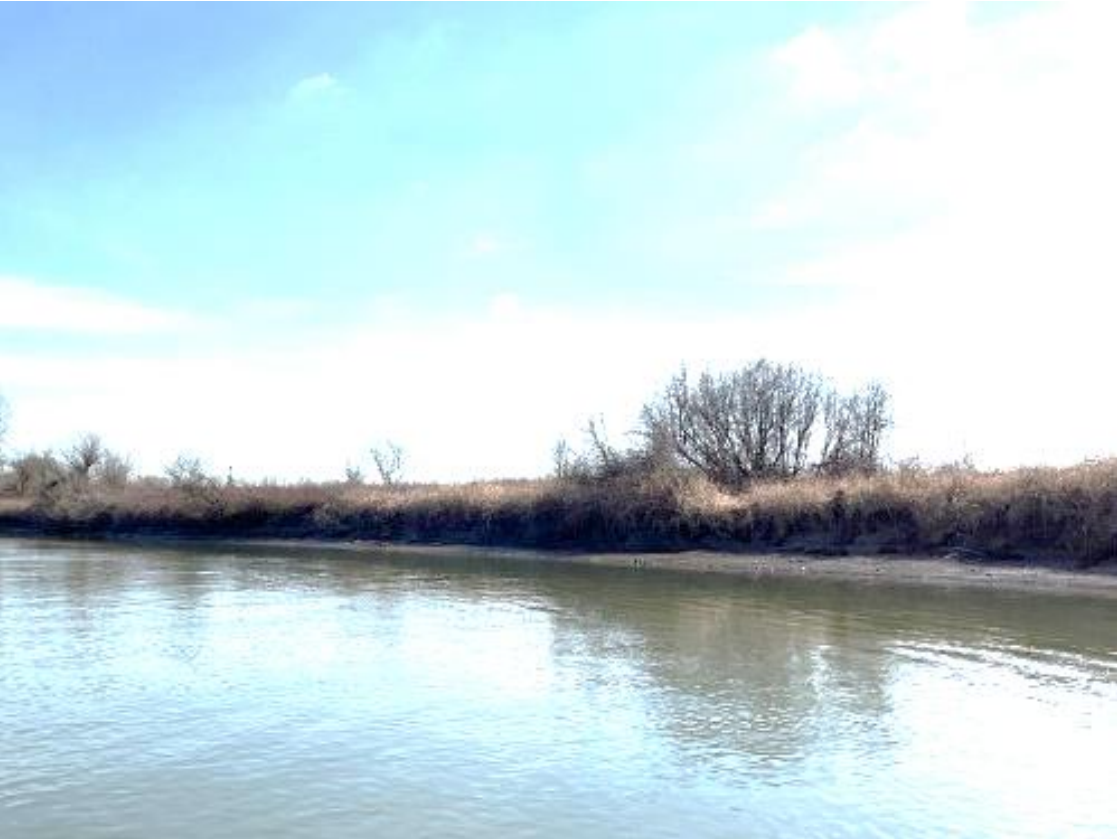
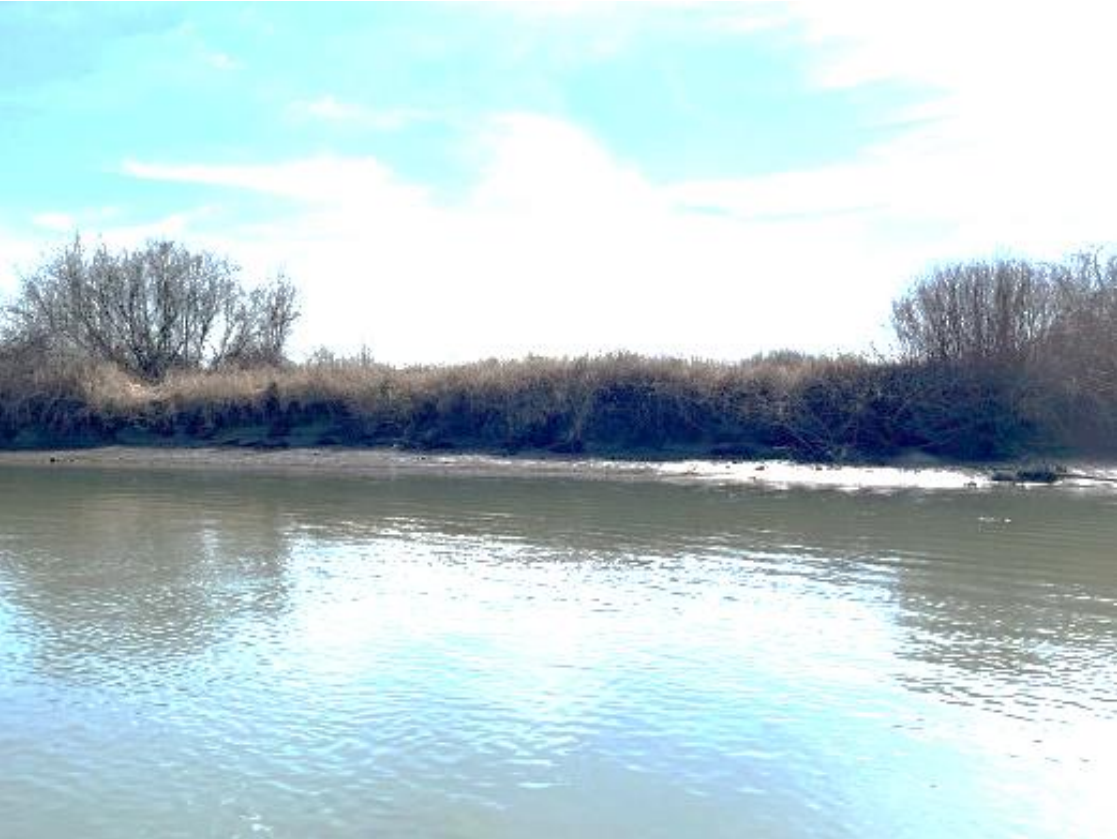
<div>Dike Station</div> <div>5+075</div>	<div>Inspection Location</div> <div>

</div>
<div>Active Erosion</div> <div>Yes</div>	<div>Bank Protection</div> <div>No</div>
<div>Notes</div> <div>Bank is steep and lacks mature vegetation between the bank and the dike. Sandy terrace is visible at bottom of upper bank.</div>

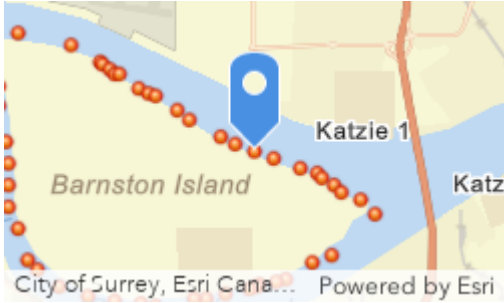
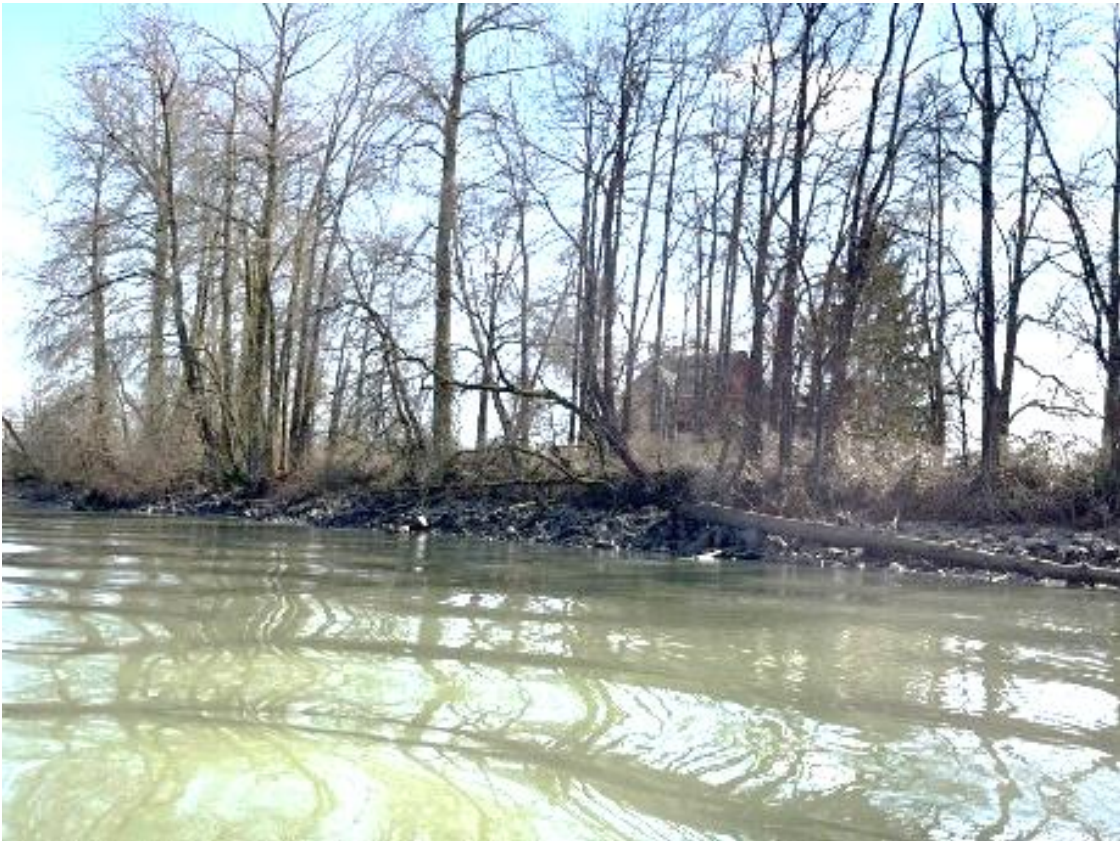
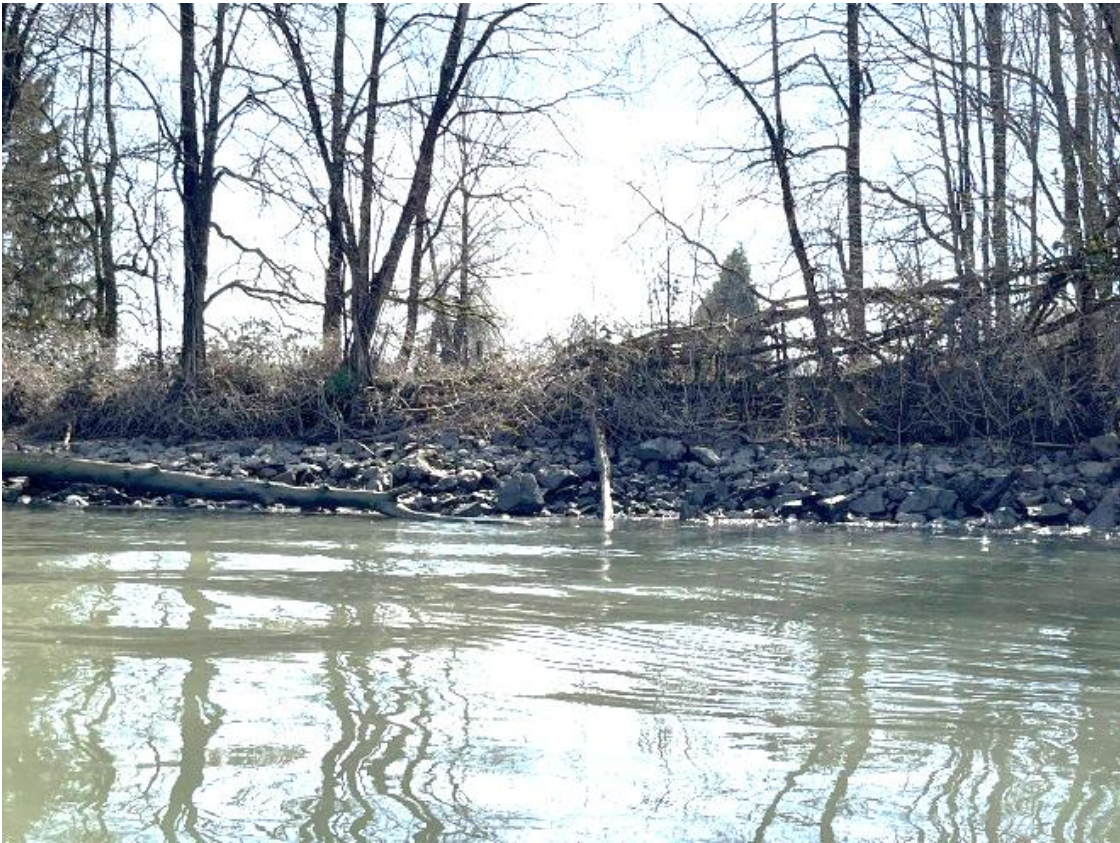
<div>Dike Station</div> <div>5+275</div>	<div>Inspection Location</div> <div>

</div>
<div>Active Erosion</div> <div>Yes</div>	<div>Bank Protection</div> <div>Yes</div>
<div>Notes</div> <div>Riprap is present at this location. Rock sizing is relatively small, and some launching was visible; however, the riprap appears to be mitigating the typical oversteepening seen elsewhere along the reach.</div>

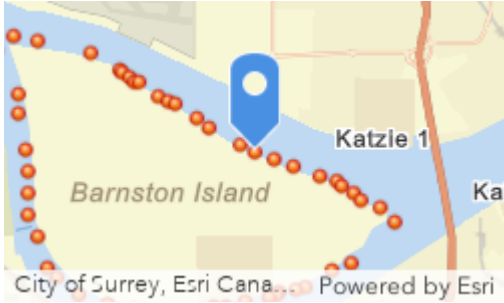
<div>Dike Station</div> <div>5+500</div>	<div>Inspection Location</div> <div>

</div>
<div>Active Erosion</div> <div>Yes</div>	<div>Bank Protection</div> <div>No</div>
<div>Notes</div> <div>Bank retreat has exposed the roots of mature trees. Root structures have created hard points that have resulted in small erosion arcs forming upstream and downstream of mature trees.</div>

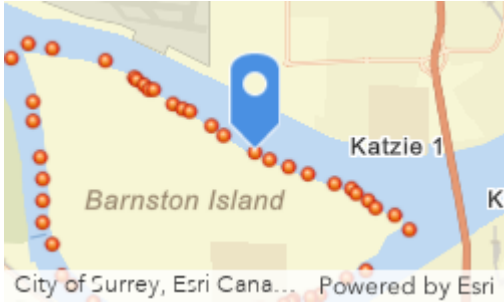
<div>Dike Station</div> <div>5+675</div>	<div>Inspection Location</div> <div>

</div>
<div>Active Erosion</div> <div>Yes</div>	<div>Bank Protection</div> <div>Yes</div>
<div>Notes</div> <div>Riprap is present near an intake structure. Bank is actively eroding upstream and downstream of the limits of the riprap.</div>

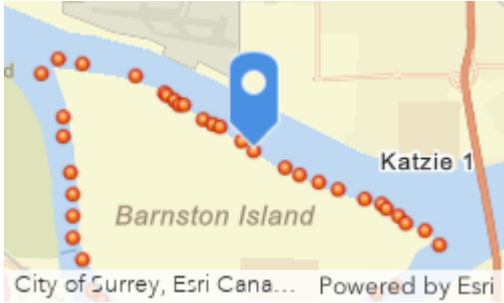
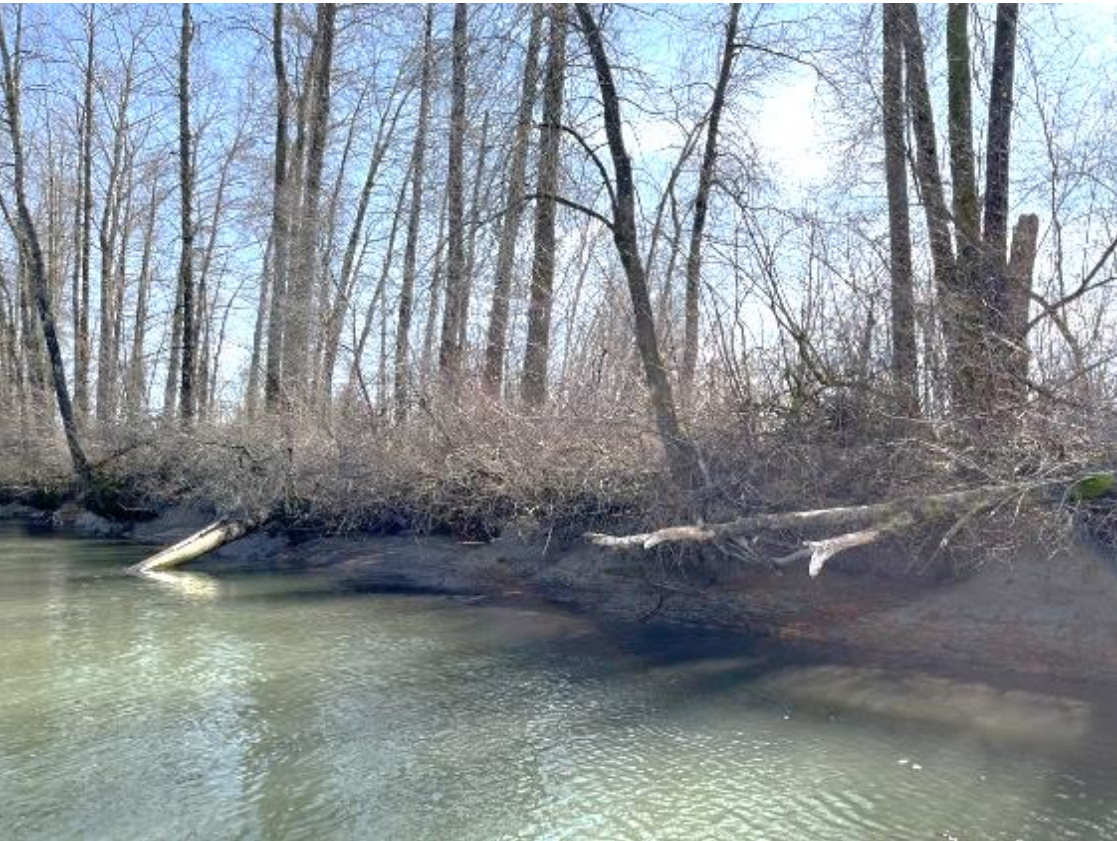
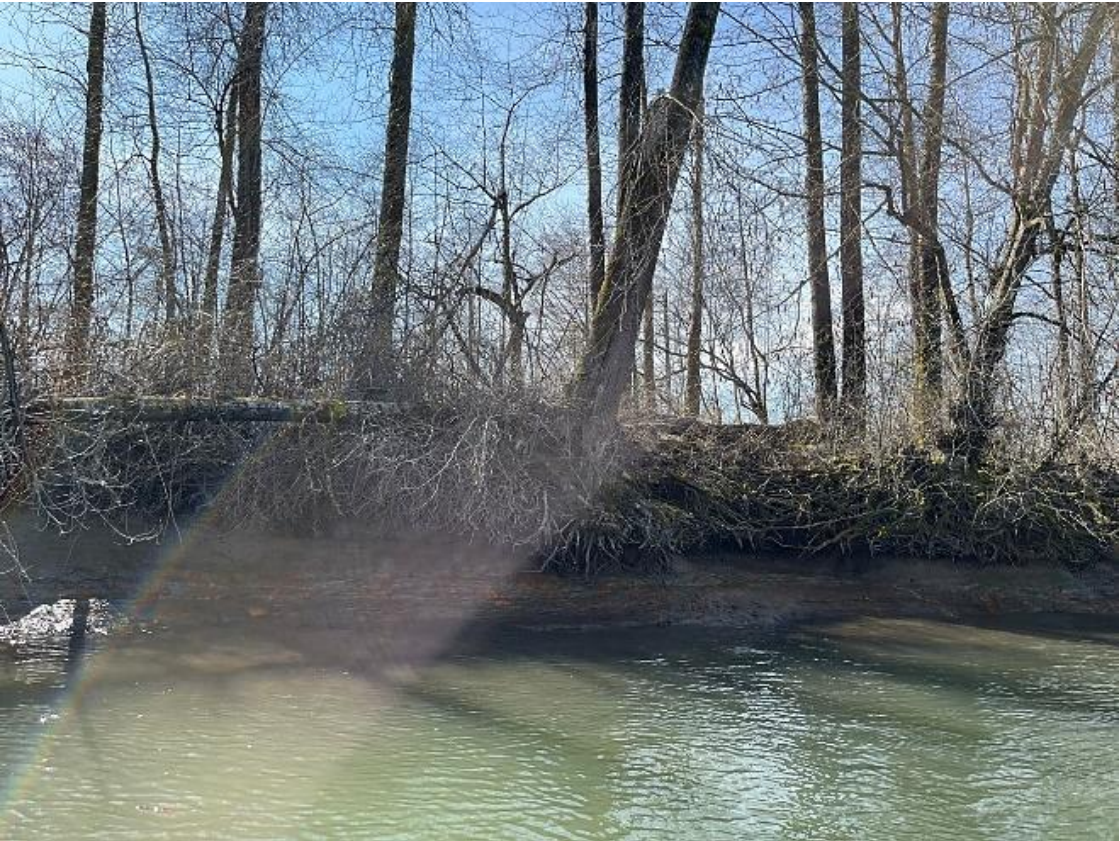
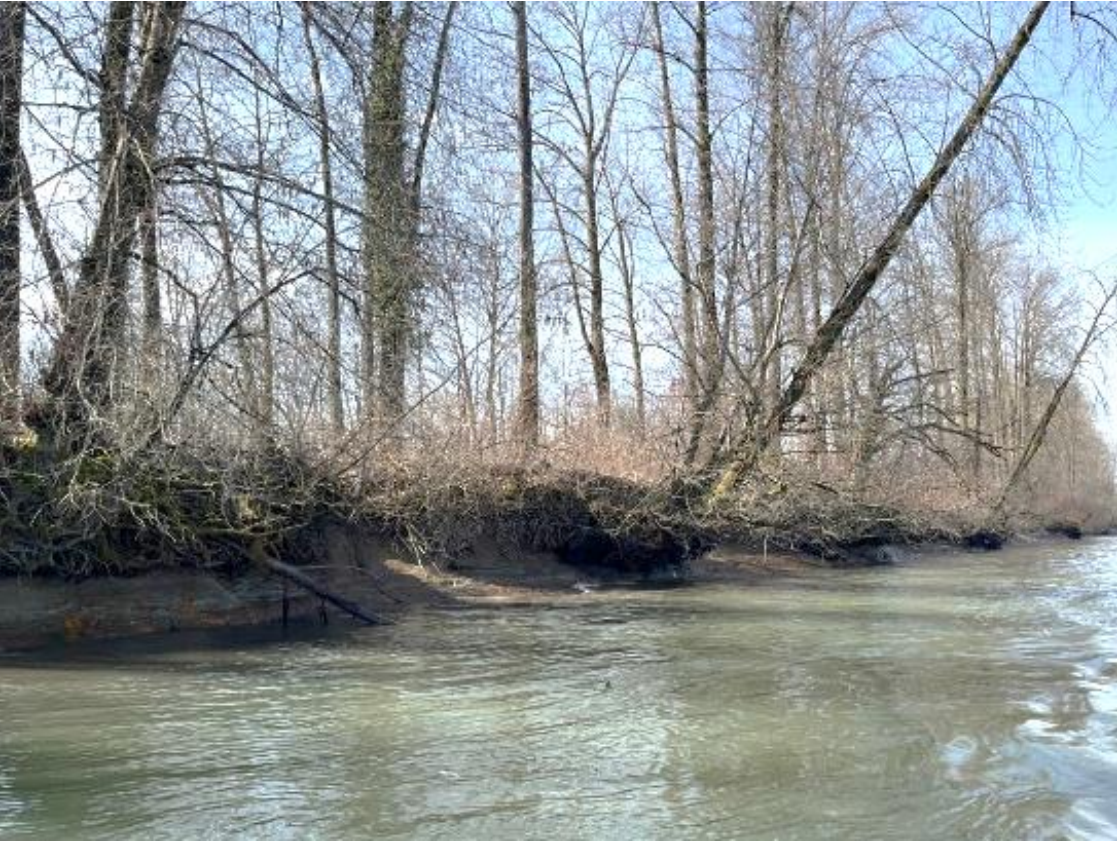
<div>Dike Station</div> <div>6+025</div>	<div>Inspection Location</div> <div>

</div>
<div>Active Erosion</div> <div>Yes</div>	<div>Bank Protection</div> <div>No</div>
<div>Notes</div> <div>Typical undercut banks. Small erosion arcs are present downstream of some exposed mature tree root structures.</div>

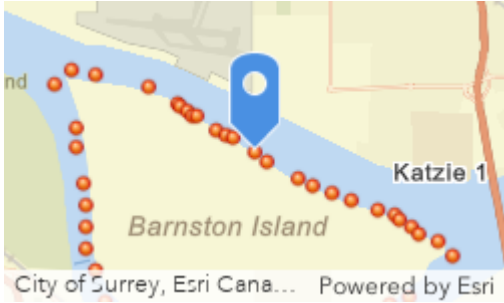
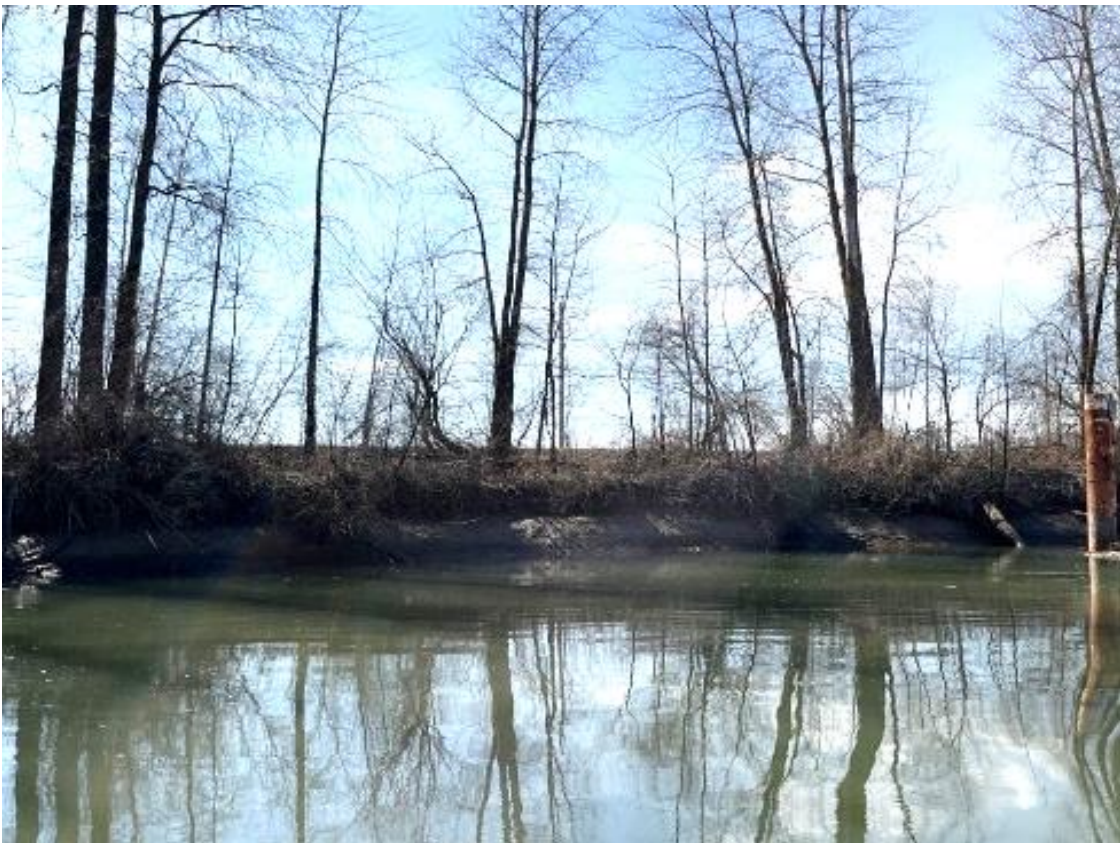
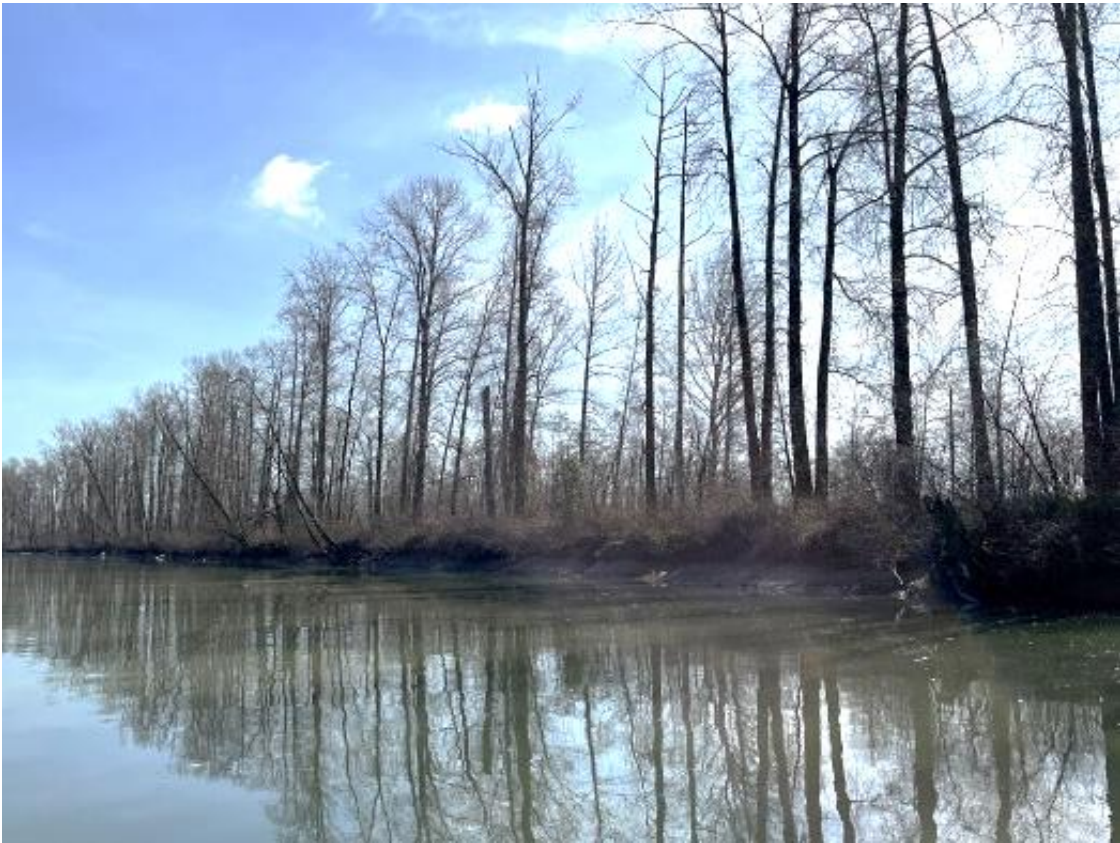
<div>Dike Station</div> <div>6+200</div>	<div>Inspection Location</div> <div>

</div>
<div>Active Erosion</div> <div>Yes</div>	<div>Bank Protection</div> <div>No</div>
<div>Notes</div> <div>Bank is near-vertical with leaning trees and roots exposed.</div>
