**Northwest Hydraulic Consultants Ltd.**

NHC Reference 3008460  
May 10, 2024

**Re:** **Barnston Island Dike Assessment Update 2023**  
**Preliminary Report, Final**

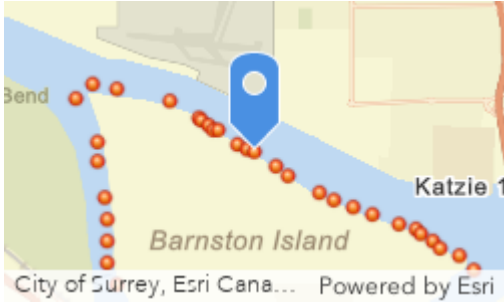
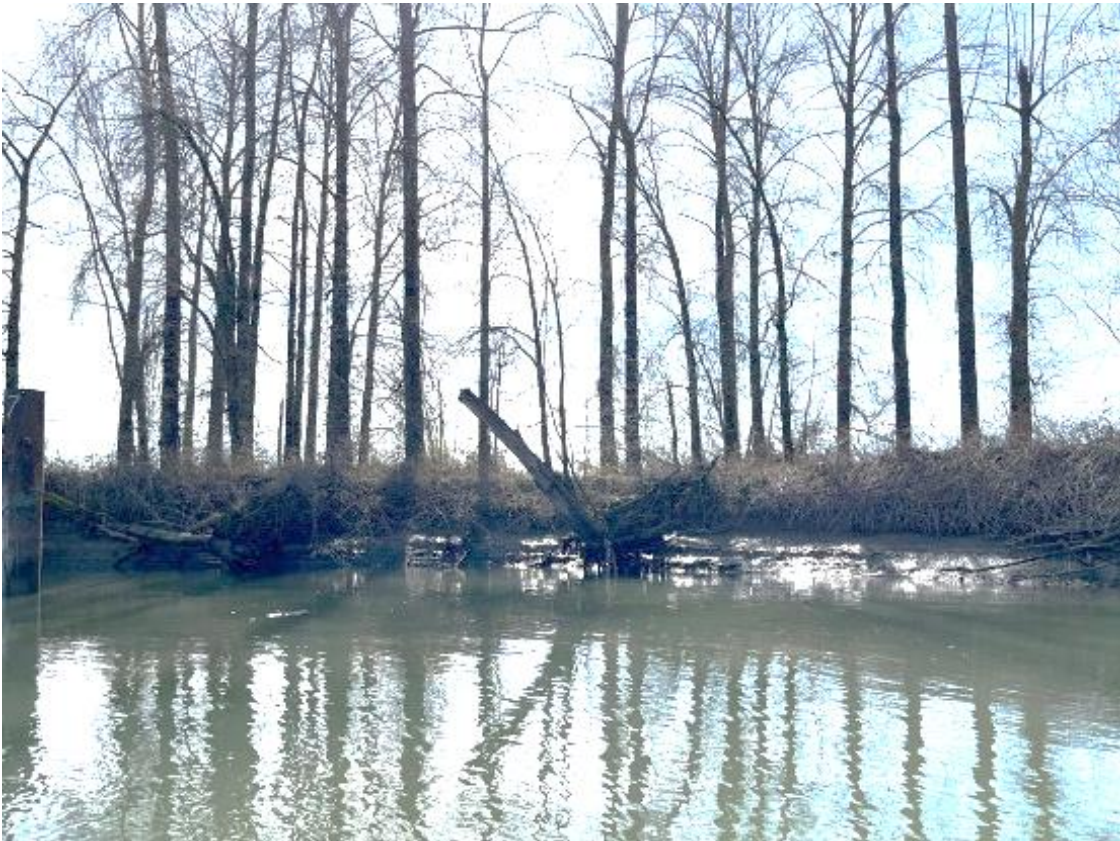
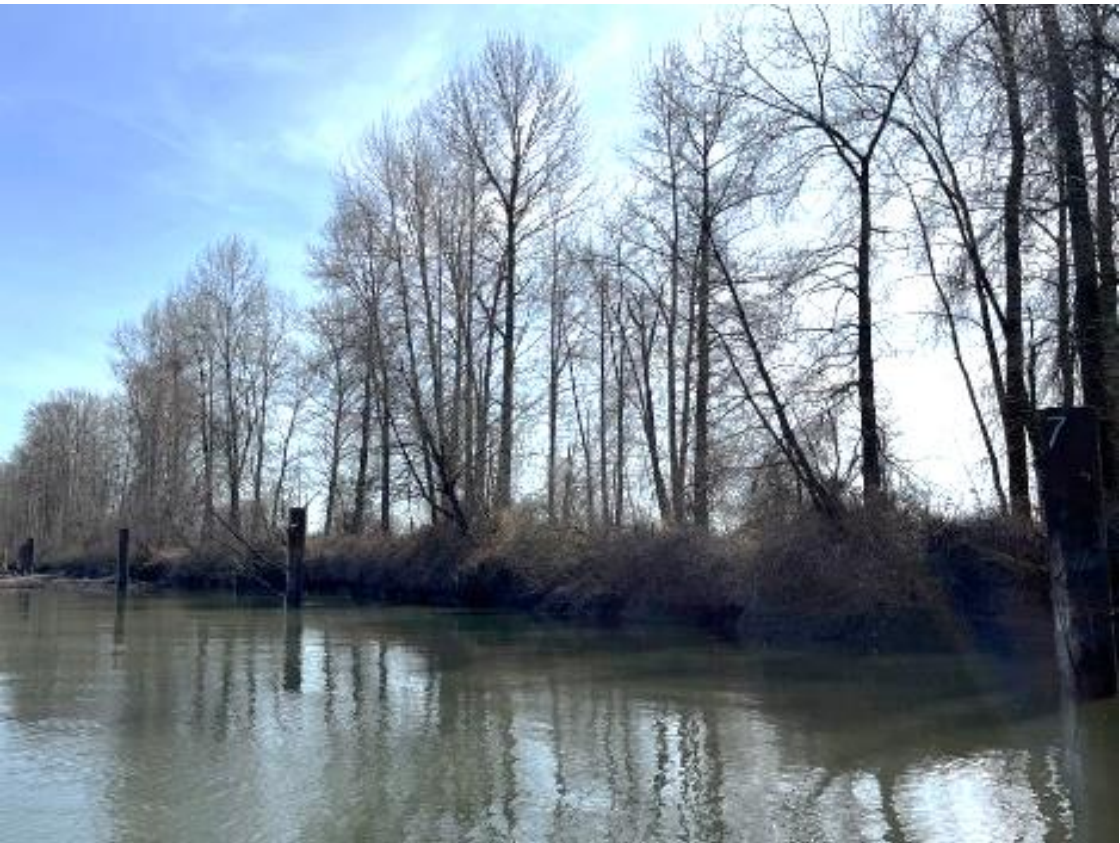
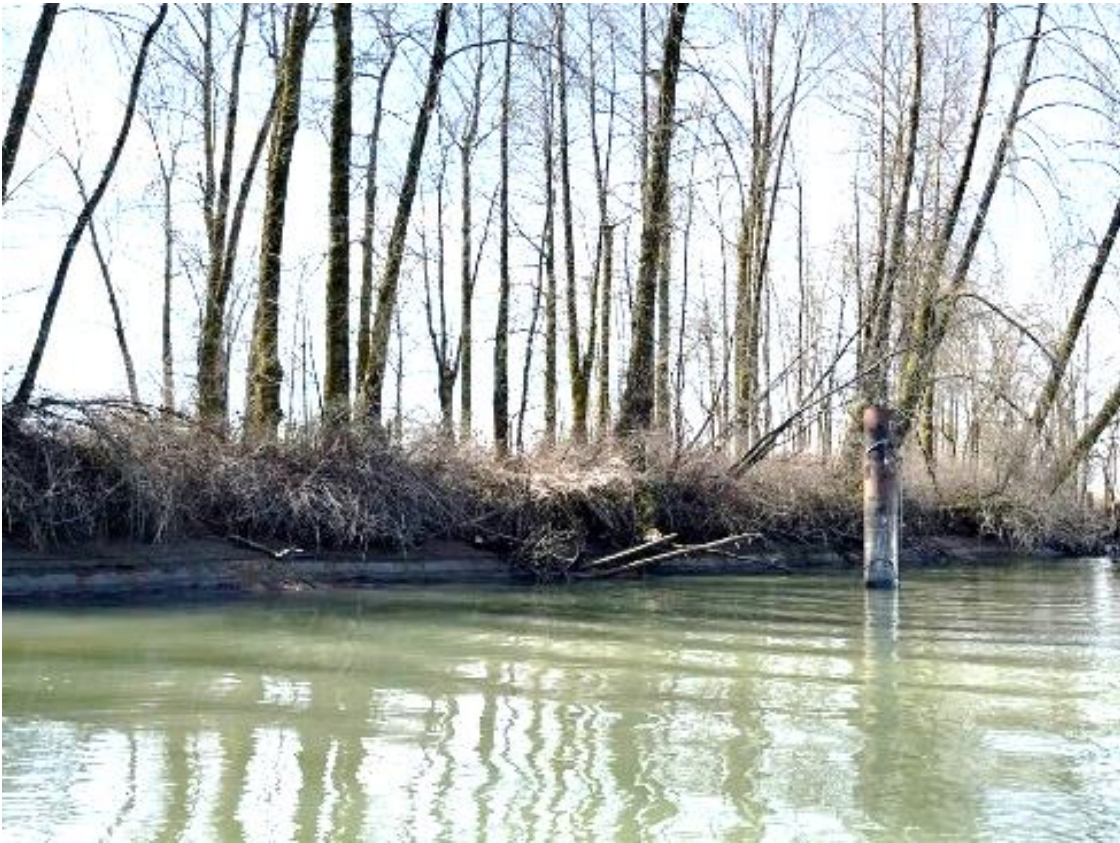
<div>Dike Station</div> <div>6+450</div>	<div>Inspection Location</div> <div>

</div>
<div>Active Erosion</div> <div>Yes</div>	<div>Bank Protection</div> <div>No</div>
<div>Notes</div> <div>Bank is actively eroding. Near-vertical bank slope, with loss of support to mature trees at top of bank. Some root structures have flow passing inland of them, resulting in increased scour along the bank behind these trees.</div>

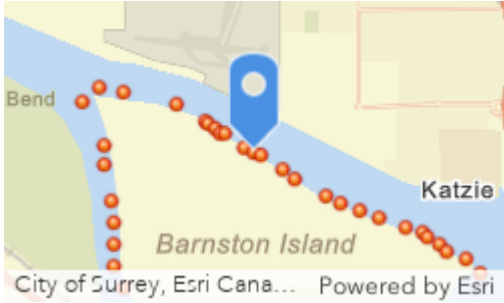
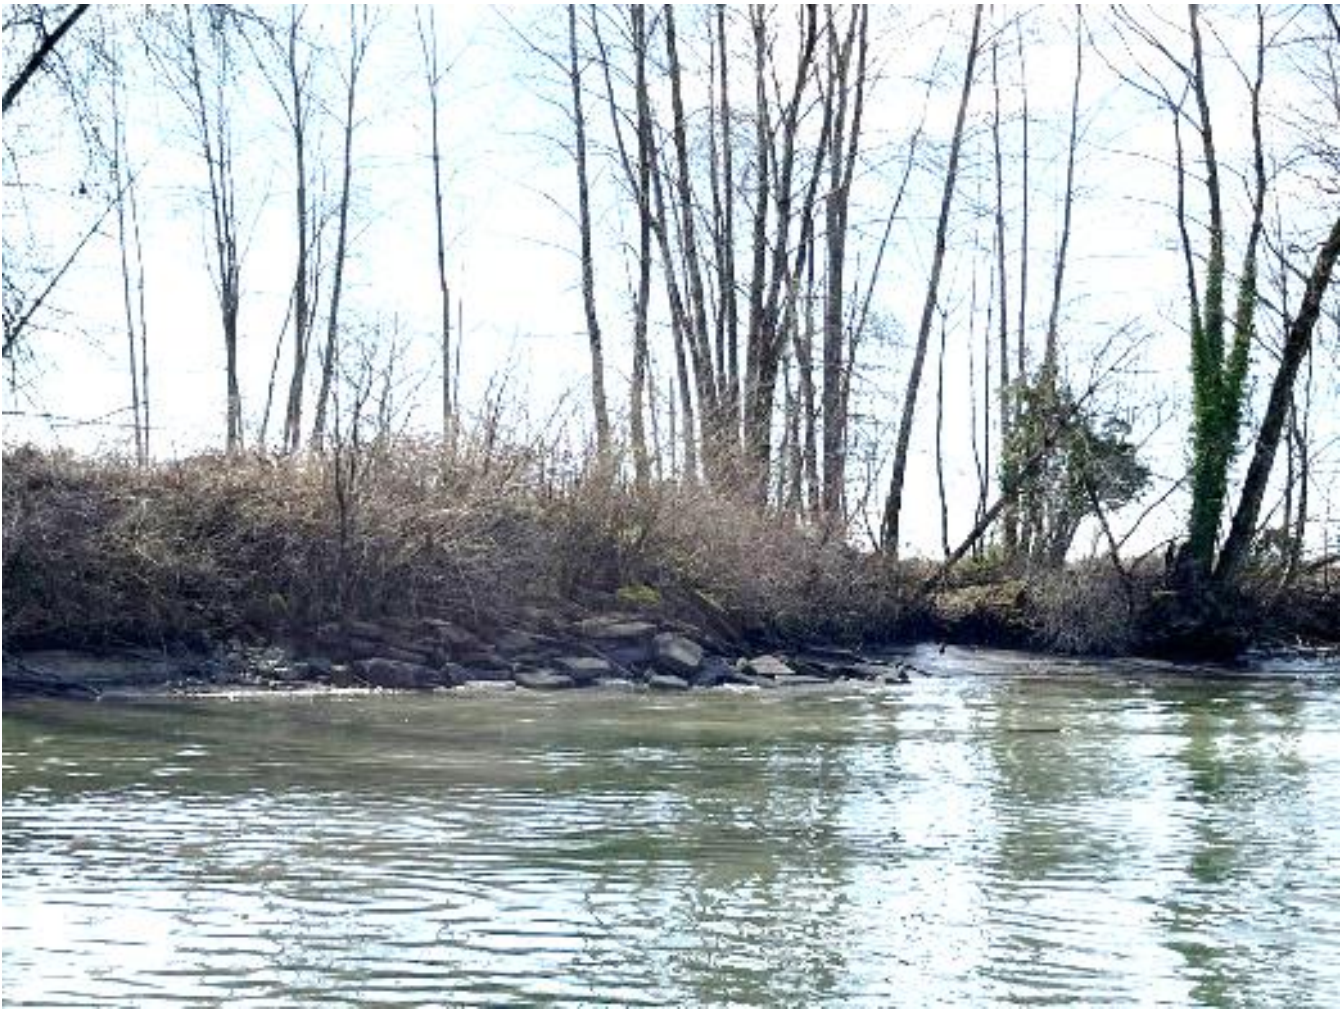
<div>Dike Station</div> <div>6+550</div>	<div>Inspection Location</div> <div>

</div>
<div>Active Erosion</div> <div>Yes</div>	<div>Bank Protection</div> <div>Yes</div>
<div>Notes</div> <div>Localized riprap (10 m long section), which appears to be launching. This riprap has created a hard point along the bank that has resulted in a small erosion arc downstream of it.</div>

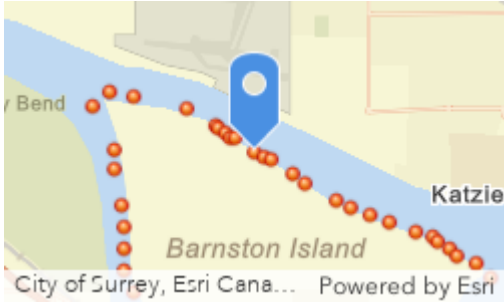
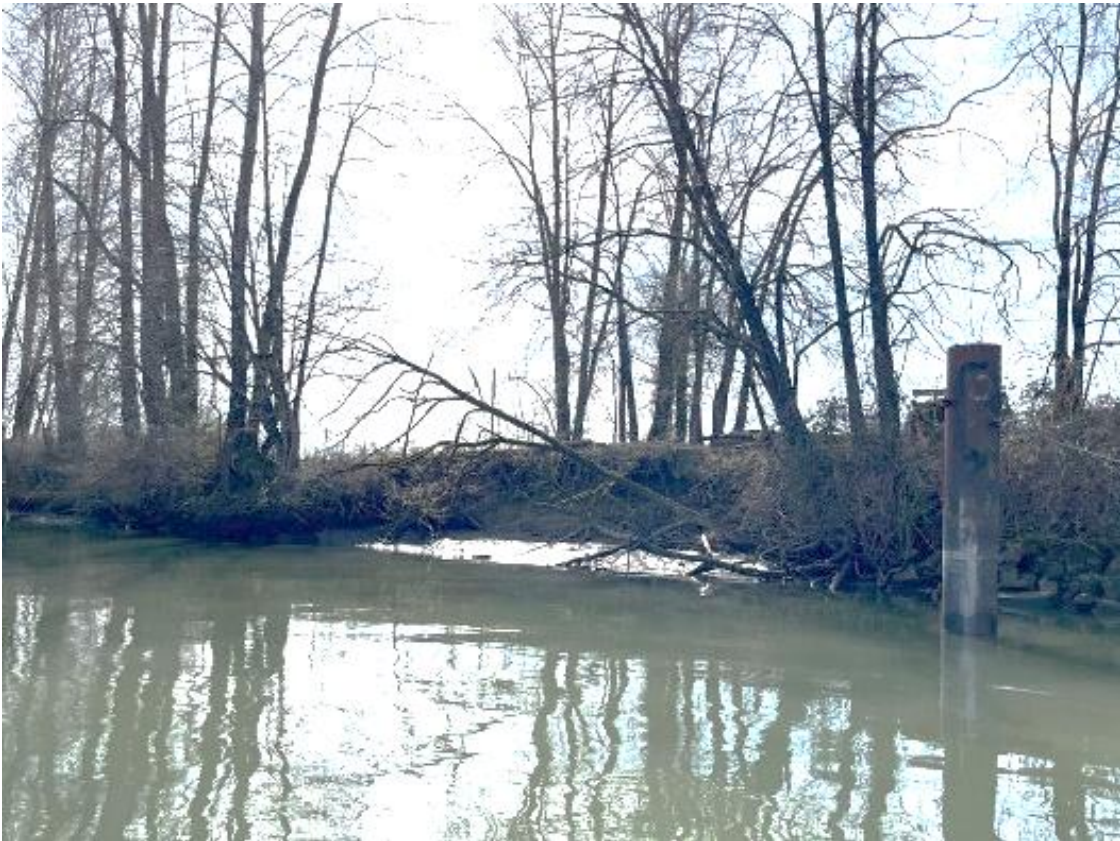
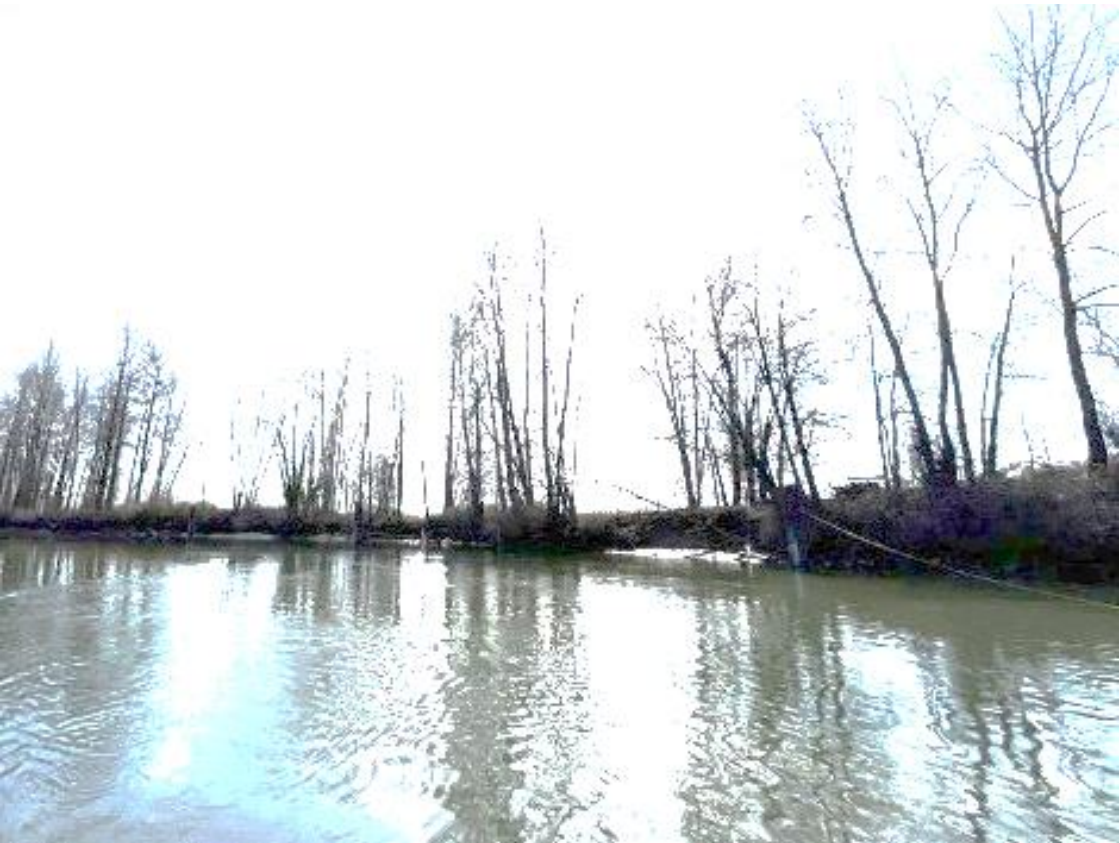
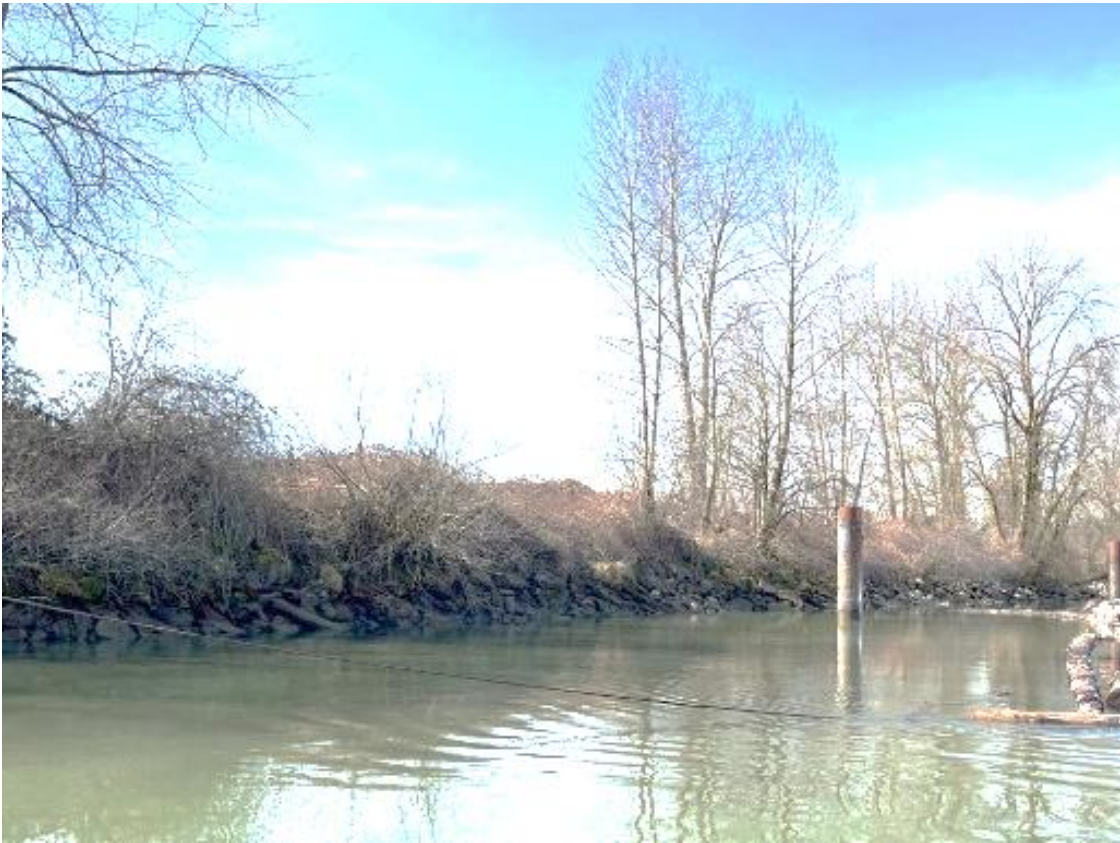
<div>Dike Station</div> <div>6+675</div>	<div>Inspection Location</div> <div>

</div>
<div>Active Erosion</div> <div>Yes</div>	<div>Bank Protection</div> <div>No</div>
<div>Notes</div> <div>Upstream end of riprap section. Bank is actively eroding, overly steep and unsupported. Bankline is retreating upstream of riprap.</div>

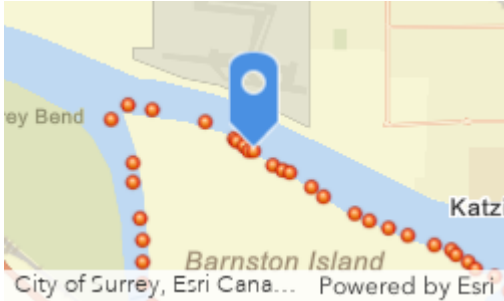
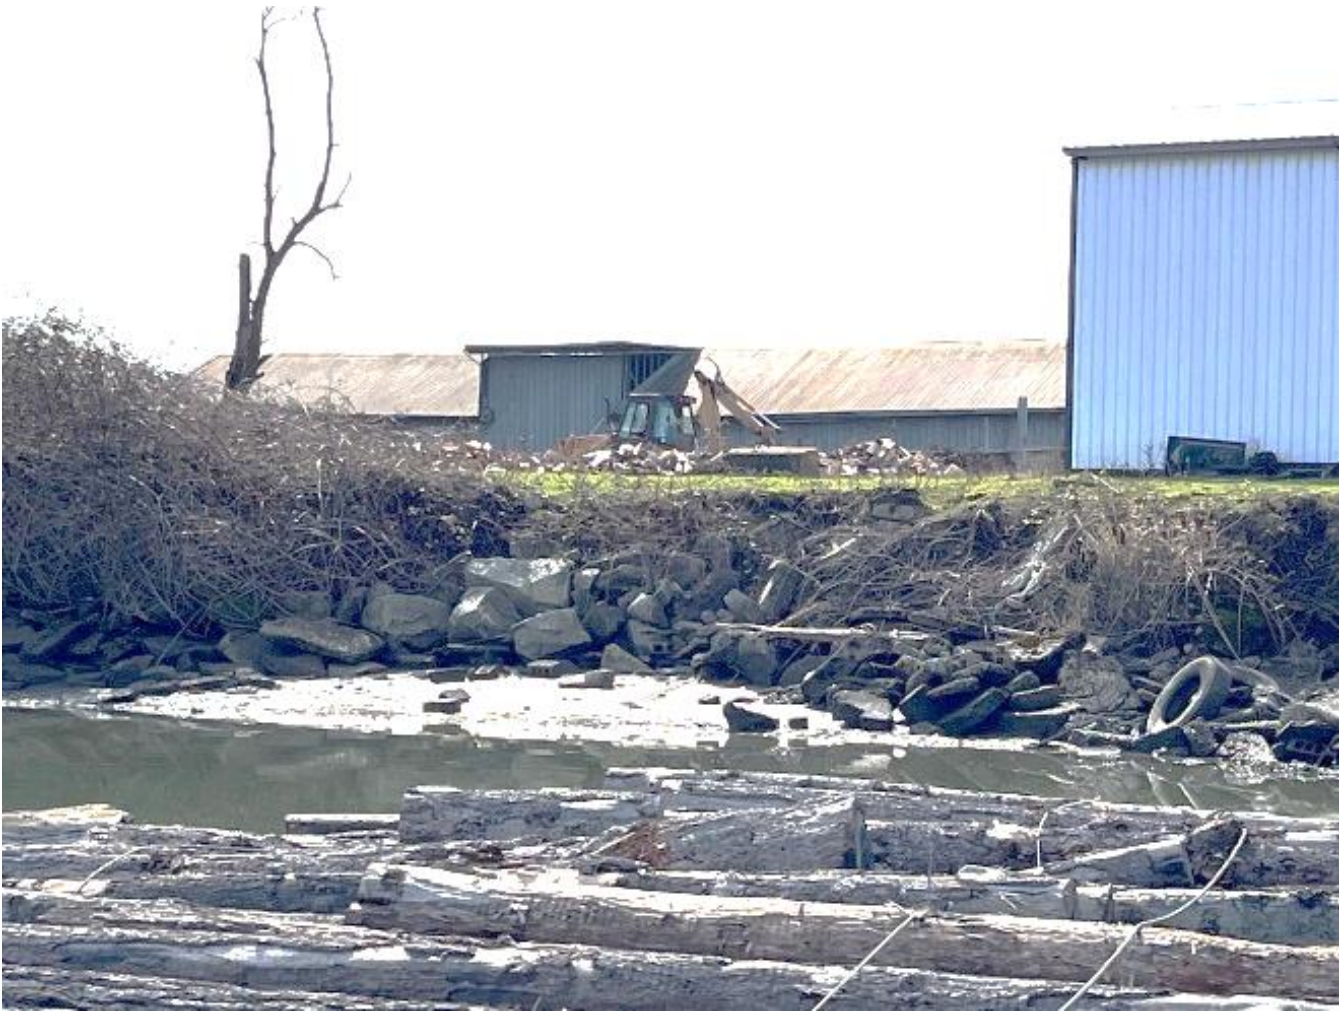
<div>Dike Station</div> <div>6+900</div>	<div>Inspection Location</div> <div>

</div>
<div>Active Erosion</div> <div>Yes</div>	<div>Bank Protection</div> <div>Yes</div>
<div>Notes</div> <div>Riprap has been placed on the upper bank following localized bank retreat. This location is directly adjacent to a developed property, with no mature trees along top of bank. The bank is generally steep and undercut in the vicinity of this riprap.</div>

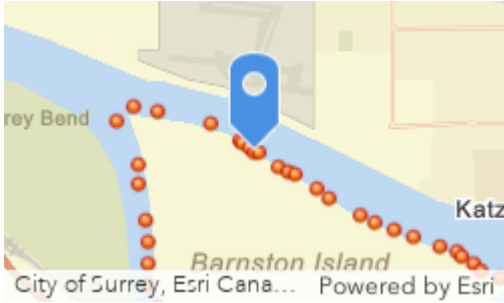
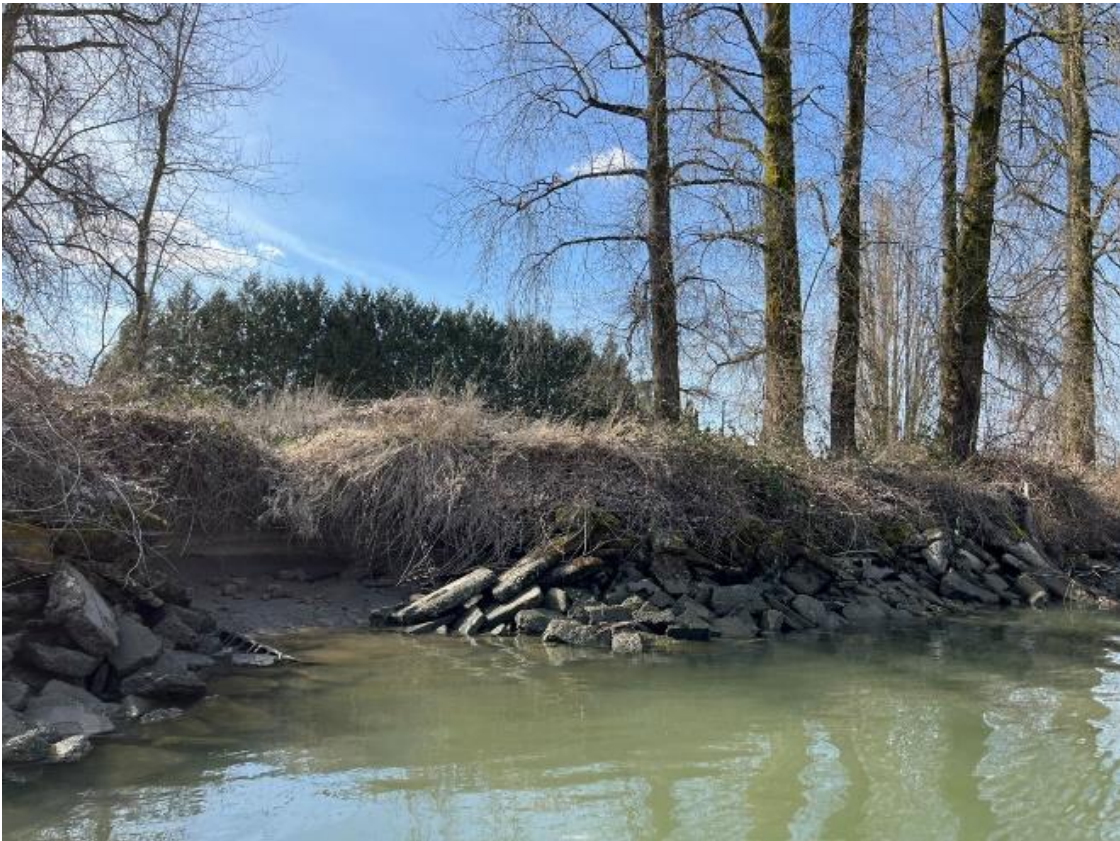
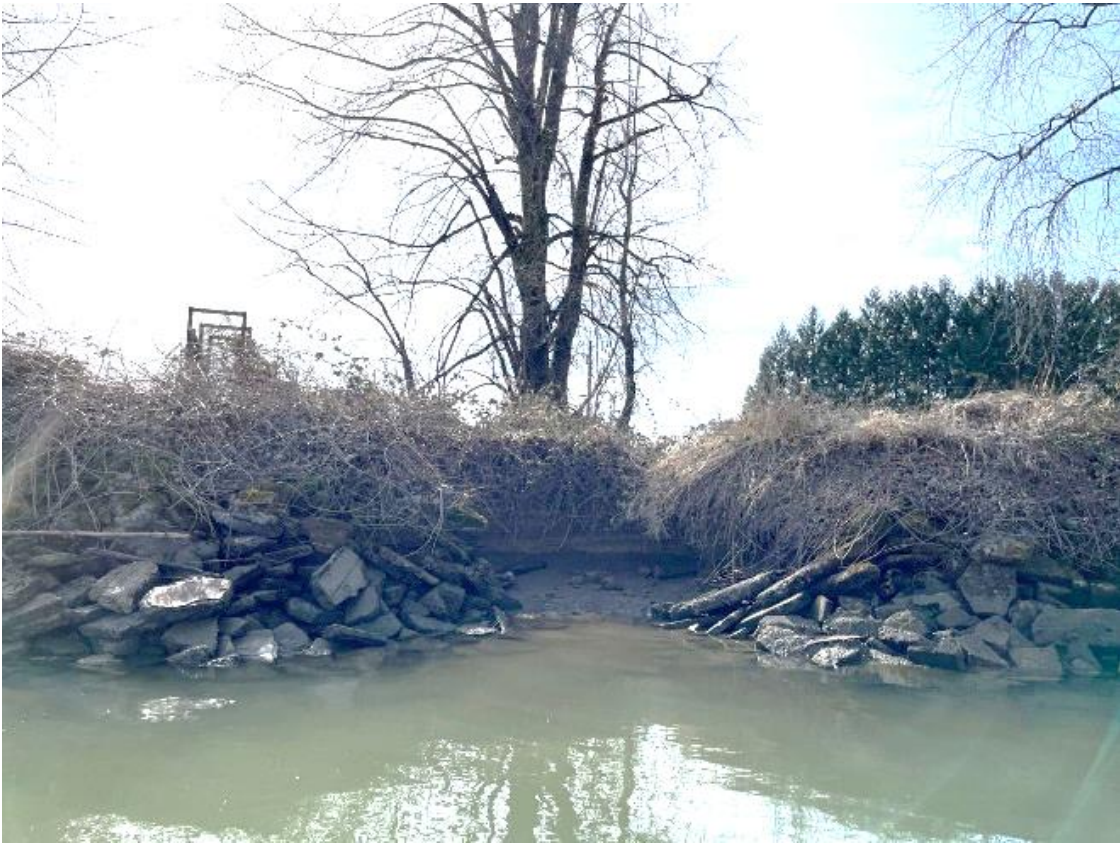
<div>Dike Station</div> <div>6+975</div>	<div>Inspection Location</div> <div>

</div>
<div>Active Erosion</div> <div>Yes</div>	<div>Bank Protection</div> <div>Yes</div>
<div>Notes</div> <div>Riprap is present, except along a 5 m long section. At this location without riprap, the bank has retreated relative to the armoured banks. There is sparse mature vegetation at top of bank.</div>

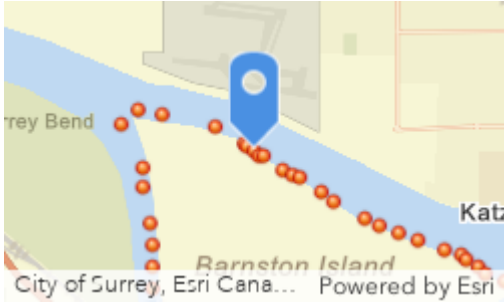
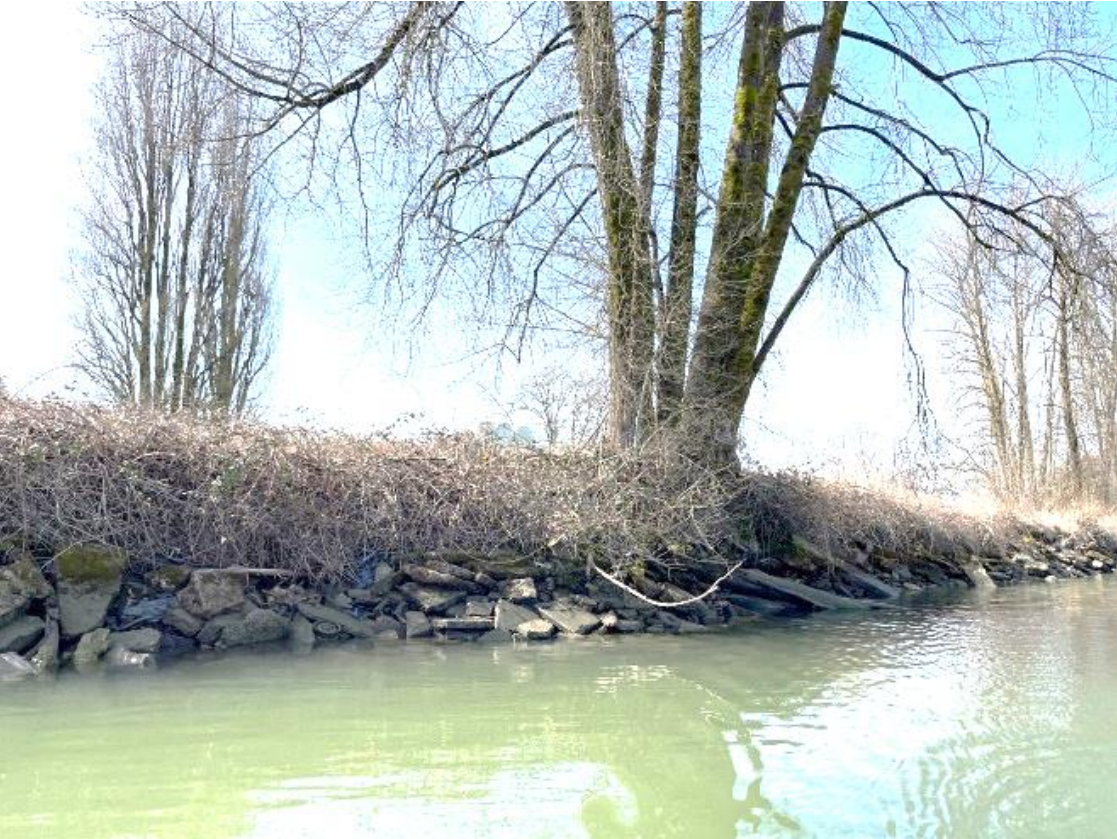
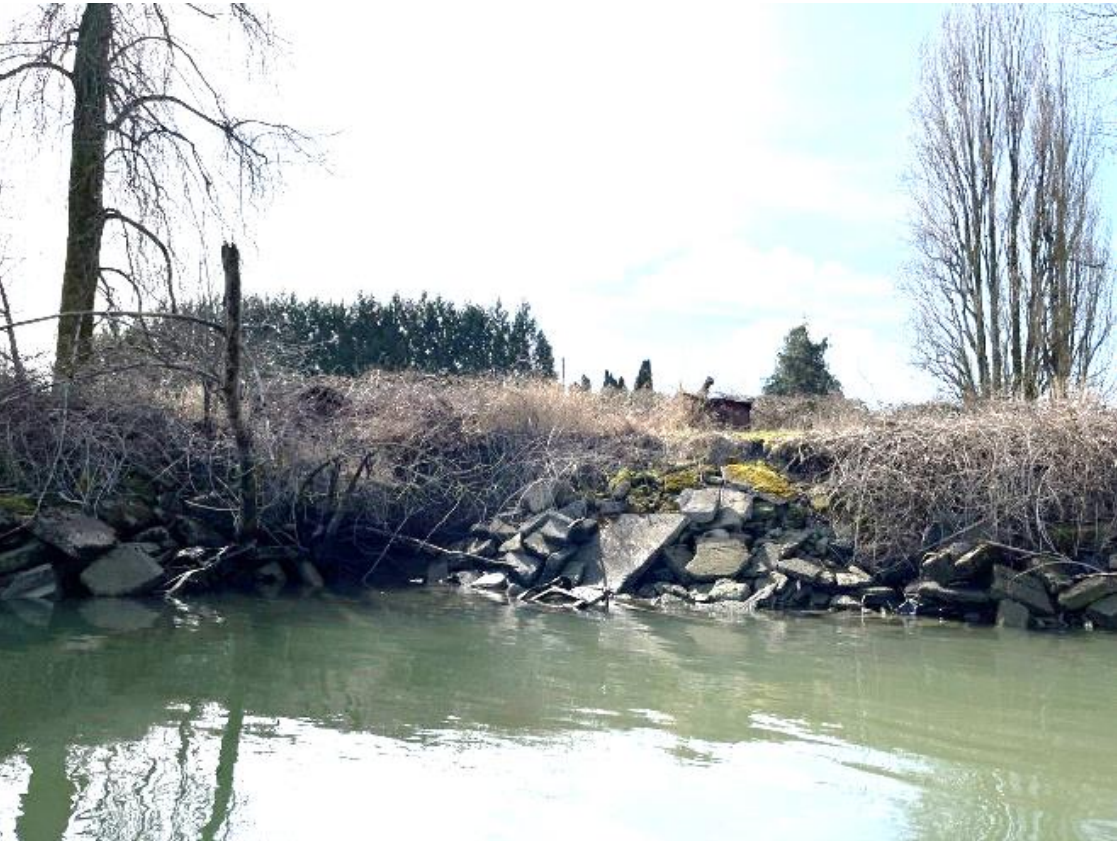
<div>Dike Station</div> <div>7+025</div>	<div>Inspection Location</div> <div>

</div>
<div>Active Erosion</div> <div>Yes</div>	<div>Bank Protection</div> <div>Yes</div>
<div>Notes</div> <div>Some riprap is present, but is launching, which has resulted in inconsistent bank coverage. The bank is actively eroding at locations where the riprap is absent. There is little vegetation between the bank and the dike here.</div>

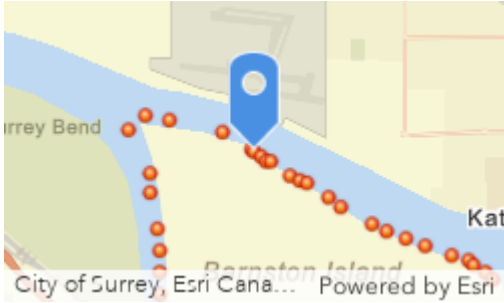
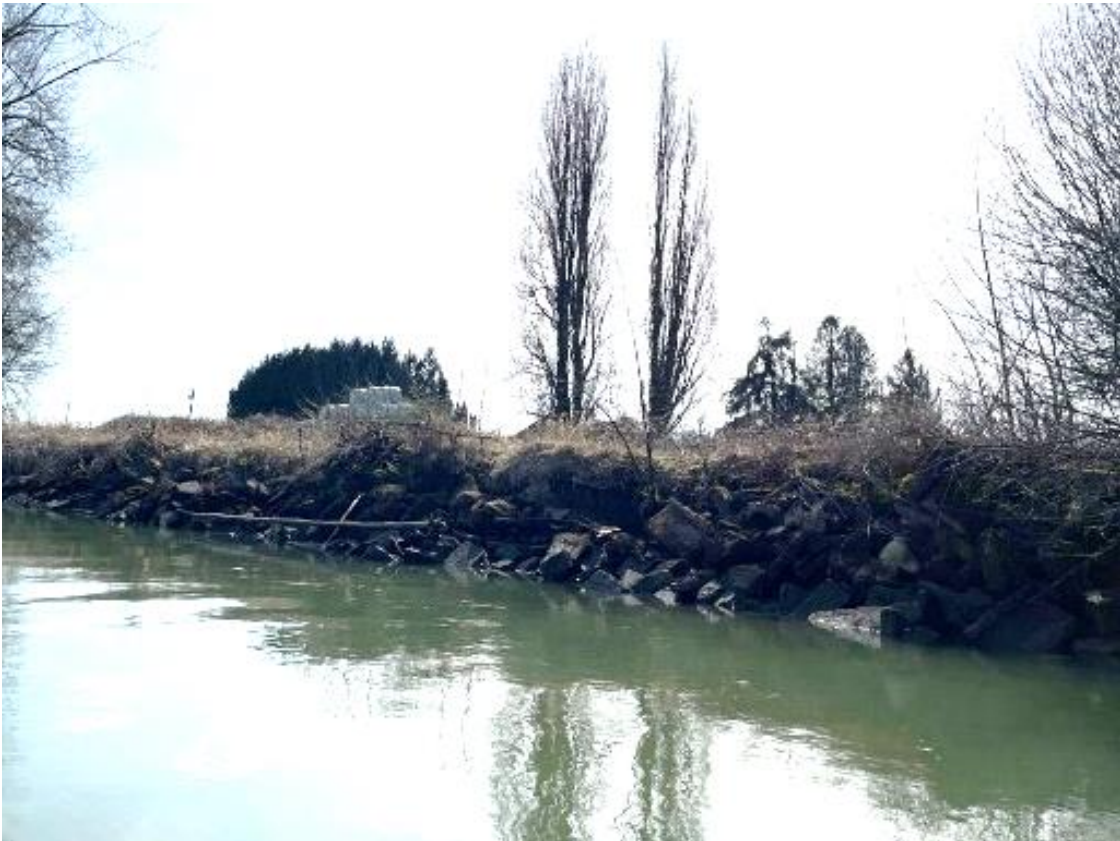
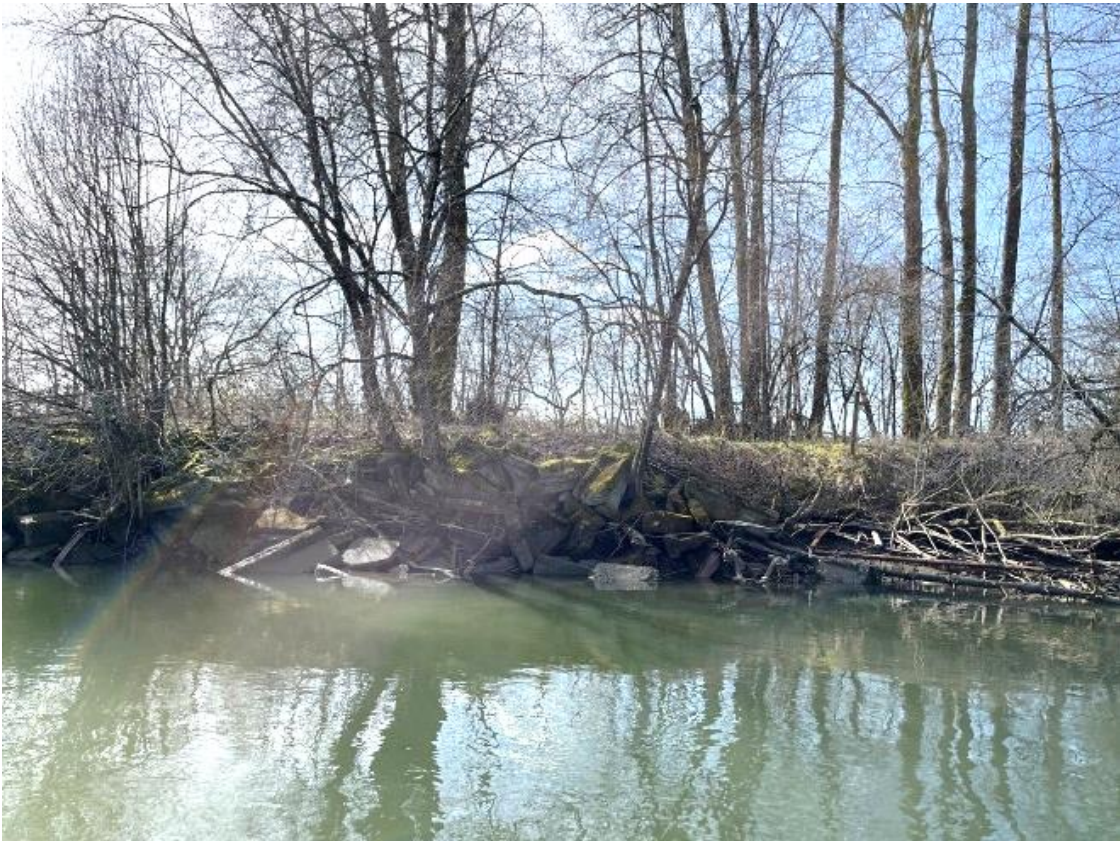
<div>Dike Station</div> <div>7+125</div>	<div>Inspection Location</div> <div>

</div>
<div>Active Erosion</div> <div>Yes</div>	<div>Bank Protection</div> <div>Yes</div>
<div>Notes</div> <div>Riprap is present but has launched in some locations, leaving sections of the bank unprotected. The bank is oversteepened at these locations. There is minimal vegetation between the bank and the dike.</div>

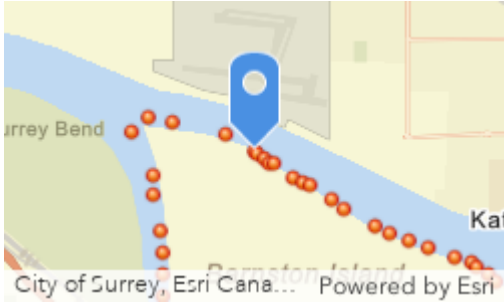
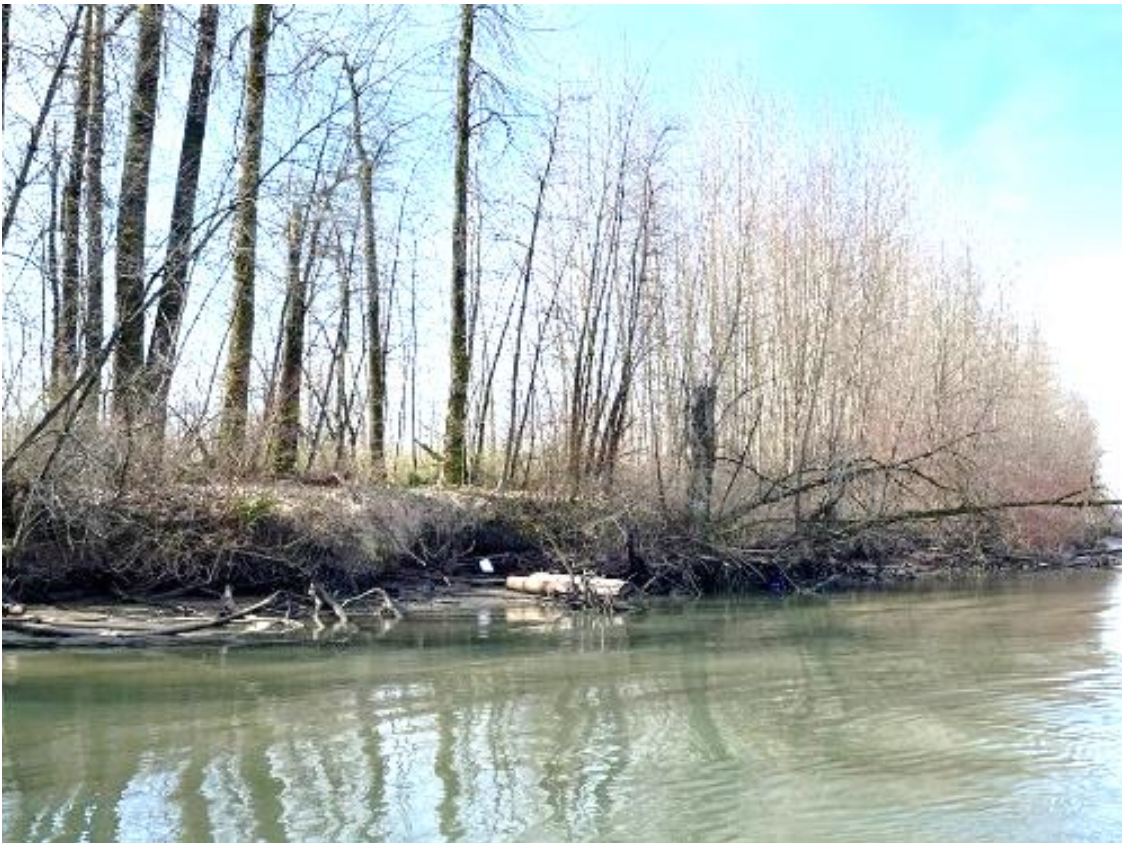
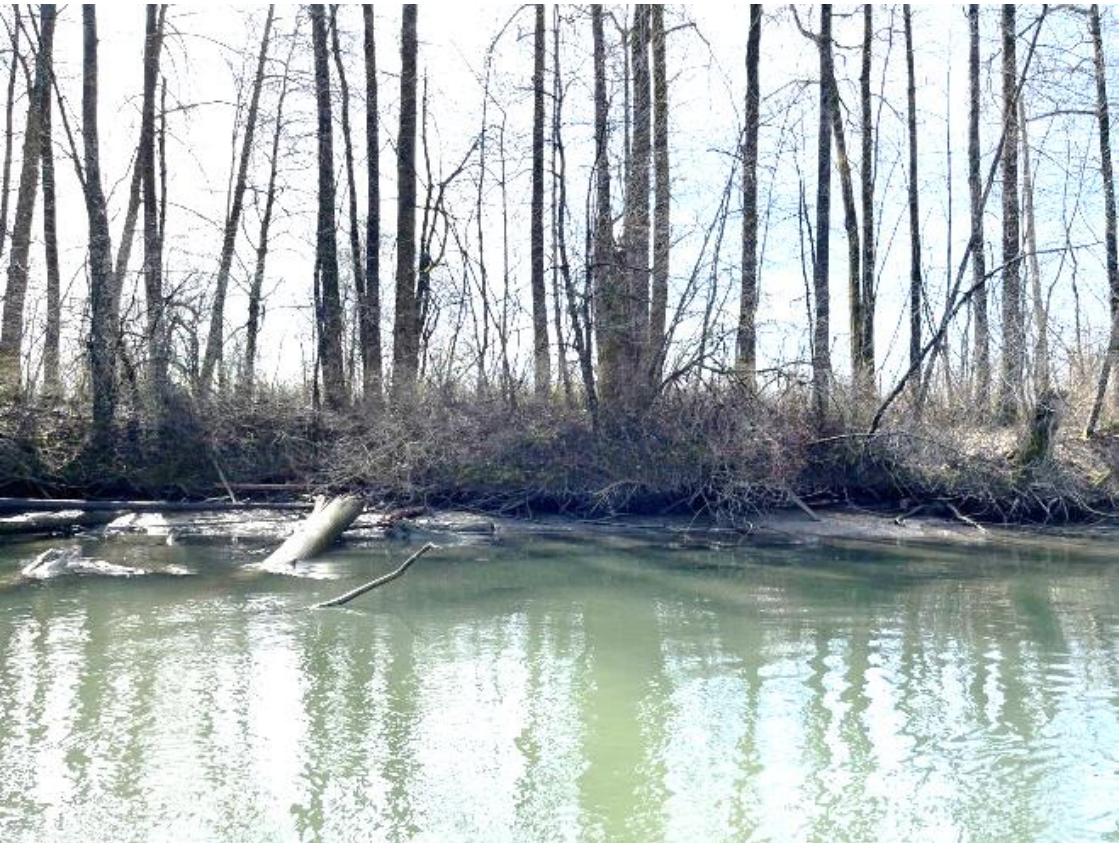
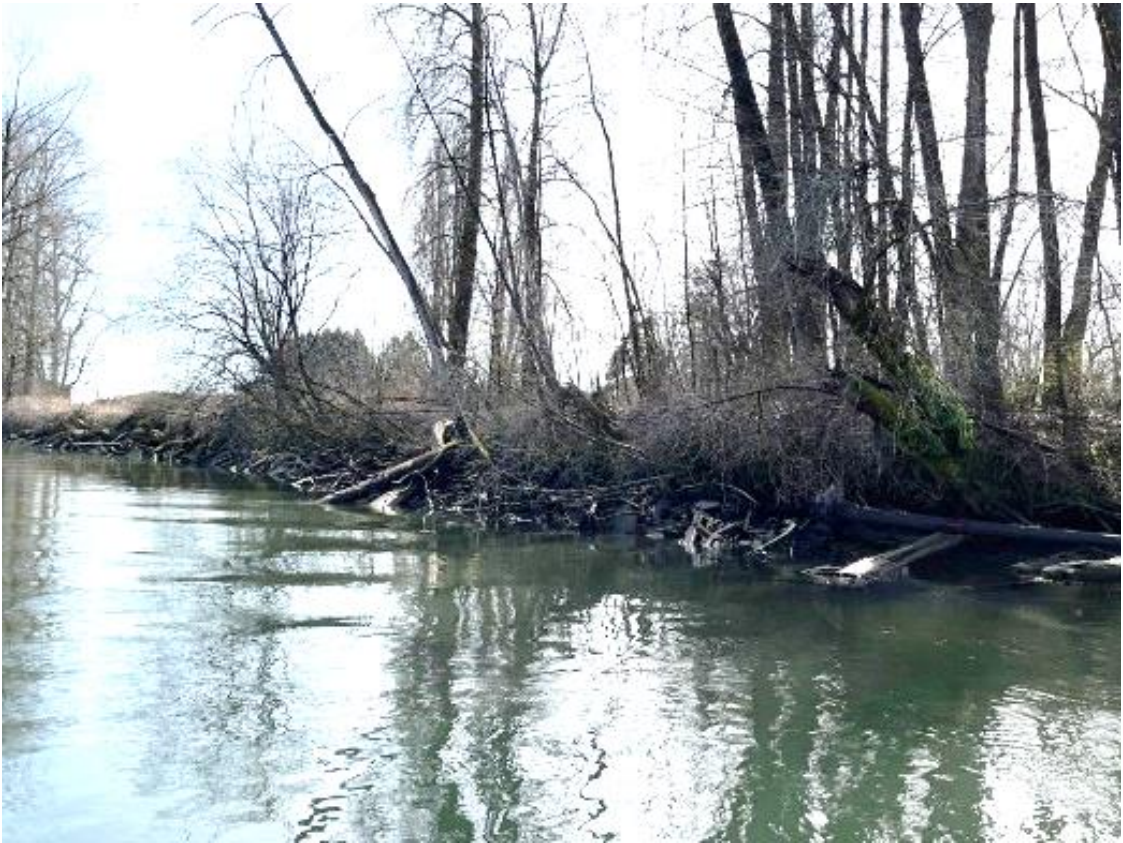
<b>Dike Station</b> 7+150	<b>Inspection Location</b>

<b>Active Erosion</b> Yes	<b>Bank Protection</b> No
<b>Notes</b> Location of downstream end of riprap section. There is active erosion downstream of where the riprap ends, with undercut banks and exposed tree roots.

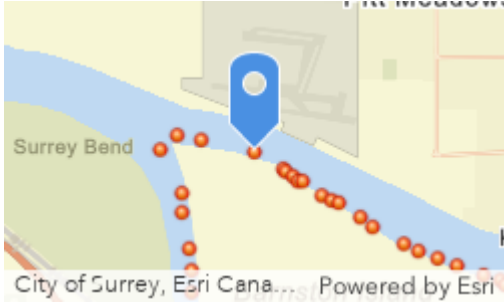
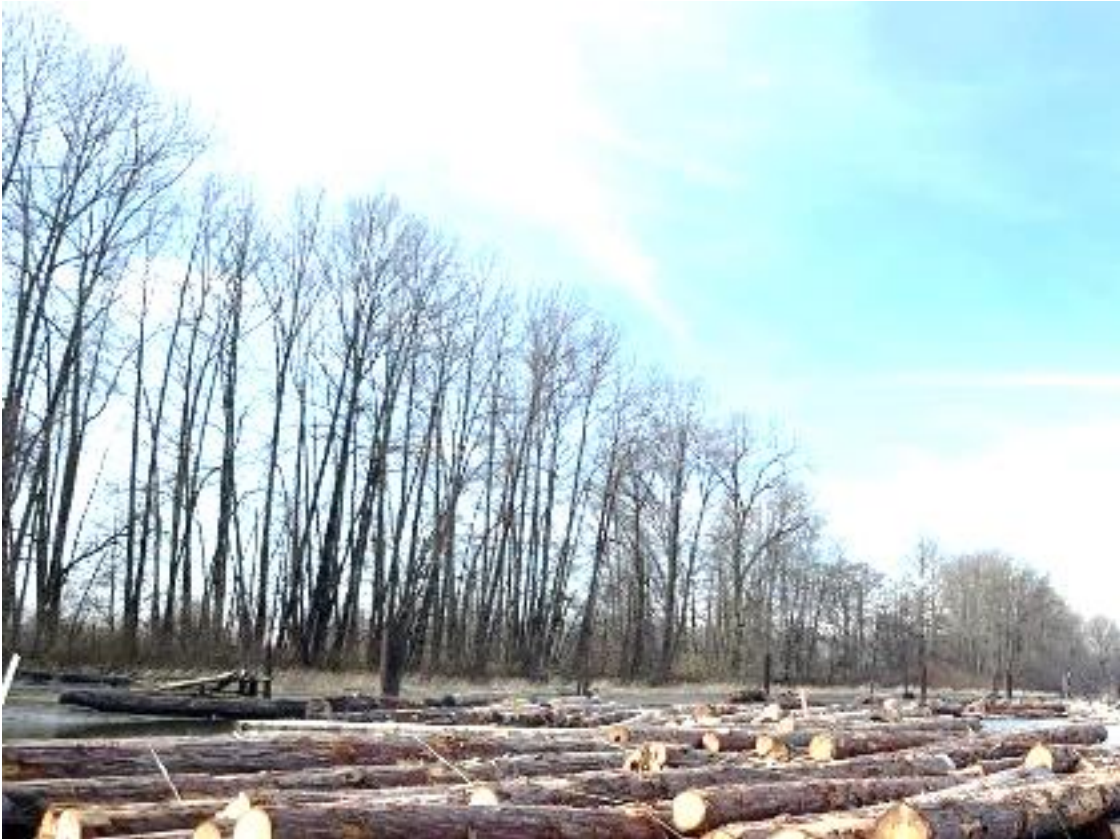
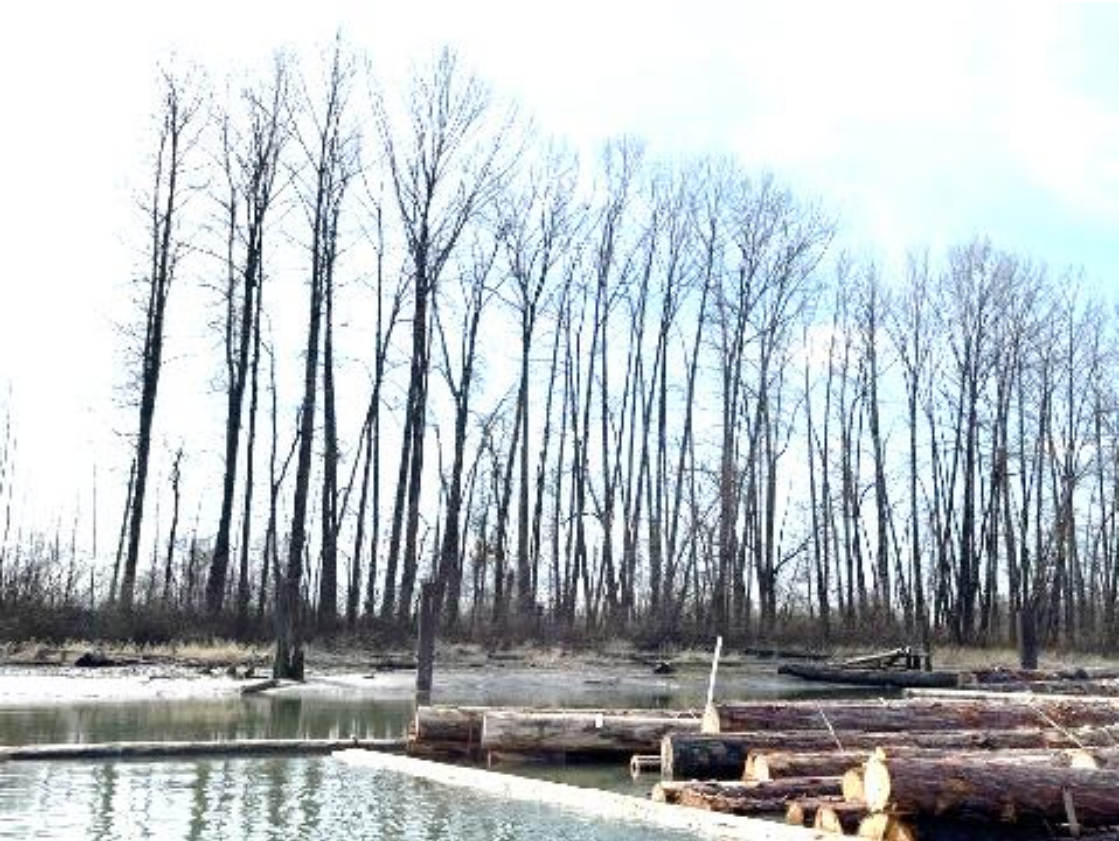
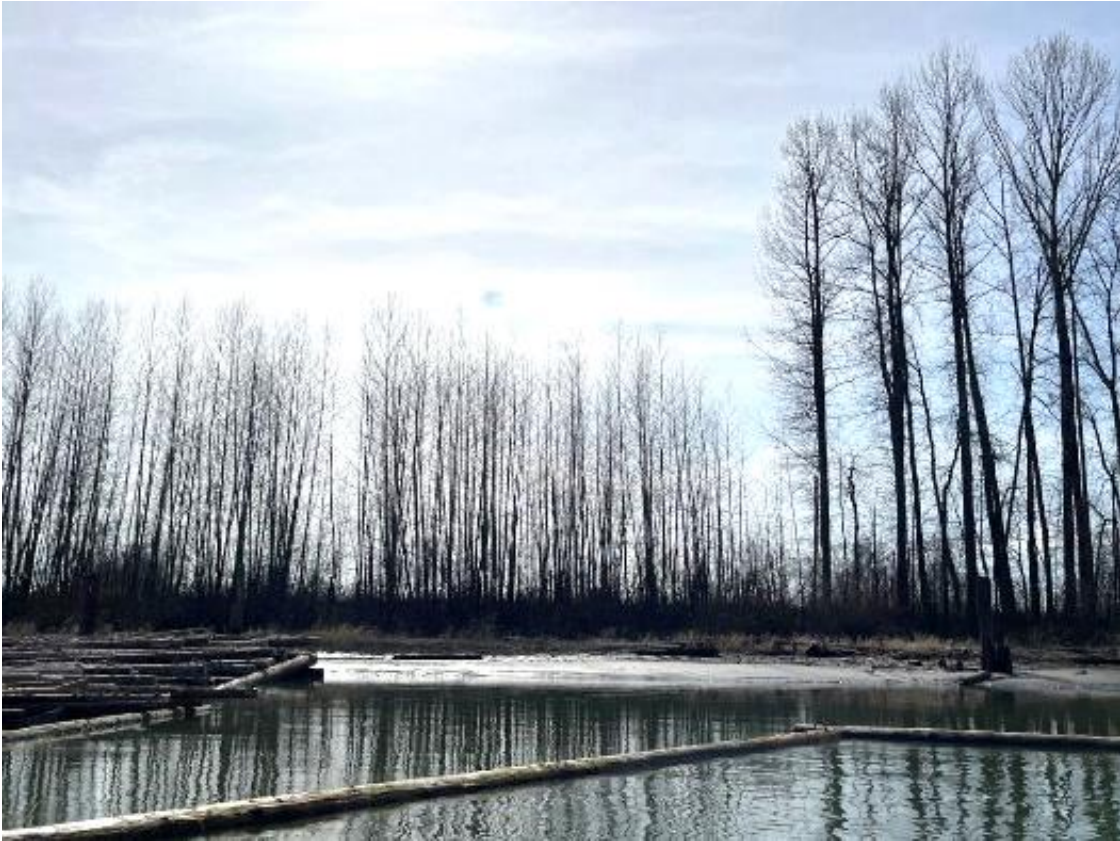
<b>Dike Station</b> 7+475	<b>Inspection Location</b>

<b>Active Erosion</b> No	<b>Bank Protection</b> No
<b>Notes</b> Sandy beach at bottom of upper bank. Widespread erosion not observed here. Dense mature vegetation is present at top of bank.
