**Northwest Hydraulic Consultants Ltd.**

NHC Reference 3008460  
May 10, 2024

**Re:** **Barnston Island Dike Assessment Update 2023**  
**Preliminary Report, Final**

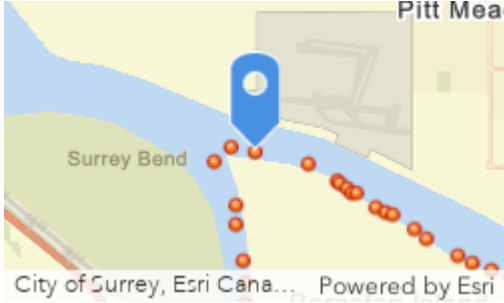
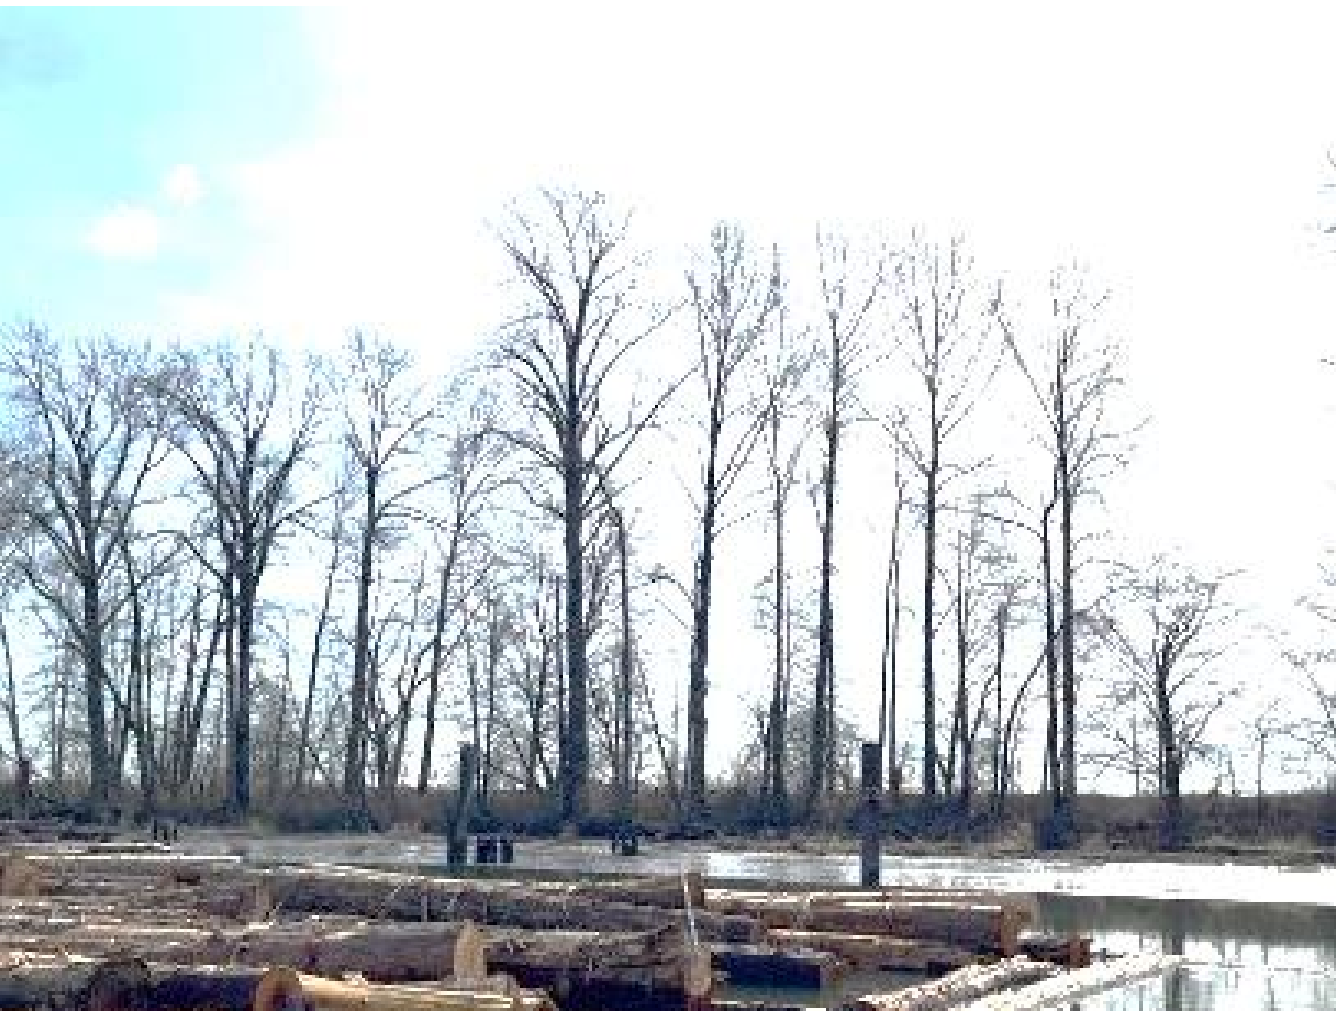
<div>Dike Station</div> <div>8+025</div>	<div>Inspection Location</div> <div>

</div>
<div>Active Erosion</div> <div>No</div>	<div>Bank Protection</div> <div>No</div>
<div>Notes</div> <div>A sandy terrace is visible at bottom of bank. Mature trees are present at top of bank. Erosion does not appear to be progressing here.</div>

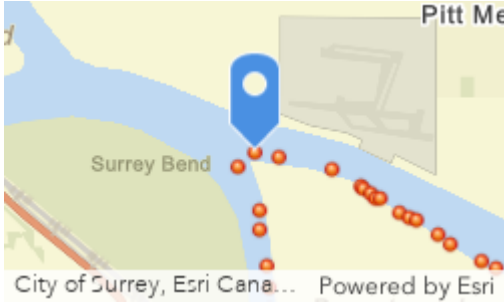
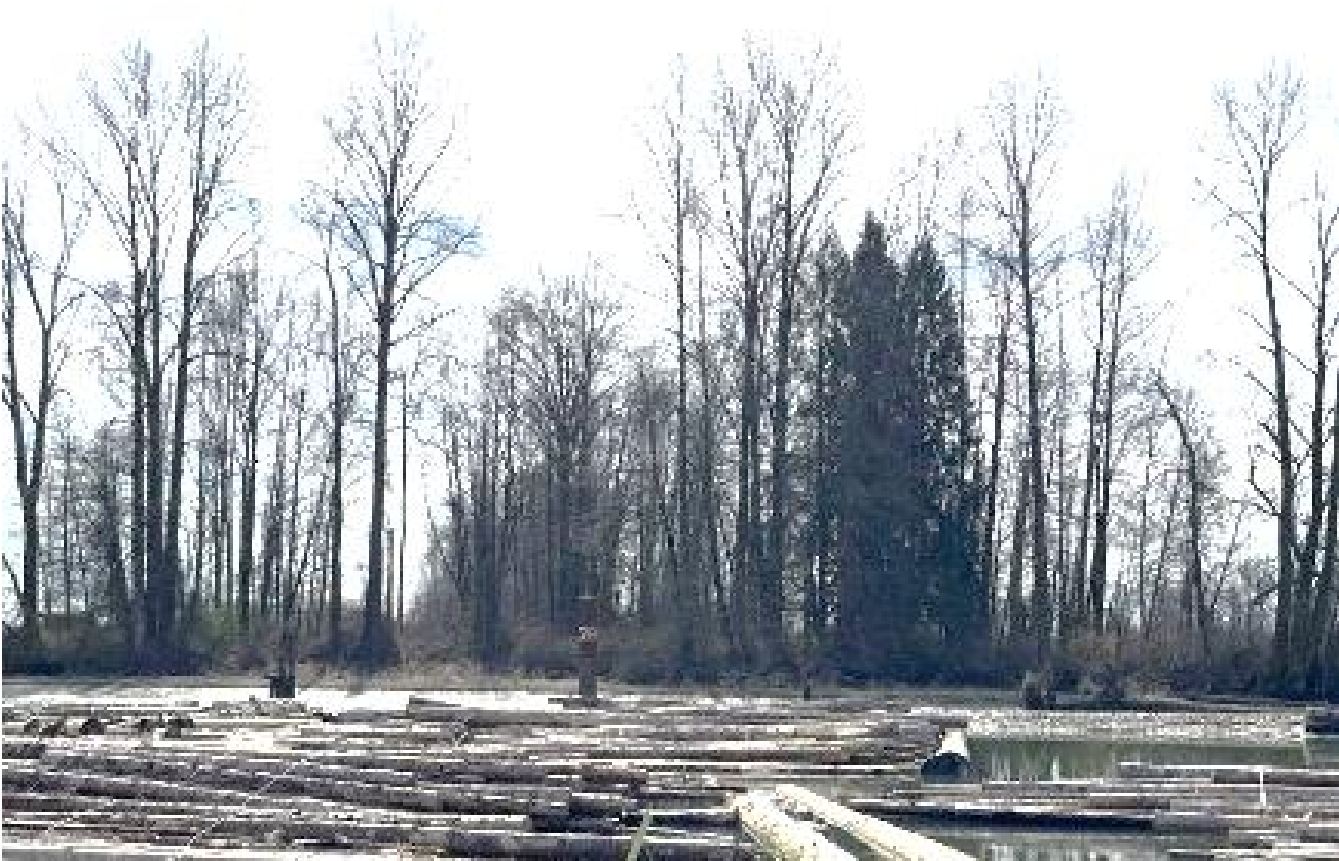
<div>Dike Station</div> <div>8+175</div>	<div>Inspection Location</div> <div>

</div>
<div>Active Erosion</div> <div>No</div>	<div>Bank Protection</div> <div>No</div>
<div>Notes</div> <div>Sandy terrace present at bottom of upper bank. Upper bank is steep with mature trees that have some roots exposed, but trees are not leaning toward the channel. Bank line appears more stable than farther upstream along Bishops Reach.</div>

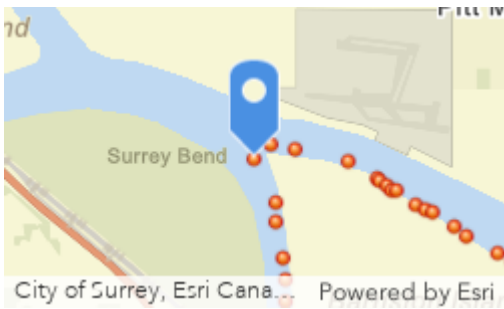
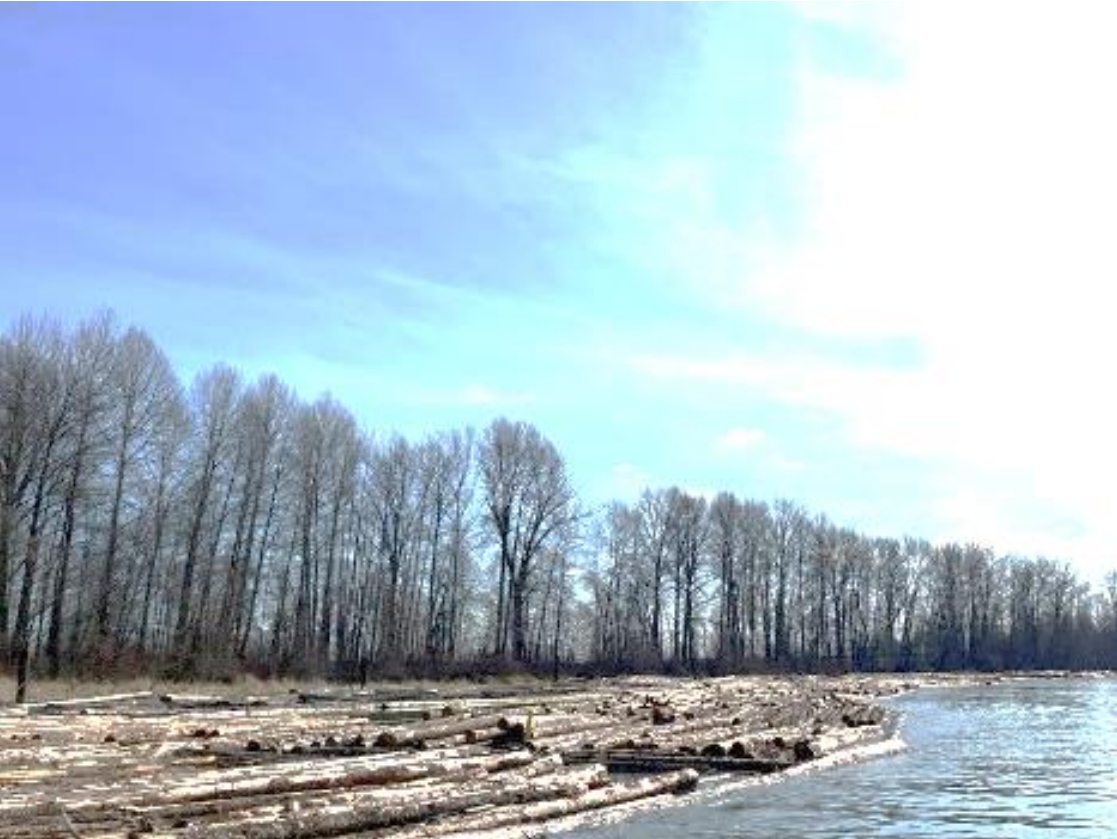
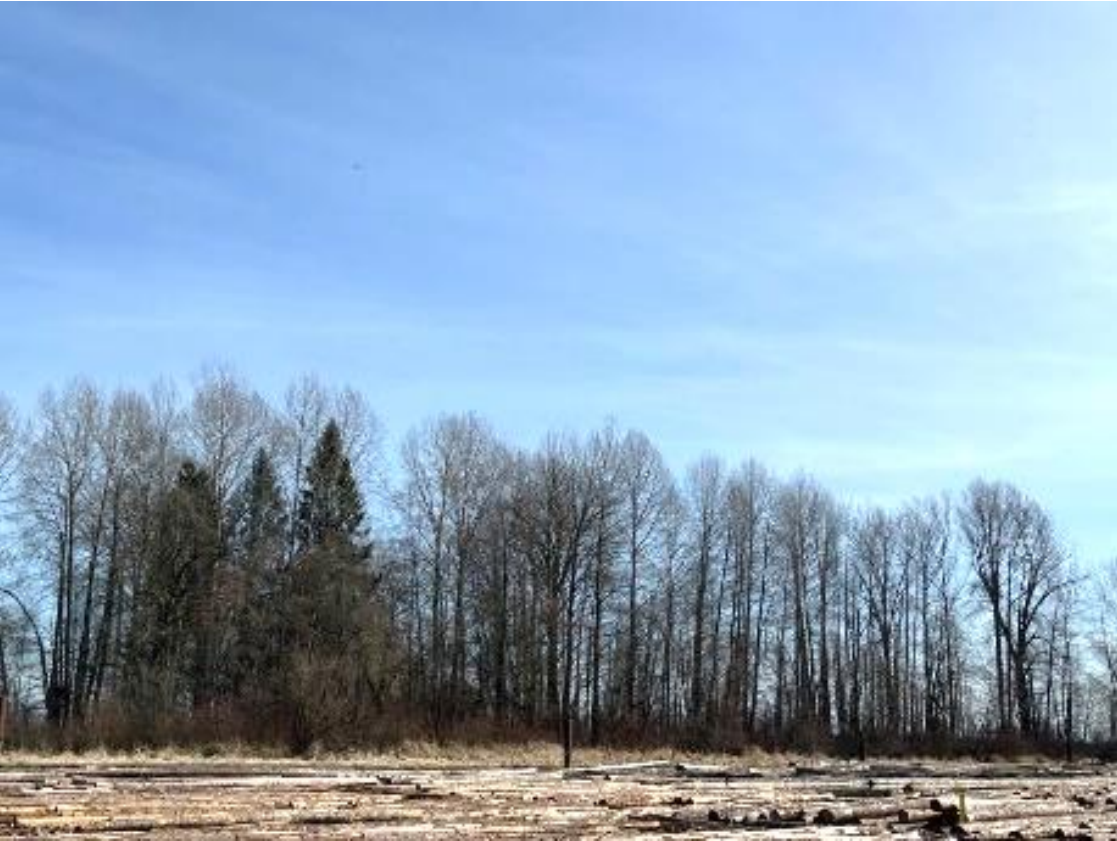
<div>Dike Station</div> <div>8+250</div>	<div>Inspection Location</div> <div>

</div>
<div>Active Erosion</div> <div>No</div>	<div>Bank Protection</div> <div>No</div>
<div>Notes</div> <div>West end of Barnston Island. No evidence of erosion. Thick mature vegetation is present at top of bank.</div>

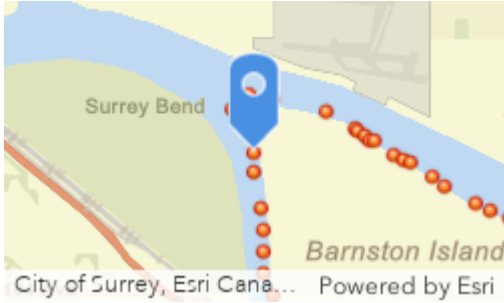
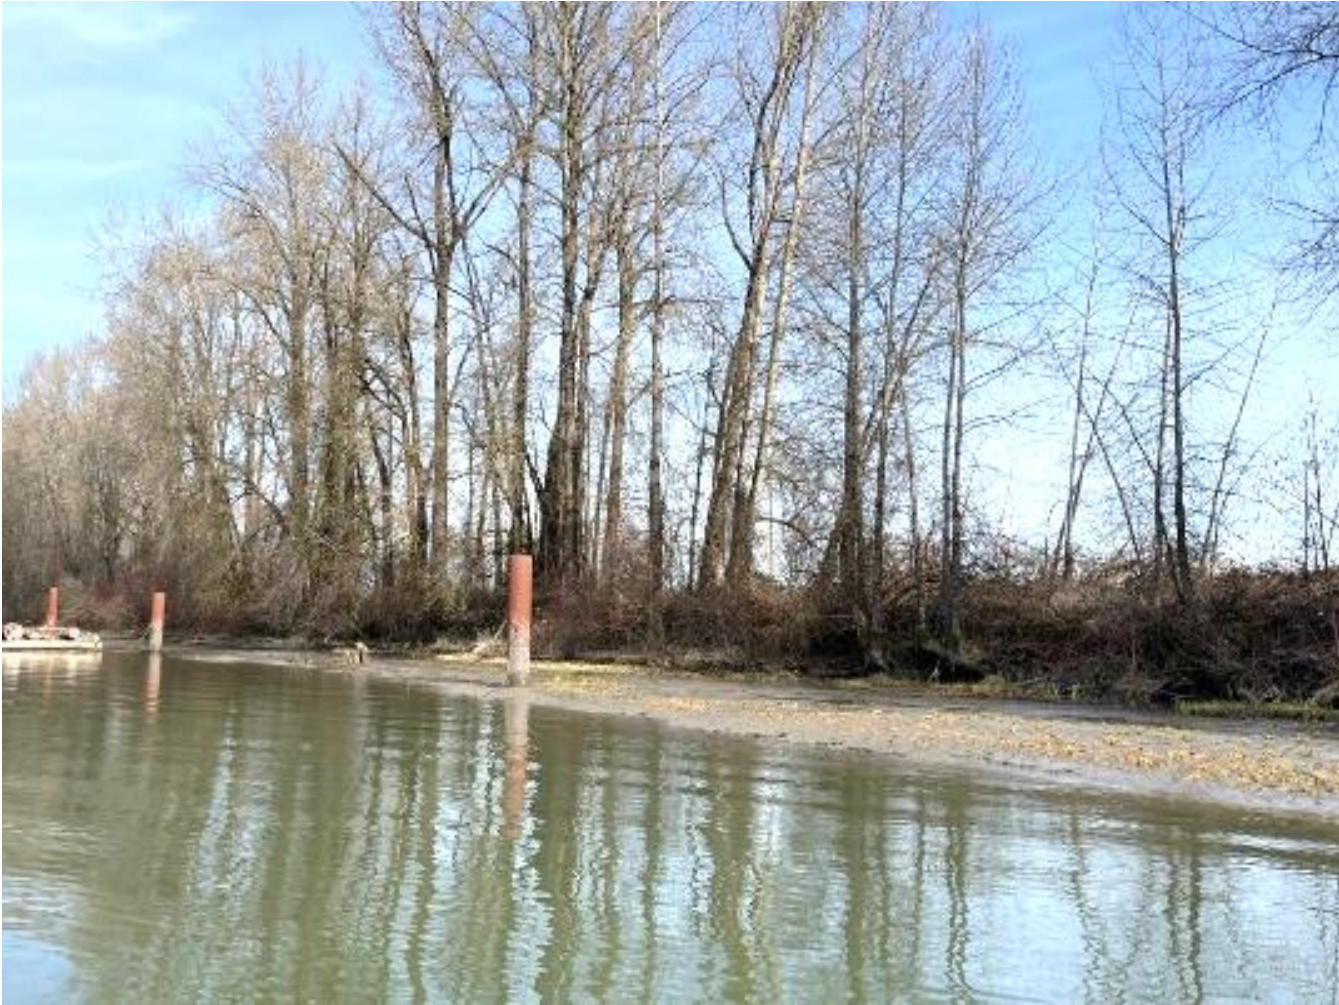
<div>Dike Station</div> <div>8+625</div>	<div>Inspection Location</div> <div>

</div>
<div>Active Erosion</div> <div>Yes</div>	<div>Bank Protection</div> <div>No</div>
<div>Notes</div> <div>Mature trees have roots exposed by erosion, but are not leaning into channel</div>

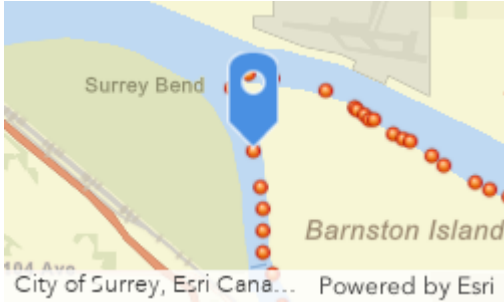
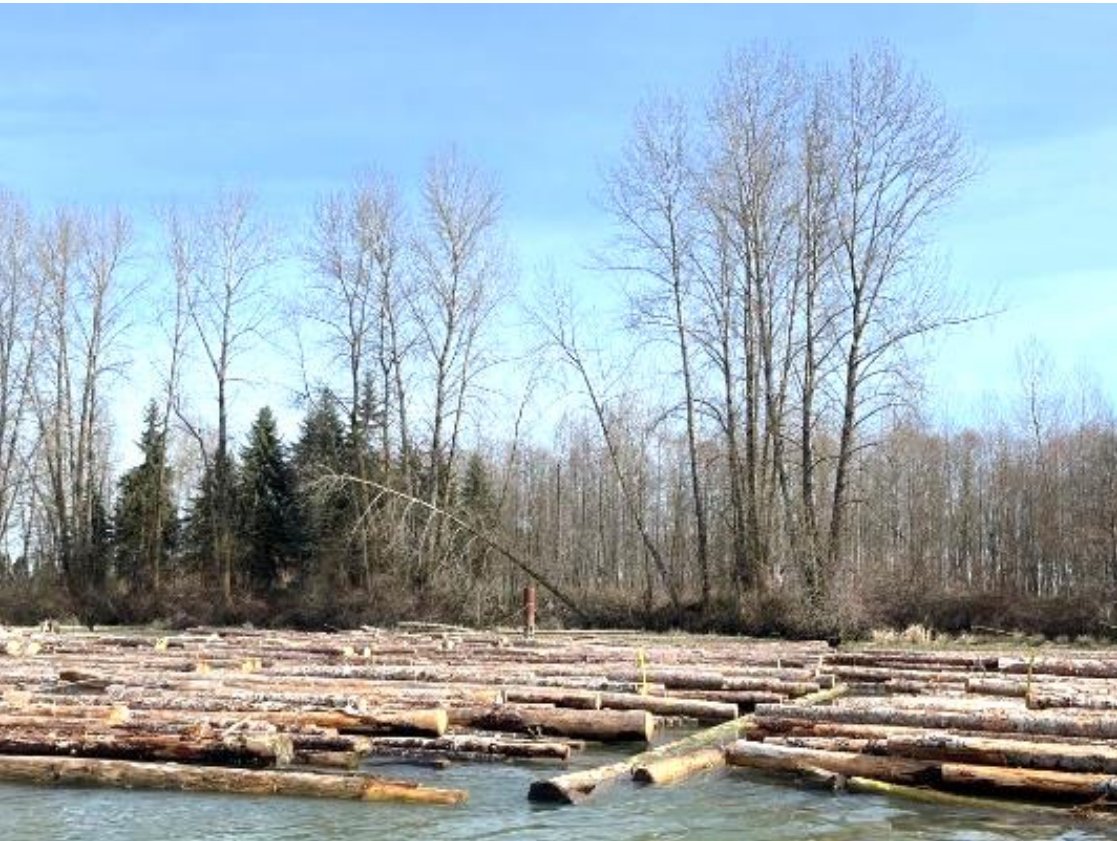
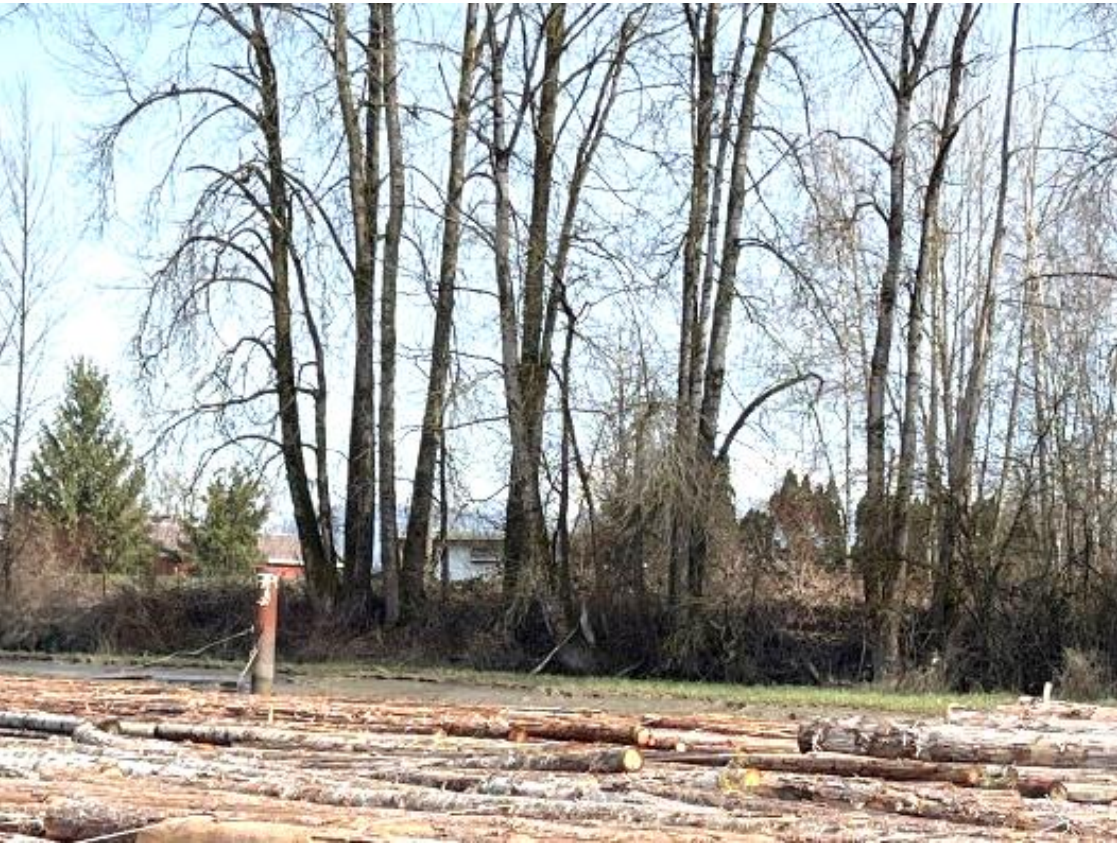
<div>Dike Station</div> <div>8+850</div>	<div>Inspection Location</div> <div>

</div>
<div>Active Erosion</div> <div>No</div>	<div>Bank Protection</div> <div>Yes</div>
<div>Notes</div> <div>Localized minor bank erosion, evidenced by leaning trees and exposed roots</div>

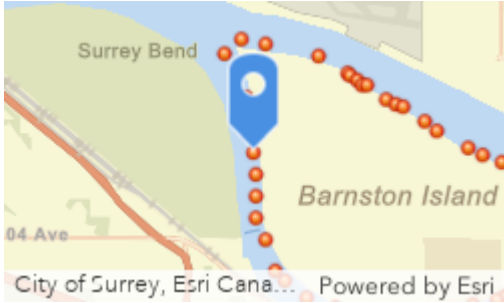
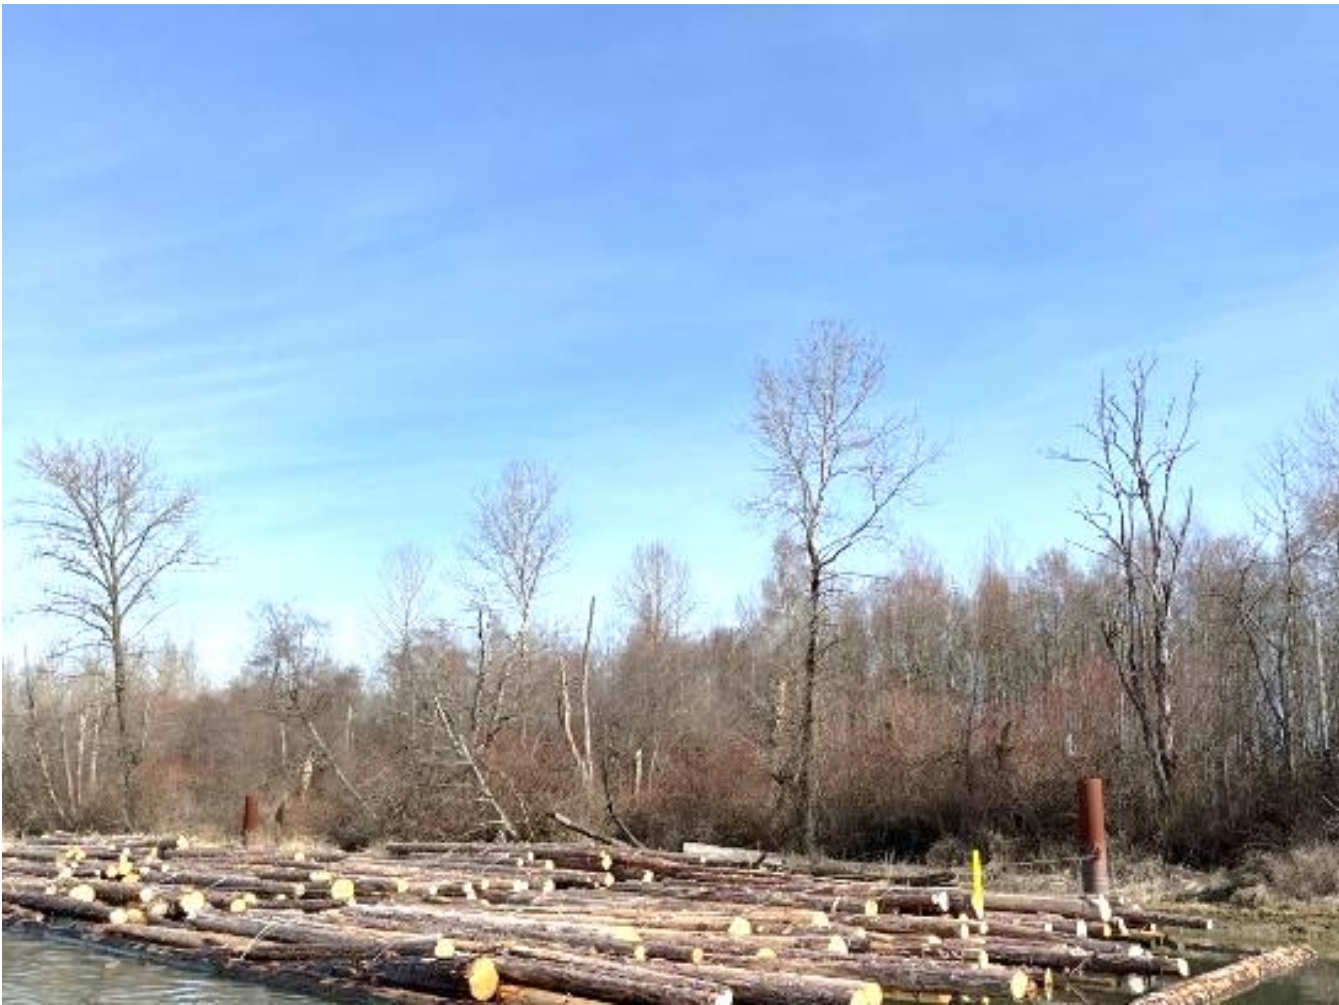
<div>Dike Station</div> <div>9+200</div>	<div>Inspection Location</div> <div>

</div>
<div>Active Erosion</div> <div>No</div>	<div>Bank Protection</div> <div>No</div>
<div>Notes</div> <div>Minor localized erosion, but bank is well vegetated</div>

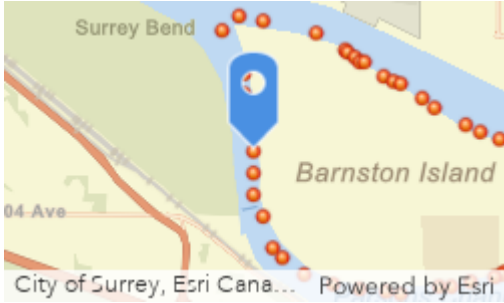
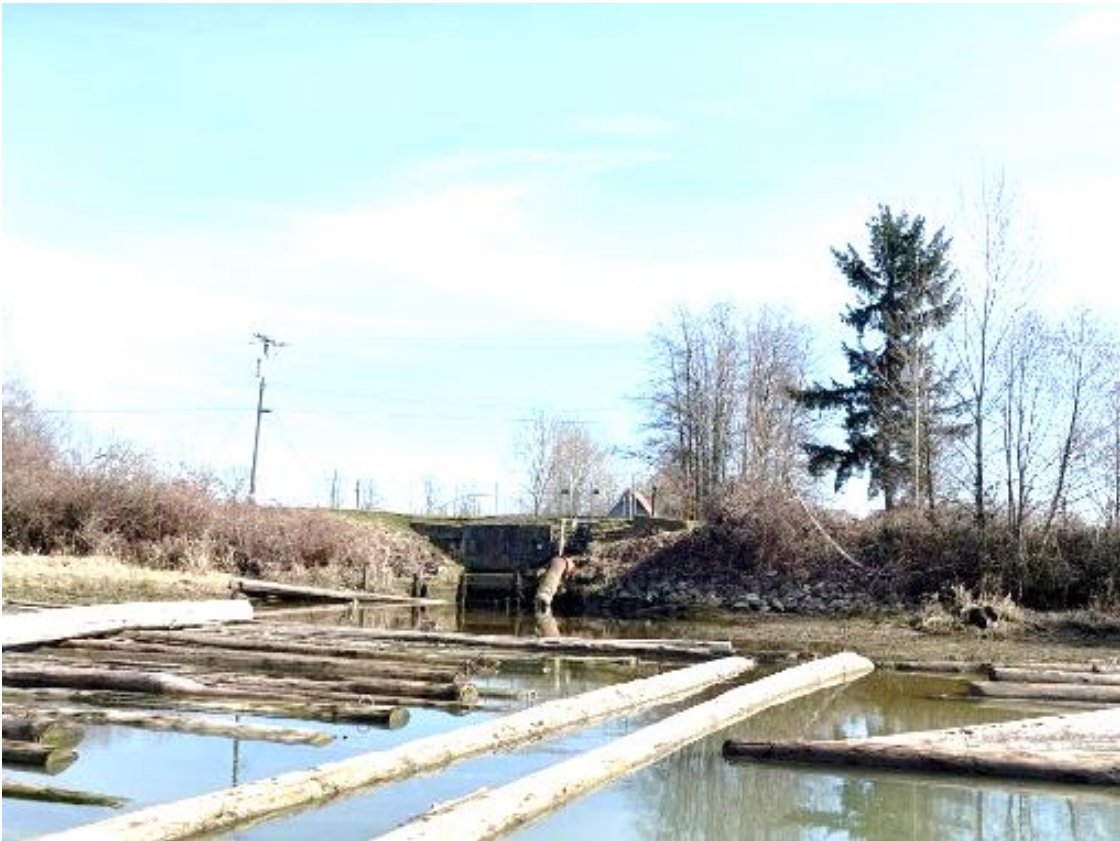
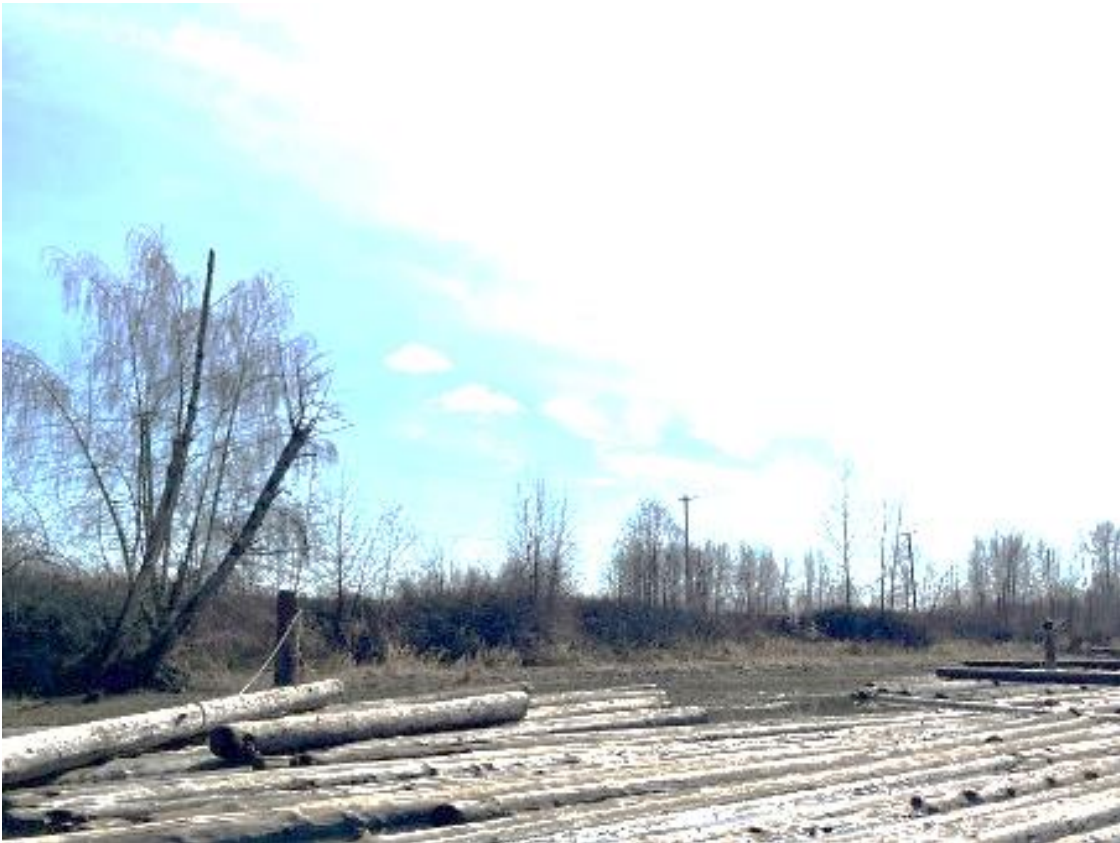
<div>Dike Station</div> <div>9+450</div>	<div>Inspection Location</div> <div>

</div>
<div>Active Erosion</div> <div>Yes</div>	<div>Bank Protection</div> <div>Yes</div>
<div>Notes</div> <div>Location of pump station. There is localized riprap upstream of pump station. Bank upstream of pump station is steep and not well vegetated. Dike is close to bank.</div>

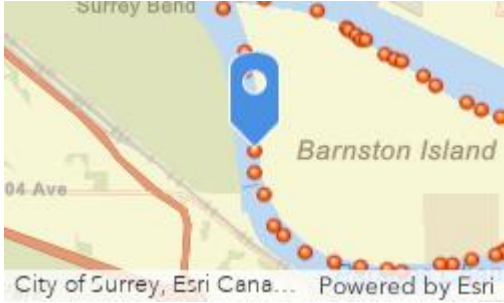
<div>Dike Station</div> <div>9+675</div>	<div>Inspection Location</div> <div>

</div>
<div>Active Erosion</div> <div>Yes</div>	<div>Bank Protection</div> <div>No</div>
<div>Notes</div> <div>Bank is quite close to dike, with minimal mature vegetation providing protection against erosion. Exposed tree roots indicate active erosion. This is the location of self-launching riprap that is buried in a trench on land. It was observed during the October 2023 inspection by car that the riprap was exposed/imminently launching in some locations, indicating bank retreat since 2012.</div>

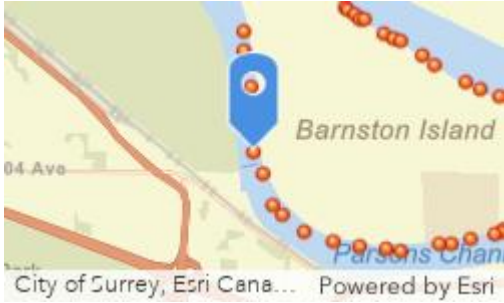
<div>Dike Station</div> <div>9+875</div>	<div>Inspection Location</div> <div>

</div>
<div>Active Erosion</div> <div>No</div>	<div>Bank Protection</div> <div>Yes</div>
<div>Notes</div> <div>Riprap placed along bank in front of house. Structures are located close to top of bank. Bank does not appear to be actively eroding.</div>
