Landslide Risk Assessment, Moonshine Bay, Pitt Lake

Cordilleran Geoscience
PO Box 612
Squamish, BC
V8B 0A5

Draft: December 8, 2020; Final: December 16, 2020

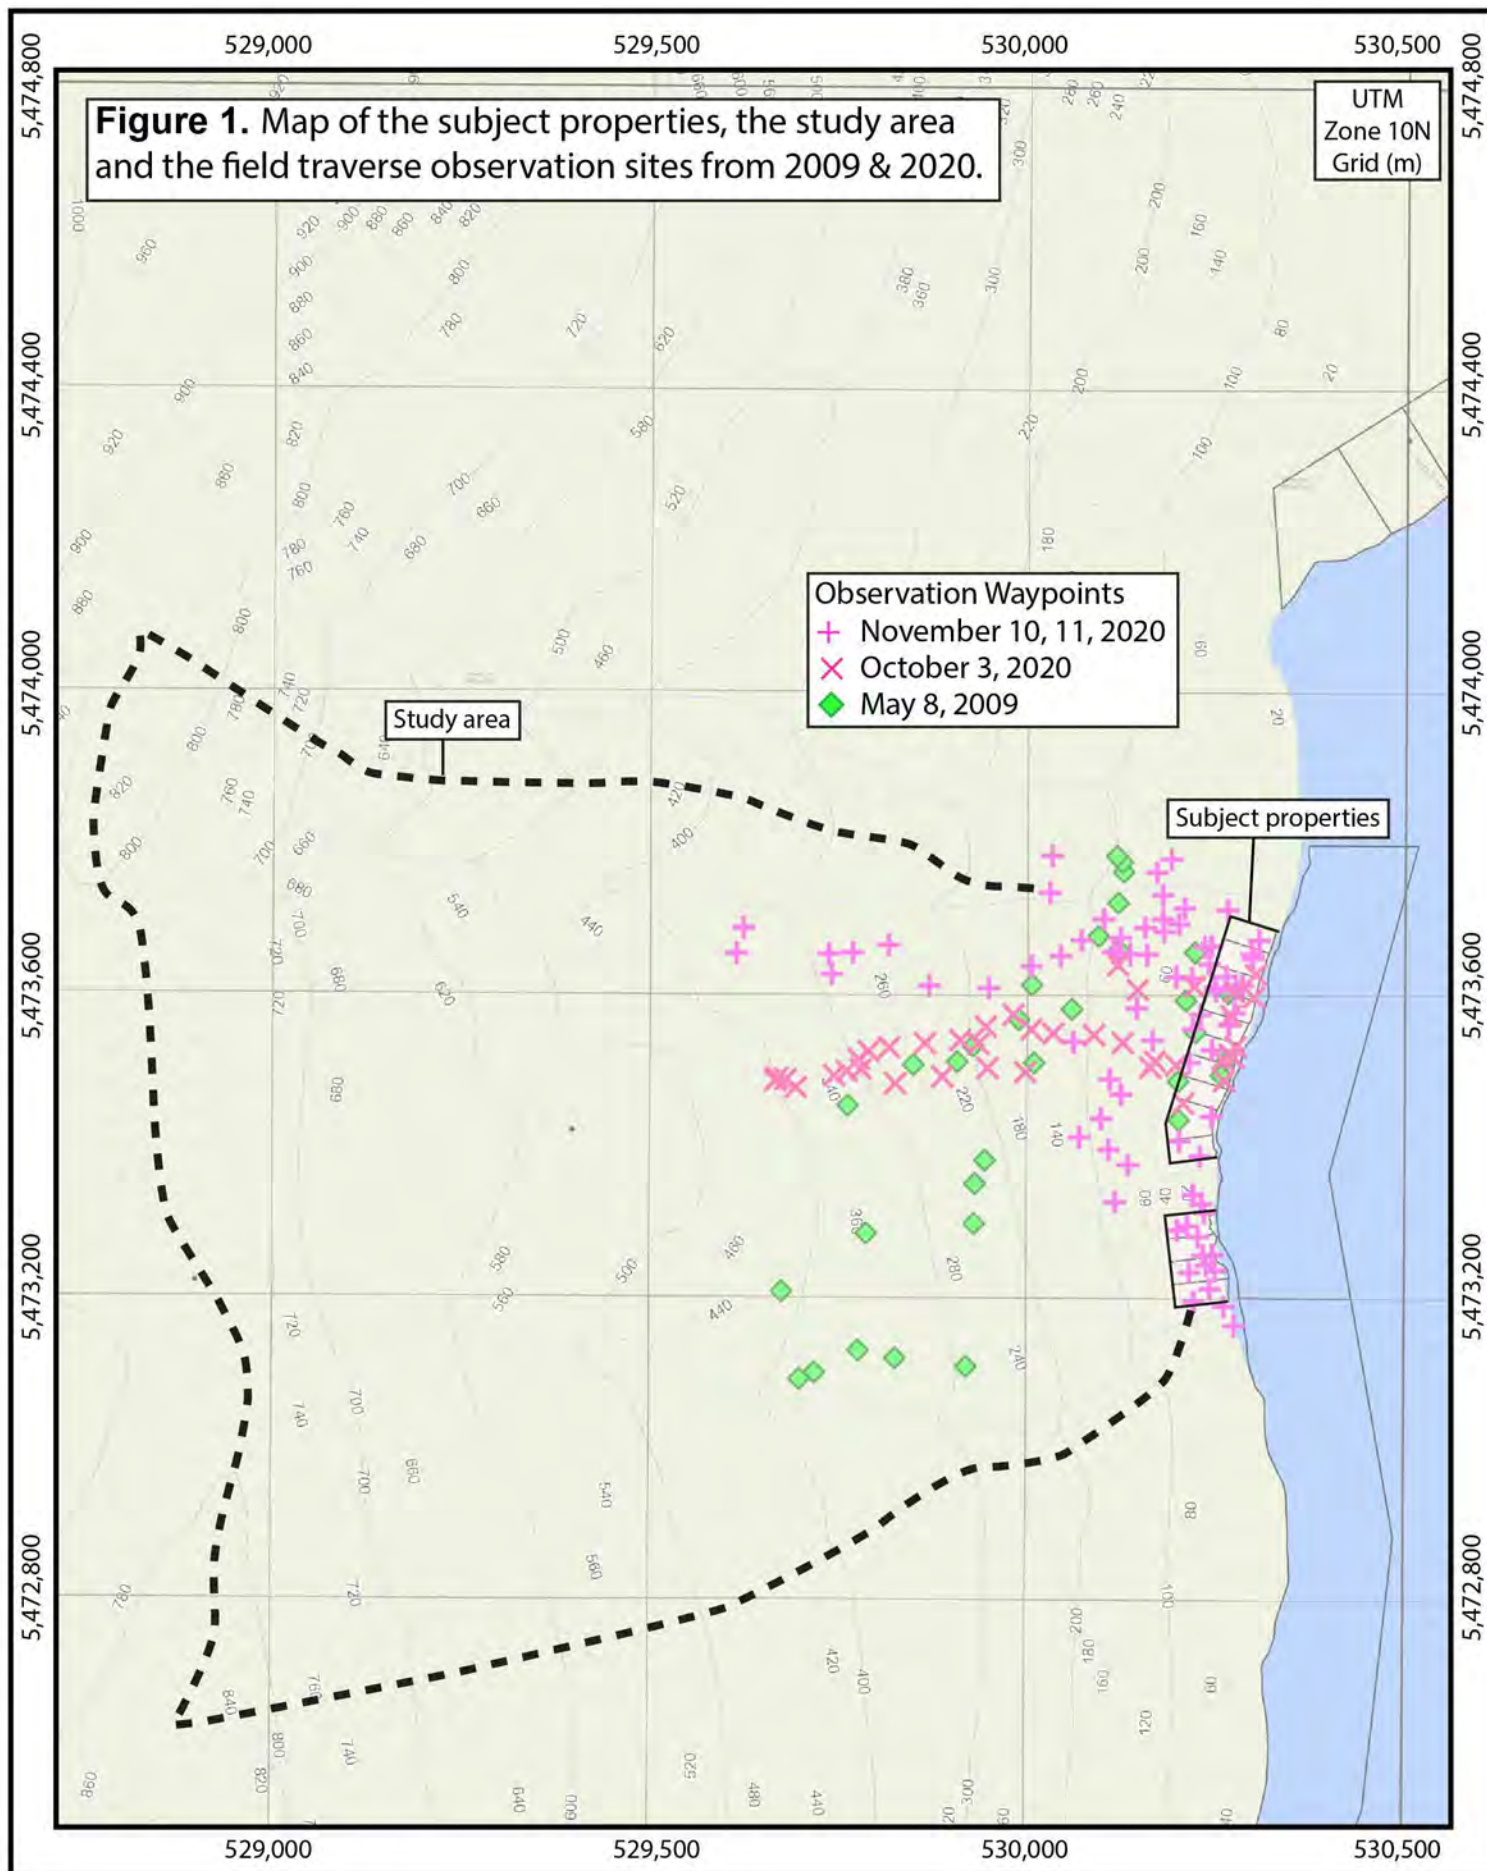
- Figure 1.** Map of the subject properties, the study area and the field traverse observation sites from 2009 & 2020.
- Figure 2.** Climate in the study area at 700 m elevation.
- Figure 3.** Geomorphic Map of the Moonshine Bay study area showing landform units, geomorphic analysis, selected field observations and Lot IDs.
- Figure 4.** Debris fencing installed to protect Highway 1 just east of Lytton

Table 2 lists lots identified by MoFLNRO as requiring hazard and risk assessment. The lots and the terrain upslope that affects the lots defines the study area (Figure 1).

In the field, observations of slope, parent material, landform type, evidence of geomorphic activity were recorded at specific sites with waypoint locations recorded by handheld GPS unit. A map of observation waypoints is included (Figure 1). A 1:10,000 scale basemap with 10 m contours and a coloured slope theme was prepared from TRIM topographic data using QGIS. A geomorphic map was prepared from field observations,

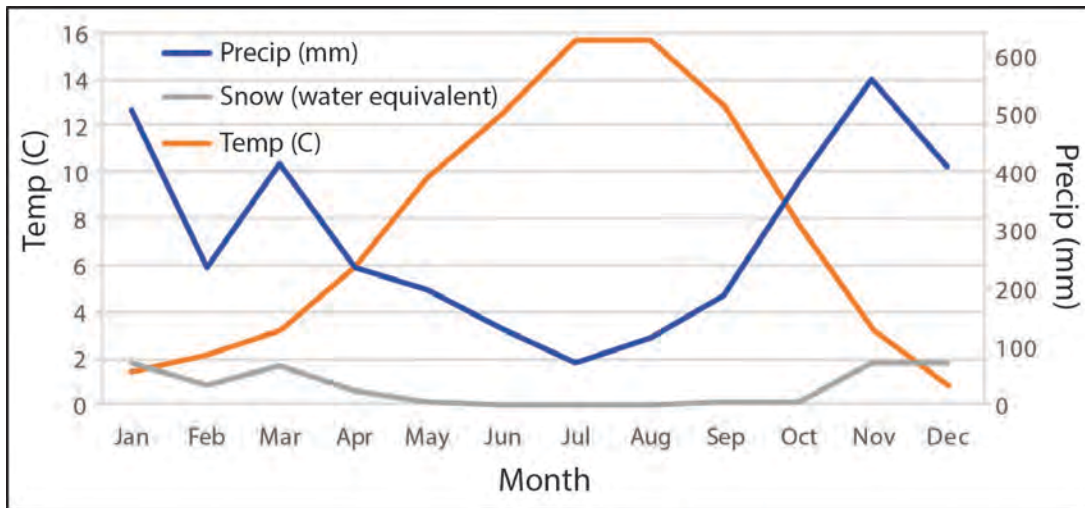
The study area (Figure 1) is located on the southwest shore of Pitt Lake. The climate at 700 m elevation above the subject properties was provided by Climate BC (<http://www.climatewna.com>). The climate is cool and wet (Figure 2). The mean annual temperature is 7.6 °C, with average monthly temperatures of 1-2 °C in winter months rising to 16 °C in July/August. The area is seasonally very wet, with a mean annual precipitation of 3452 mm, with the wettest months (>200 mm) extending from October through April. About 15-20% of winter precipitation falls as snow.

Figure 2. Climate in the study area at 700 m elevation.

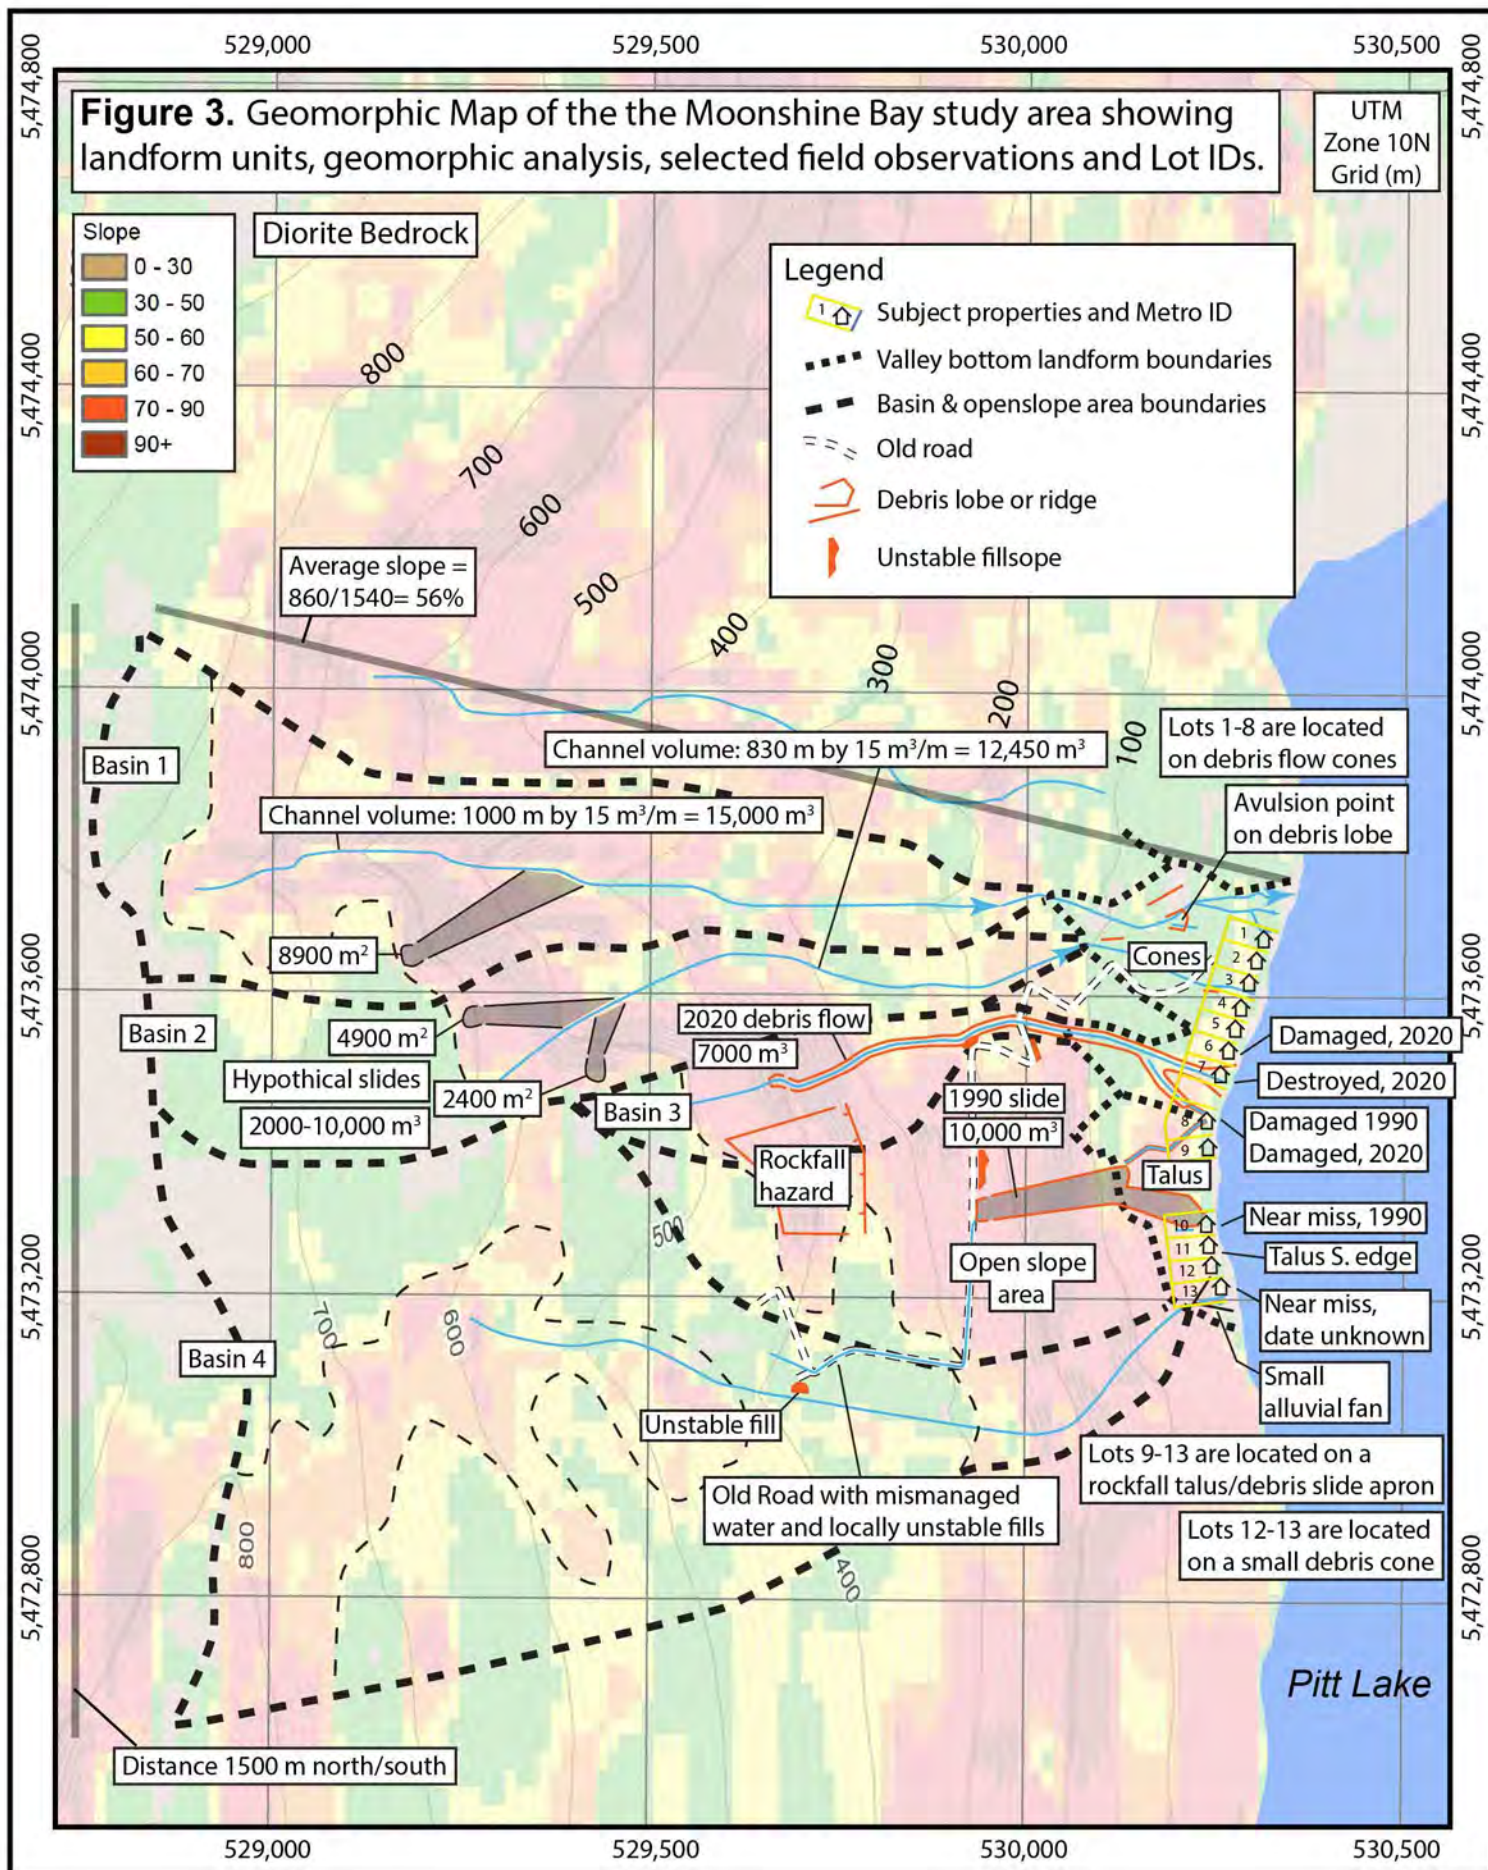
Bedrock underlying the hillslope is competent intrusive plutonic rock (diorite). The terrain above the lots rises from lake level at ~2 m elevation to the ridge crest at 860 m elevation, with an average slope of 56%. The north/south length of the study area at water level is about 575 m distance, but at the height of land it is about 1500 m, indicating considerable horizontal convergence (Figure 3).

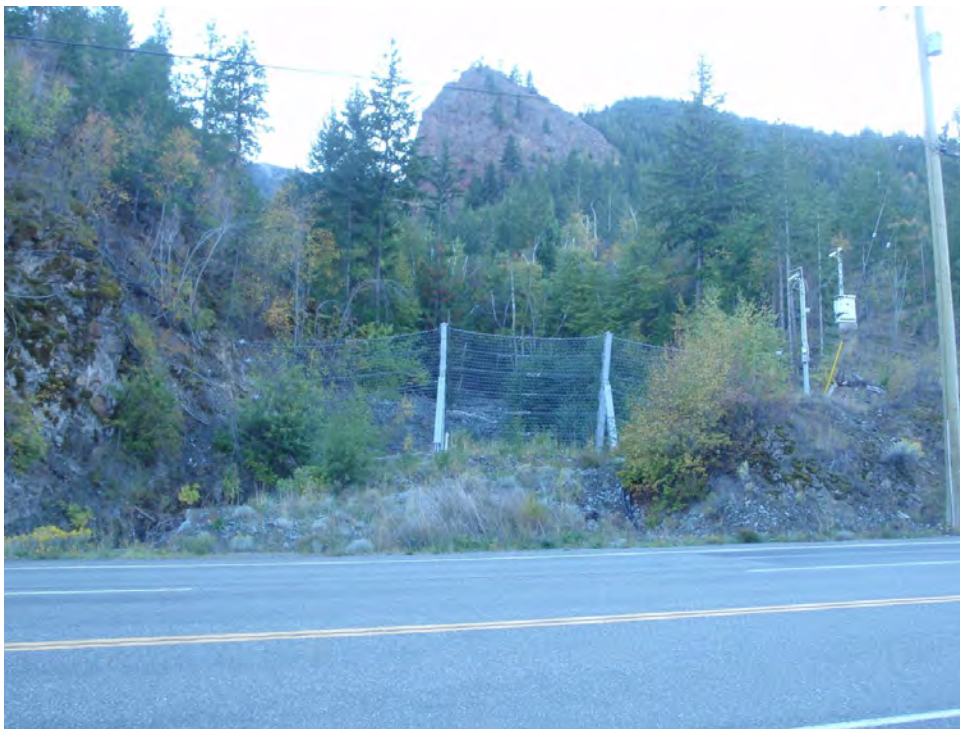
Figure 4. Debris fencing installed to protect Highway 1 just east of Lytton.

Landslide netting. These are less invasive, less expensive, and require management plan and maintenance. Questions arise over authority/responsibility. Geobrugg & Maccaferri are local suppliers that specialize in rockfall and debris flow netting solutions (www.geobrugg.com; www.maccaferri.com) They or other suppliers can be approached for budget estimates.
